**AVIATION INVESTIGATION REPORT
A11P0027**

MIDAIR COLLISION

**CESSNA 150G C-FVXY AND
CESSNA 150L C-GZUB**

**DEWDNEY, BRITISH COLUMBIA
09 FEBRUARY 2011**

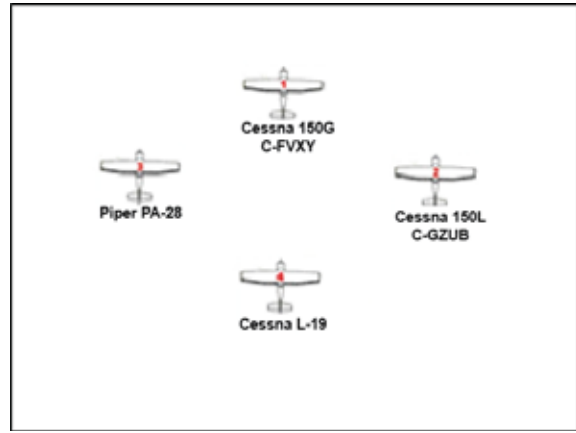
Figure 1. Diamond pattern (diagram not to scale)

The lead aircraft was the Cessna 150G (C-FVXY) with 2 occupants on board. On the right-hand wing of the leader, in the number 2 position, was the Cessna 150L (C-GZUB) with only the pilot on board. Also in the group was the Piper PA-28-180, with 2 occupants on board, in the number 3 position on the leader's left side. The solo Cessna 305A (L-19) was in the number 4 position at the rear of the other 3 aircraft.

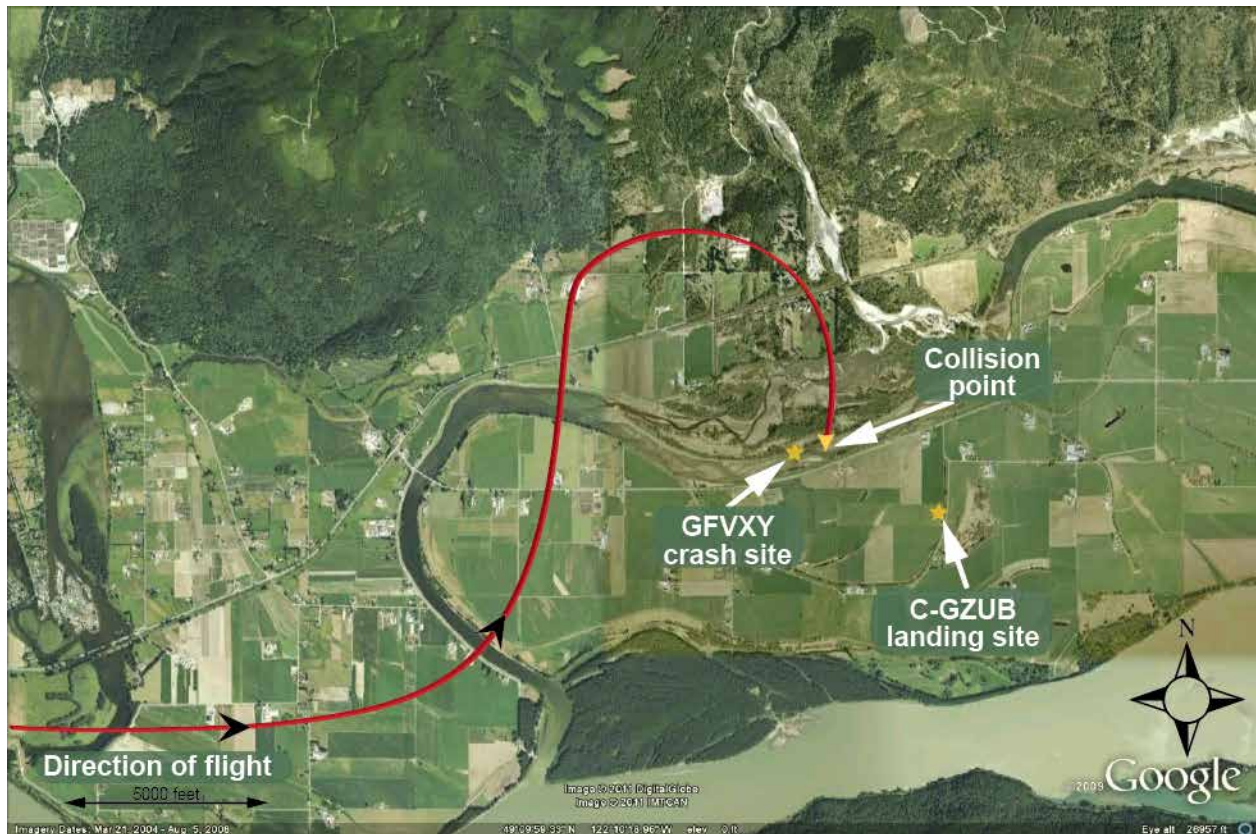
Figure 2. Site map showing route of formation flight

When the formation flight neared the township of Dewdney, British Columbia, at 1500 feet above sea level (asl), about 1450 feet above ground level (agl), and at a speed of 90 mph, the leader initiated a 15° angle-of-bank left turn for about a 90° heading change, and rolled out heading north. In preparation for this turn, the leader advised the number 2 aircraft (C-GZUB, on the outside of the turn) to increase engine power to account for the increased radius of turn. This instruction is in accordance with conventional station-keeping practice during formation flight, and was a practice this leader had often used with newcomers to the group. During this left-turn manoeuvring, the lateral distance and step-back of the number 2 aircraft on the leader's right side increased somewhat, but C-GZUB returned to its original position once the flight rolled out on the northerly heading (Figure 2).

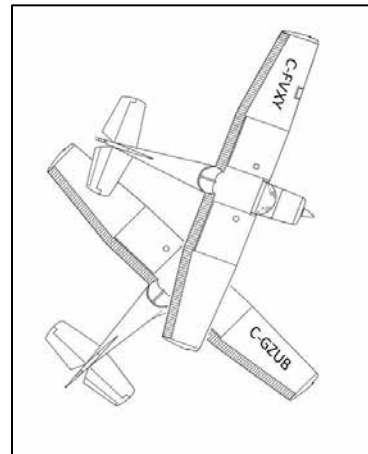
Figure 3. Collision diagram

At 1615, seconds after the leader called a roll-out, the two aircraft collided at almost 70° to each other (Figure 3). The aircraft began to rotate and descend joined together, and fell out of control for several seconds. At about 400 feet agl, the aircraft separated; C-FVXY broke up in flight and fell into a shallow slough, while the pilot of C-GZUB regained control and landed the aircraft without engine power in a farm field.

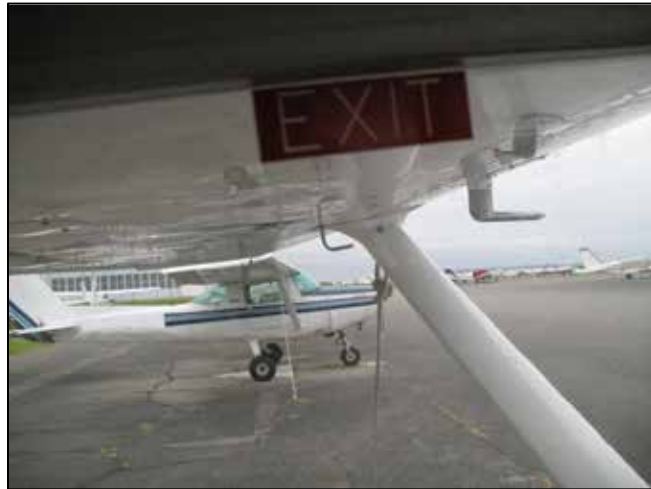
Photo 1. Typical view from left pilot seat

As with many high-wing aircraft, the pilot's field of view from the left-hand seat of a Cessna 150 is restricted in certain areas due to the cockpit size and layout, pilot seating, and fuselage dimensions. The overhead wing creates a large blind spot in the upper fields of view and to each side. In particular, the area above and left of the pilot's head is obstructed because of the close proximity of the wing. For a tall pilot, this obstruction to the field of view is even larger. Practical examinations of standard Cessna 150 aircraft show that the left-forward field of view of an average-height pilot is adequate below the wing tips, but severely compromised above that level (Photo 1). This makes it challenging for pilots to detect and avoid other aircraft.

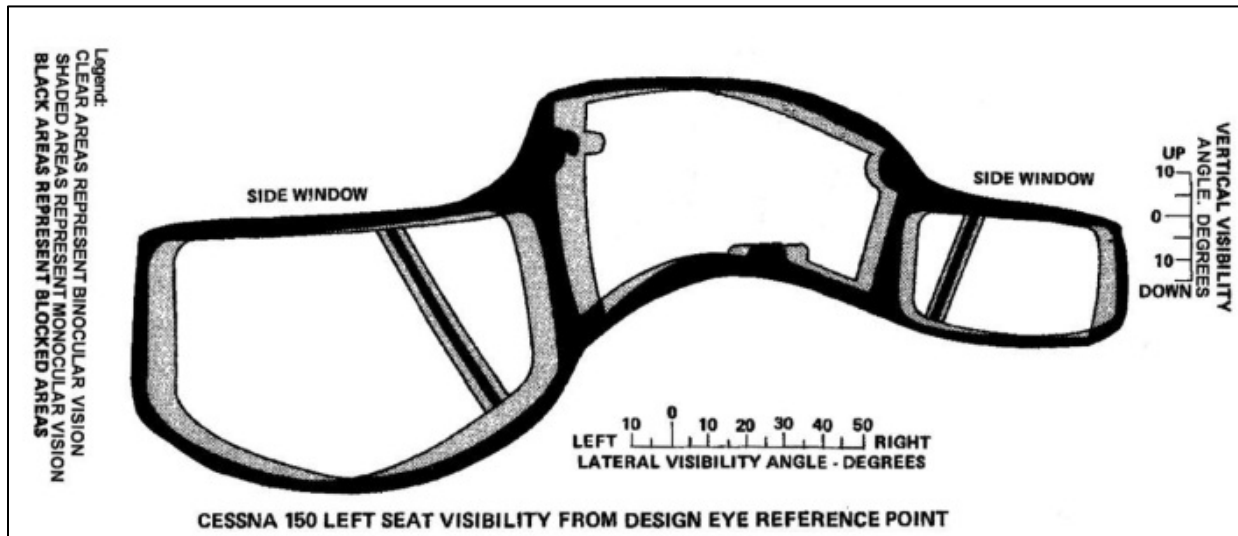
Figure 4. Cessna 150 left seat visibility from the DERP

For each pilot, there is an optimum seating position for the best vision inside and outside the cockpit, and for access to cockpit switches and controls. This position is usually termed by aircraft manufacturers as the design eye reference point or DERP (Figure 4). In small aircraft such as the Cessna 150, the pilot usually makes seat adjustments to optimize the following factors:

- full and free flight controls;
- access to critical controls;
- unobstructed view of all instruments and warning lights;
- outside forward visibility; and
- pilot comfort.

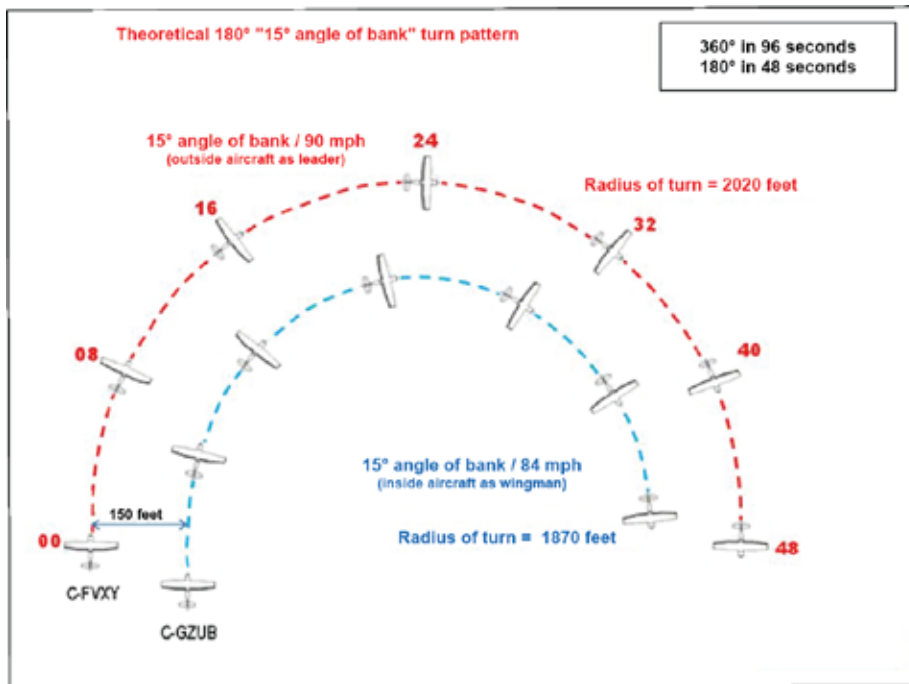
Figure 5. Formation turn at 15° angle of bank (diagram not to scale)

With regards to a 15° angle-of-bank right turn (Figure 5), with the 2 aircraft spaced 150 feet apart,⁵ the aircraft on the inside of the turn will have to reduce speed to maintain the proper relative position with the leader. In the case of the accident flight, with the leader travelling at 90 mph, the wingman would have had to reduce speed to about 84 mph to keep in place. Even with one aircraft travelling faster than the other, as long as the relative bearing remains constant, the aircraft will stay in proper formation station.

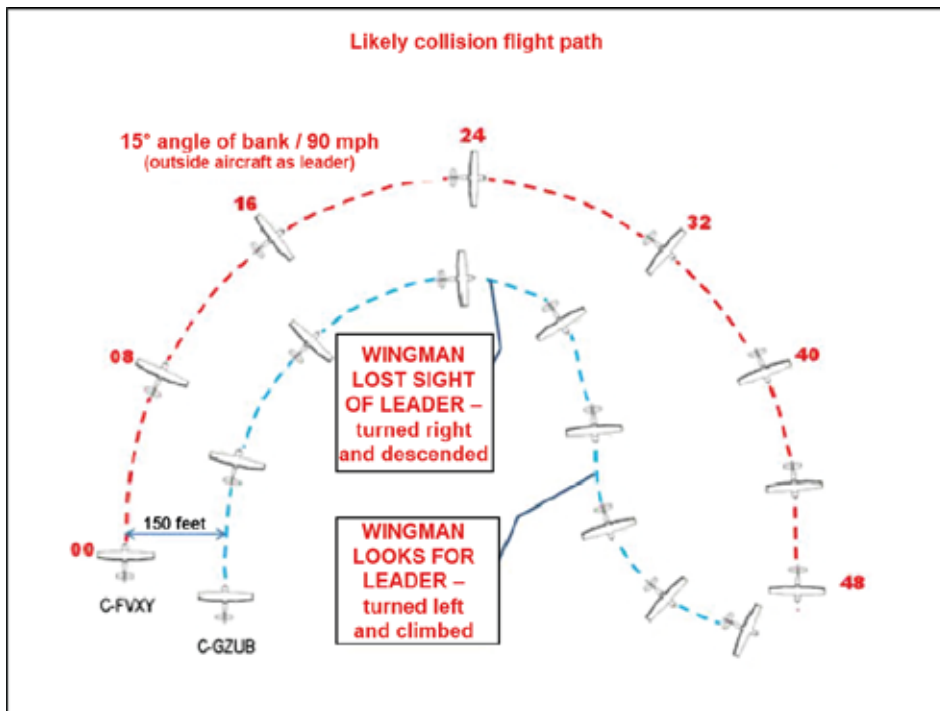
Figure 6. Likely collision flight path (diagram not to scale)

In summary, the Laboratory analysis concluded that, during the entry to the right turn (Figure 6), the speed differential would have caused C-GZUB to overtake and lose sight of the leader. This would also have prevented the pilot of C-GZUB from seeing the leader during the last left turn before the collision. It was also concluded that the leader would have been unable to see the wingman aircraft approaching from the right side until it was too late to avoid contact.

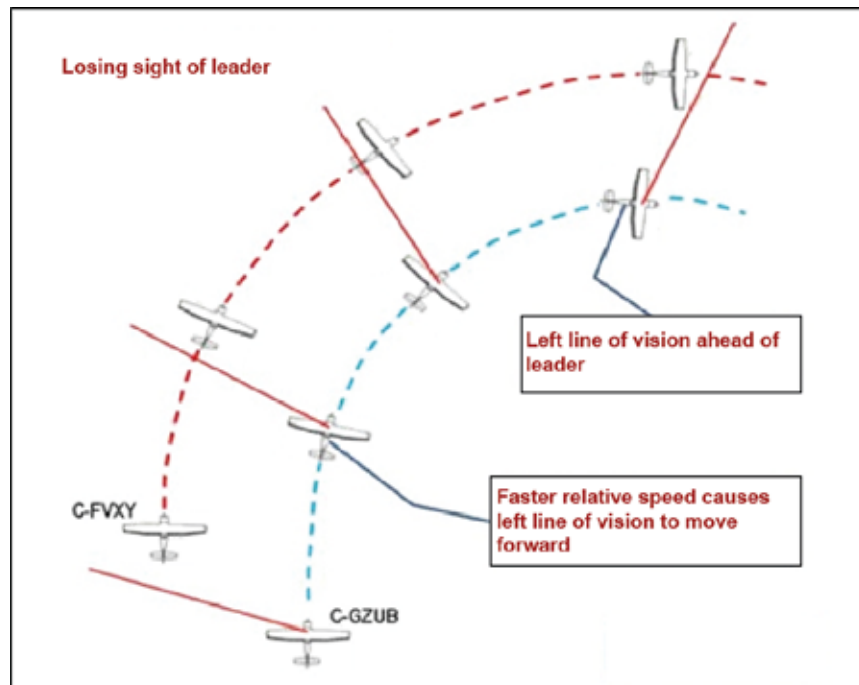
Figure 7. Losing sight of leader (diagram not to scale)

When aircraft are in formation, the wingman must maintain a constant relative position with the leader. To keep this position, the wingman continuously adjusts aircraft attitude and engine power to correct for relative height and speed variation. In this accident, when the leader (C-FVXY) turned right, the wingman (C-GZUB) had to reduce both airspeed and height so as to maintain the correct formation station. These changes require a significant and timely reduction in engine power. Because of the close proximity of the aircraft to each other, a small differential in speed has a significant effect on the constant line-of-bearing required for station-keeping. If the wingman (C-GZUB) did not reduce power sufficiently or quickly enough, the aircraft would have started to move forward and out of the arc of available vision under the left wing (Figure 7).

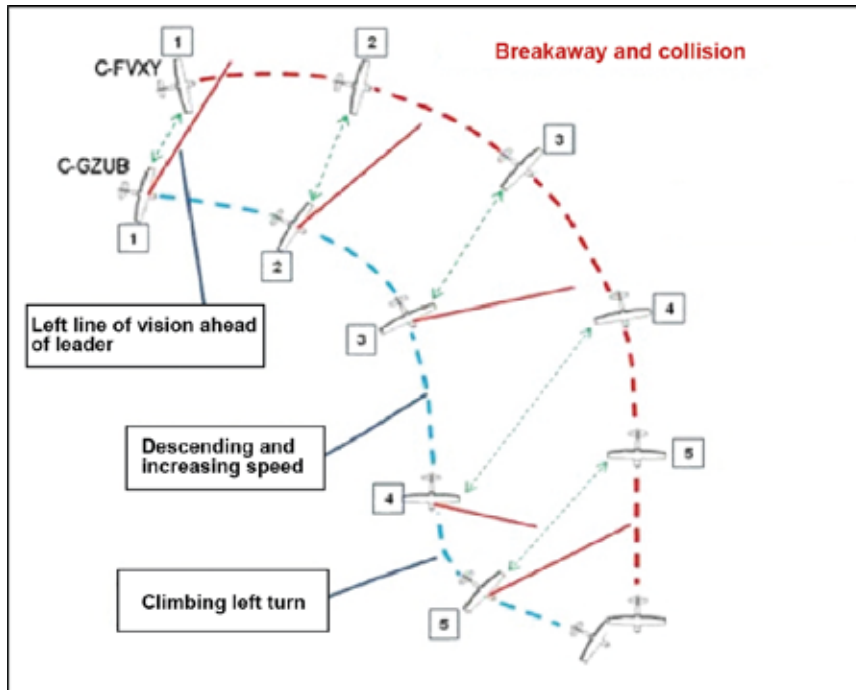
Figure 8. Breakaway and collision (diagram not to scale)

As a result, the pilot of C-GZUB would have lost sight of the leader. At this point, C-GZUB would have turned away to the right and descended, flying clear of the lead aircraft and resolving the risk of collision. From this point on, the pilot of C-GZUB would have been unable to see C-FVXY behind and to the left of him because of limited visibility from the cockpit. When the pilot of C-GZUB would have turned back to the left, seeking the leader, the line of vision would have been further compromised and would have afforded the pilot of C-GZUB even less of an opportunity to see C-FVXY approaching from the left quarter (Figure 8).
