**RAILWAY INVESTIGATION REPORT
R13W0083**

CROSSING ACCIDENT

**CANADIAN NATIONAL RAILWAY
FREIGHT TRAIN L50041-26
MILE 37.06, LAMPMAN SUBDIVISION
CARLYLE, SASKATCHEWAN
26 MARCH 2013**

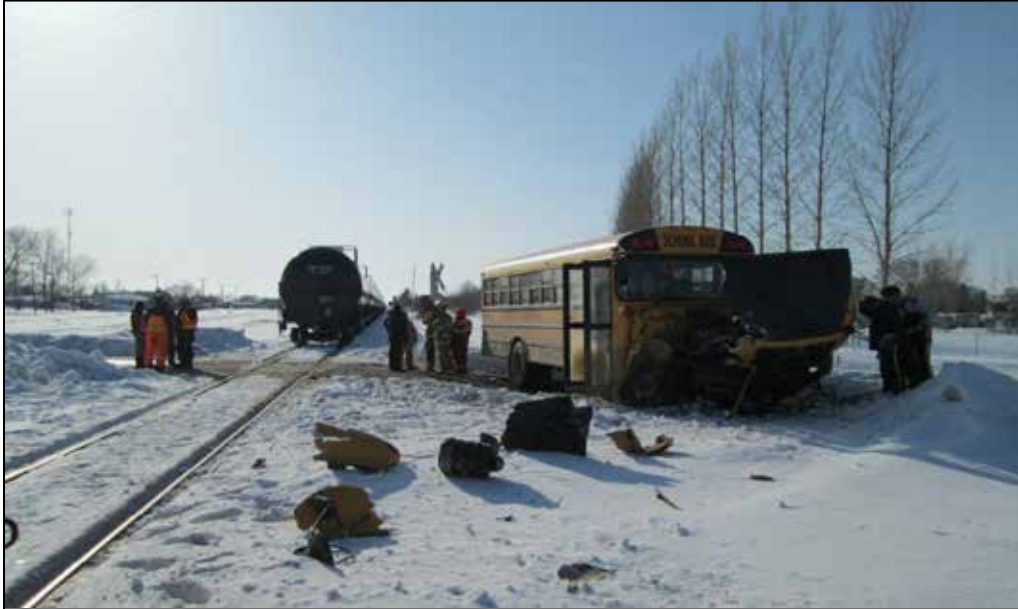
Photo 1. Accident scene looking west (Source: Canadian National Railway)

Damage to the locomotive and the track infrastructure was minimal. The front end of the bus was torn from the frame on the passenger side of the bus. As a result of the impact, the bus came to rest across the northbound lane of 4th Street East, partially in the ditch. The train came to a stop about 1200 feet down the tracks (Figure 2).

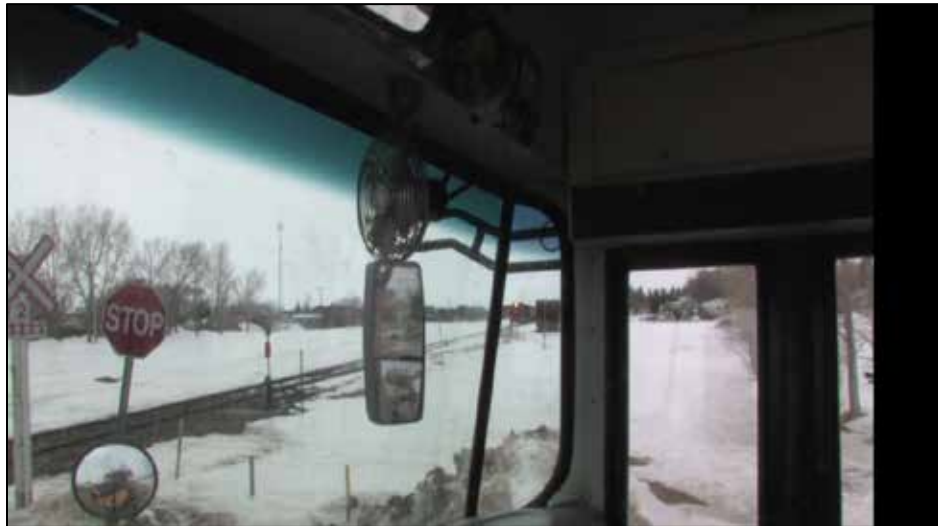
Photo 2. Driver's view westward of approaching train during TSB re-enactment

A number of other Transportation Safety Board (TSB) investigations¹³ determined that portions of the view along the rail line were obstructed by the roof pillar and side mirror on either the driver or passenger side of the cab, which hindered the ability of the driver to see the approaching train (Photo 2).

Without fully opening the passenger side entrance door while stopped at the stop sign, the driver's westward view along the railway tracks can be obstructed by the bus side pillar and/or side mirror, depending on the location where the bus stops.
