**AVIATION INVESTIGATION REPORT  
A11C0152**

**FREEWHEEL-ASSEMBLY MALFUNCTION DURING PRACTICE  
AUTOROTATIONAL LANDING**

**WISK-AIR LIMITED  
BELL 206B (HELICOPTER), C-GDPE  
THUNDER BAY, ONTARIO  
13 SEPTEMBER 2011**

Report Number A11C0152

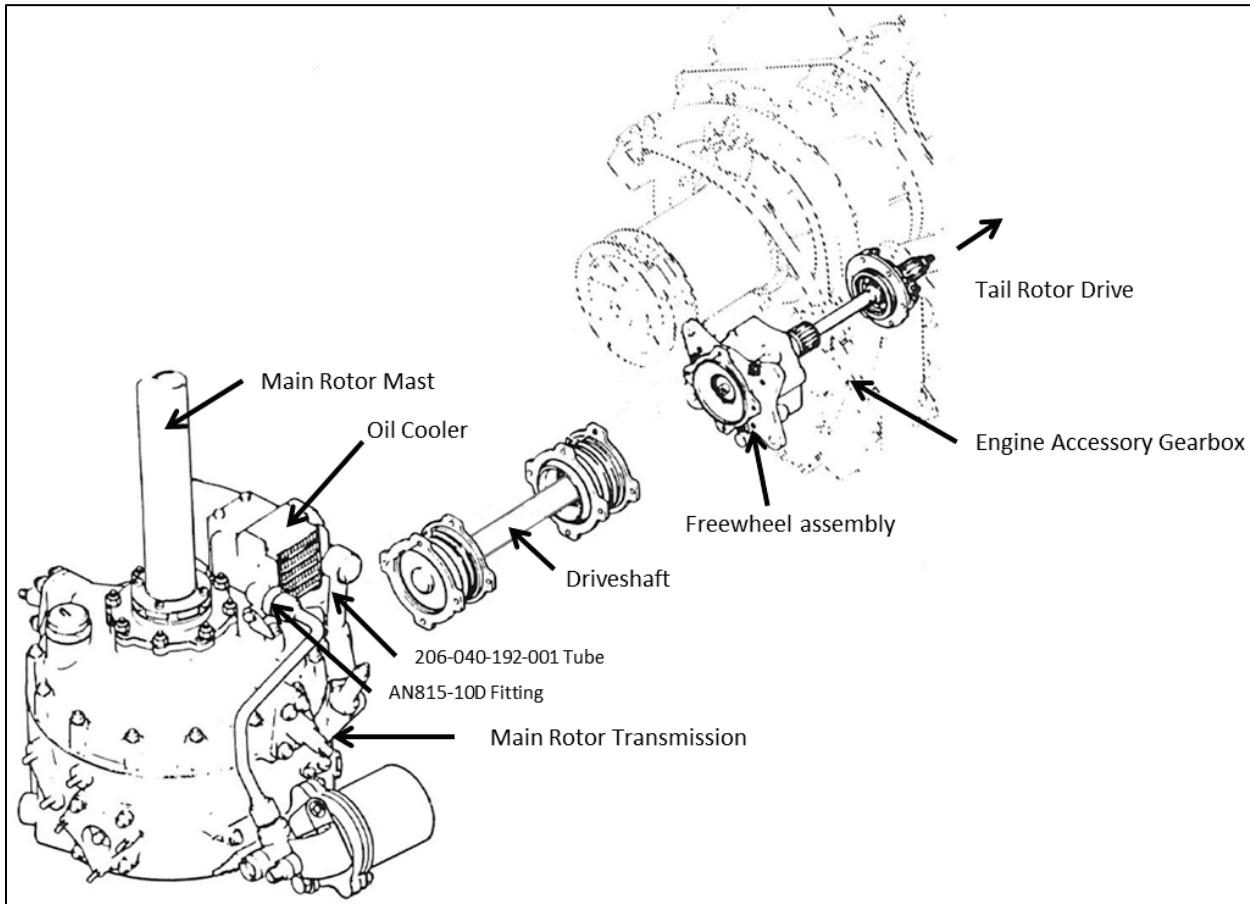
Figure 1. Drive system

A freewheel assembly is installed on the engine accessory gearbox. The outer race of the freewheel assembly is splined directly to the power takeoff gear shaft. A sprag clutch transmits engine power to the inner shaft of the freewheel assembly. The forward end of the inner shaft drives the main-rotor transmission via a driveshaft that incorporates 2 flexible couplings to allow for transmission movement. The tail-rotor driveshaft is connected to the aft end of the freewheel assembly inner shaft as it exits the engine gearbox (Figure 1).
