AVIATION INVESTIGATION REPORT

A16P0161

Collision with terrain

Bell 206B (Helicopter), C-FWHF

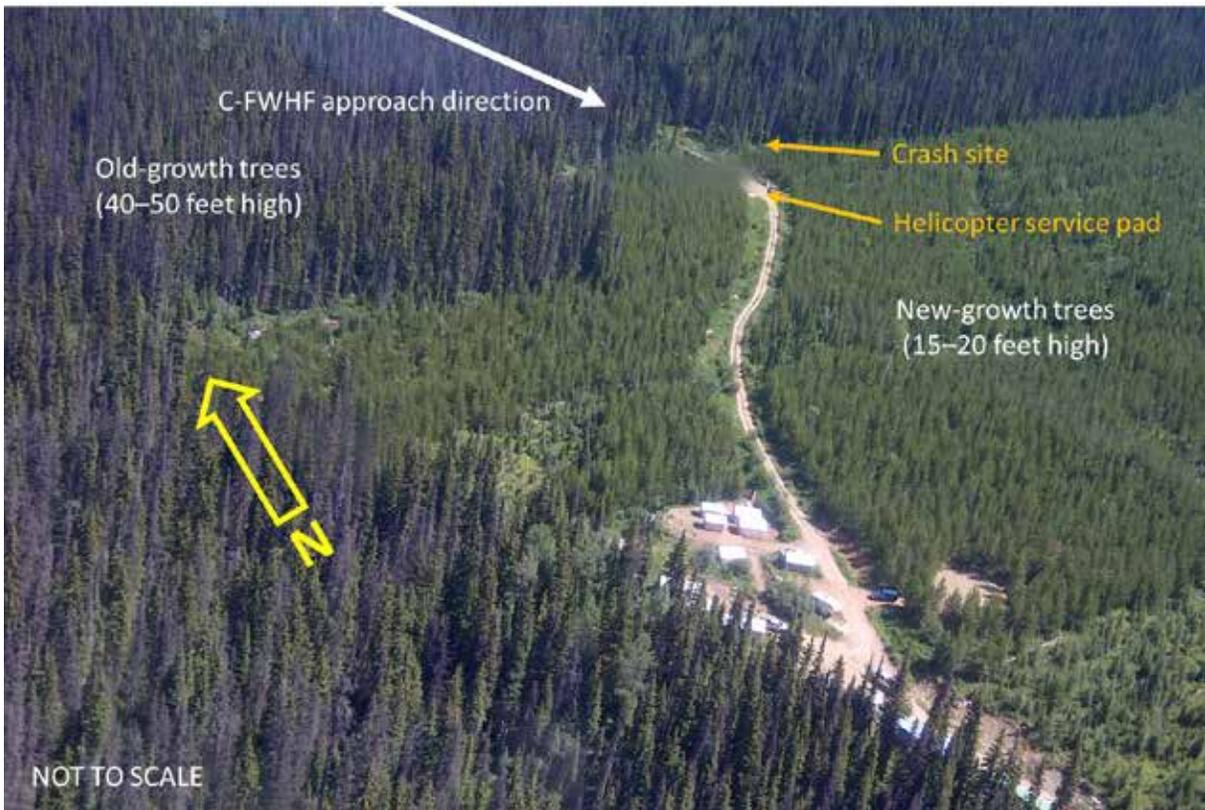
Figure 1. Aerial-view photograph of the base camp and accident site, taken in 2013 (Source: Paycore Drilling, with TSB annotations)

The Far West Helicopters Ltd. Bell 206B helicopter (registration C-FWHF, serial number 1525) was operating in support of mineral exploration, out of a base camp approximately 3.6 nautical miles (nm) south-southeast of Deception Mountain, British Columbia. The camp, equipped with a helicopter service pad and fuelling equipment, was at an elevation of 4100 feet above sea level in a forest of new-growth trees, in an area that had previously been clear-cut (Figure 1).

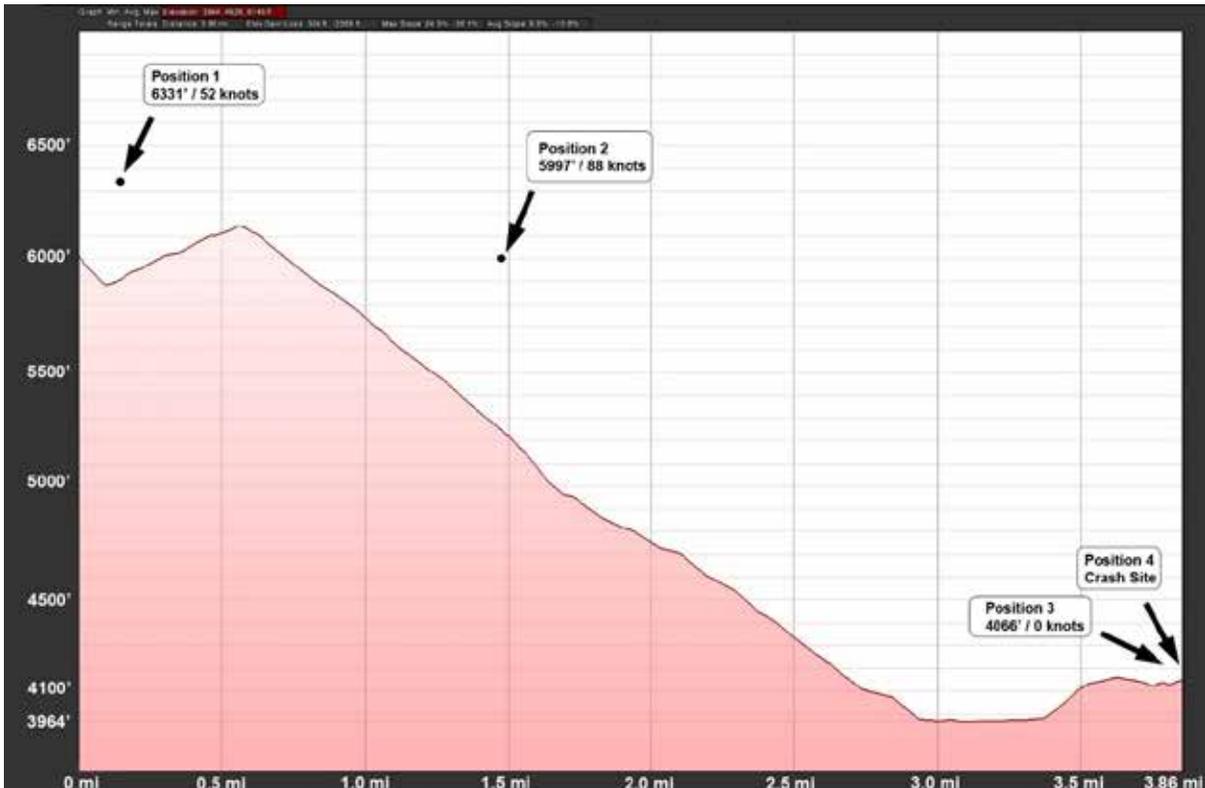
Figure 3. Distance from departure point over sloped terrain, plotted using satellite tracking system data points (Source: Google Earth, with TSB annotations. Not to scale)

The system had recorded 4 data points during the accident flight (Figure 3).
