RAILWAY OCCURRENCE REPORT  
NUMBER R97H0009

DERAILMENT

VIA RAIL CANADA INC.  
PASSENGER TRAIN NO. 2  
MILE 7.5, CN WAINWRIGHT SUBDIVISION  
NEAR BIGGAR, SASKATCHEWAN  
03 SEPTEMBER 1997

Report Number R97H0009

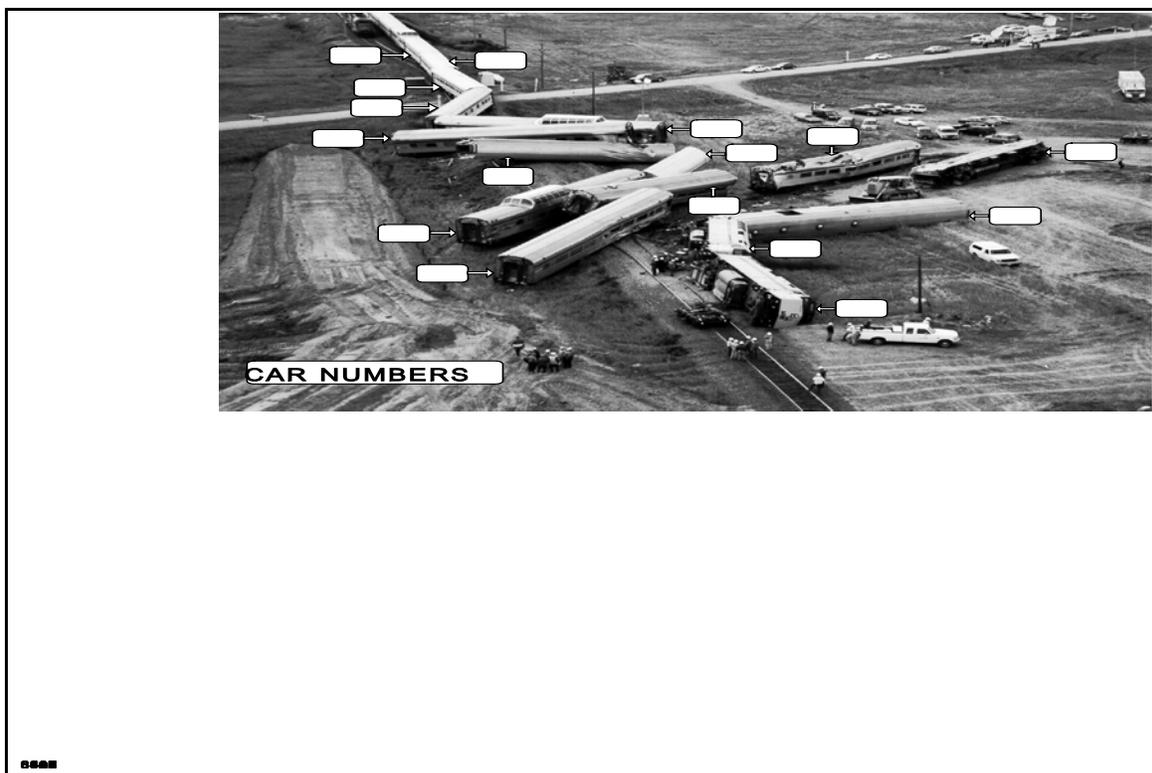
At 0150<sup>2</sup> on 03 September 1997, VIA Rail Canada Inc. (VIA Rail) eastward transcontinental Train No. 2, originating in Vancouver, British Columbia, derailed 7.5 miles west of Biggar, Saskatchewan, while travelling at about 67 mph. A section of track was destroyed; both locomotives and 13 of the 19 cars derailed. The locomotives came to rest on their sides, and the 13 derailed cars came to rest at various angles and orientations (Figure 1). The derailment resulted in the death of one of the 198 passengers and crew on board and injury to 78 others, 13 seriously. A small grass fire ensued, but was quickly extinguished. First responders arrived on site within 10 minutes and the evacuation of all passengers and crew was completed within approximately three and one half hours.
