**AVIATION INVESTIGATION REPORT  
A11C0102**

**RUNWAY OVERRUN  
BEAVER AIR SERVICES LIMITED PARTNERSHIP  
(MISSINIPPI AIRWAYS)  
CESSNA 208B, C-FMCB  
PUKATAWAGAN, MANITOBA  
04 JULY 2011**

Report Number A11C0102

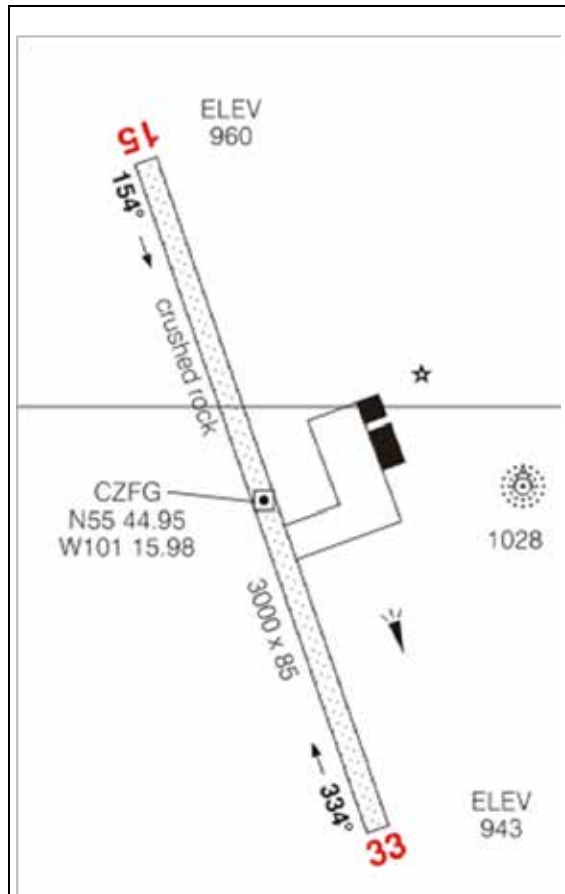
**Figure 1.** Pukatawagan Aerodrome diagram (Source: NAV CANADA, *Canada Air Pilot*, Effective 10 April to 29 July, 2011)

During the takeoff run, the aircraft's airspeed indicator initially rose as the aircraft accelerated and its nose wheel lifted off the runway. The flaps were set to 20° and the engine produced rated power. During the takeoff roll, the aircraft encountered several soft spots near the taxiway intersection (Figure 1). The pilot applied rearward pressure on the control yoke and one or both main wheels briefly lifted off the runway, but the airspeed stopped increasing and the aircraft did not remain airborne. The pilot rejected the takeoff with an estimated 600 feet of runway remaining. The pilot selected engine power to idle, reverse propeller thrust, and flaps to 0° to maximize braking traction. The aircraft continued past the end of Runway 33. The aircraft was travelling at a relatively low speed but the pilot was unable to stop before the aircraft dropped off the steep slope and proceeded down an embankment before coming to rest in a ravine (Photo 1). The aircraft encountered rocks and a sharp slope reversal at the bottom of the ravine. Several of the occupants were injured by the sudden stop. As a result of the impact, the aircraft was damaged and its fuel system was compromised. A
