AIR TRANSPORTATION SAFETY INVESTIGATION REPORT A20W0016

LOSS OF PITCH CONTROL ON LANDING

Canadian Pacific Railway Company
Bombardier CL-600-2B16 (Challenger 605), C-GKCP
Calgary International Airport, Alberta
23 February 2020

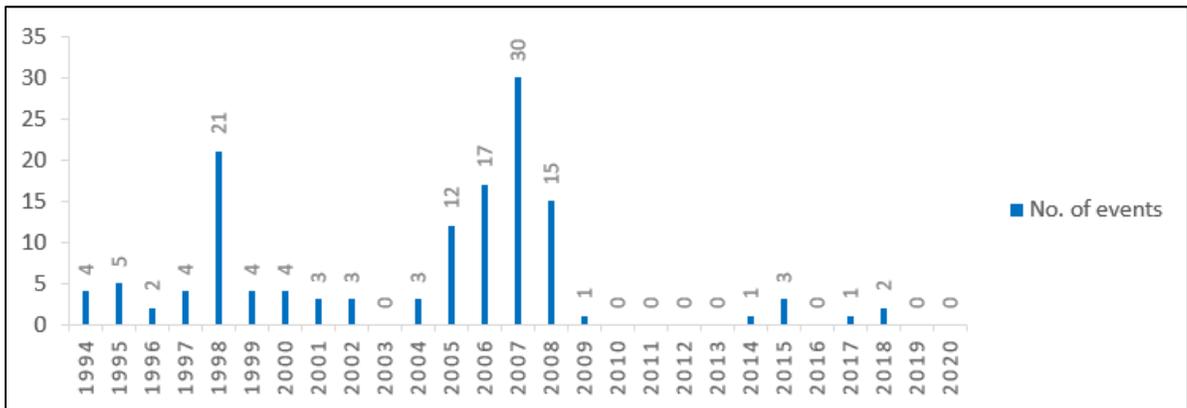
Figure 3. Canadair Regional Jet 100/200 series flap malfunction events due to flap flexible drive shaft failure, per year (Source: TSB)

A search of service difficulty reports related to flap malfunctions directly attributable to flap flexible drive shaft failure yielded the data presented in Figure 3. Although the number of service difficulty reports decreased significantly starting in 2009, it could not be determined if this was as a result of the service bulletin actions, or as a result of reduced worldwide fleet utilization.
