AIR TRANSPORTATION SAFETY INVESTIGATION REPORT A21C0052

LOSS OF CONTROL AND COLLISION WITH TERRAIN

Helicopter Transport Services (Canada) Inc.
Bell 214ST (helicopter), C-GDYZ
Nipigon, Ontario, 14 NM NE
07 June 2021

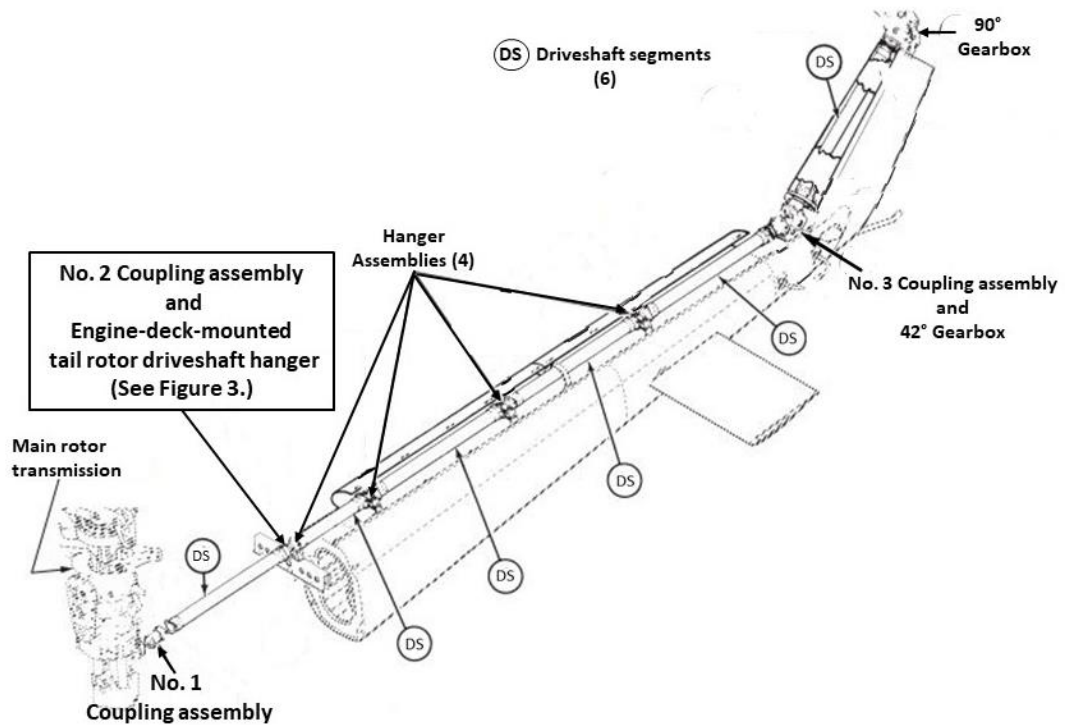
Figure 2. Tail rotor drivetrain (Source: Bell, with TSB annotations)

The tail rotor drivetrain consists of 6 driveshaft segments, 4 hanger assemblies, 3 coupling assemblies, 5 disc assemblies, and 2 gearboxes (42° and 90°) at the base and tip, respectively, of the vertical stabilizer (Figure 2). The coupling assemblies and disc assemblies provide axial and angular flexibility.

Each of the 2 gearboxes is self-lubricated by an internal oil pump and is monitored by a chip detector, temperature switch, and low oil-pressure switch. A separation of the tail rotor drivetrain in front of the 42° gearbox will cause an immediate loss of oil pressure in both gearboxes. As a result, the 42° BOX OIL PRESS and 90° BOX OIL PRESS annunciators on the main warning and caution panel will illuminate.
