AIR TRANSPORTATION SAFETY INVESTIGATION REPORT A21W0001

COLLISION WITH TERRAIN

Privately registered
Robinson R44 Raven II (Helicopter), C-FBGT
Grande Prairie, Alberta, 39 NM NE
01 January 2021

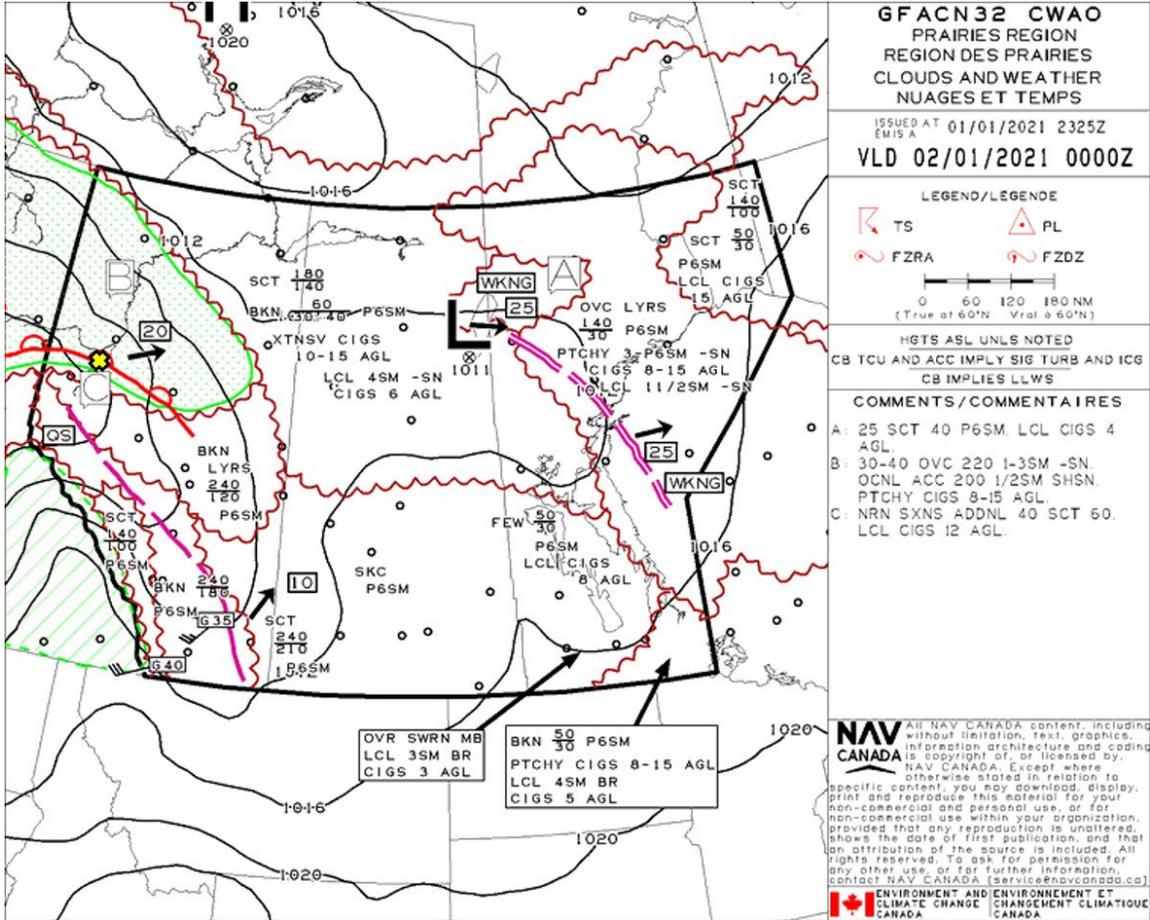
Appendix A – Graphic area forecast – Clouds and weather chart valid at 1700 Mountain Standard Time on 01 January 2021 (Yellow 'X' denotes accident site)

It is likely that, shortly after departure, the pilot encountered deteriorating weather consisting of surface-based layers and/or low cloud and poor visibility. It is also likely that the pilot did not see the approaching weather given that it was night, and that he had inadvertently entered the low-level cloud.

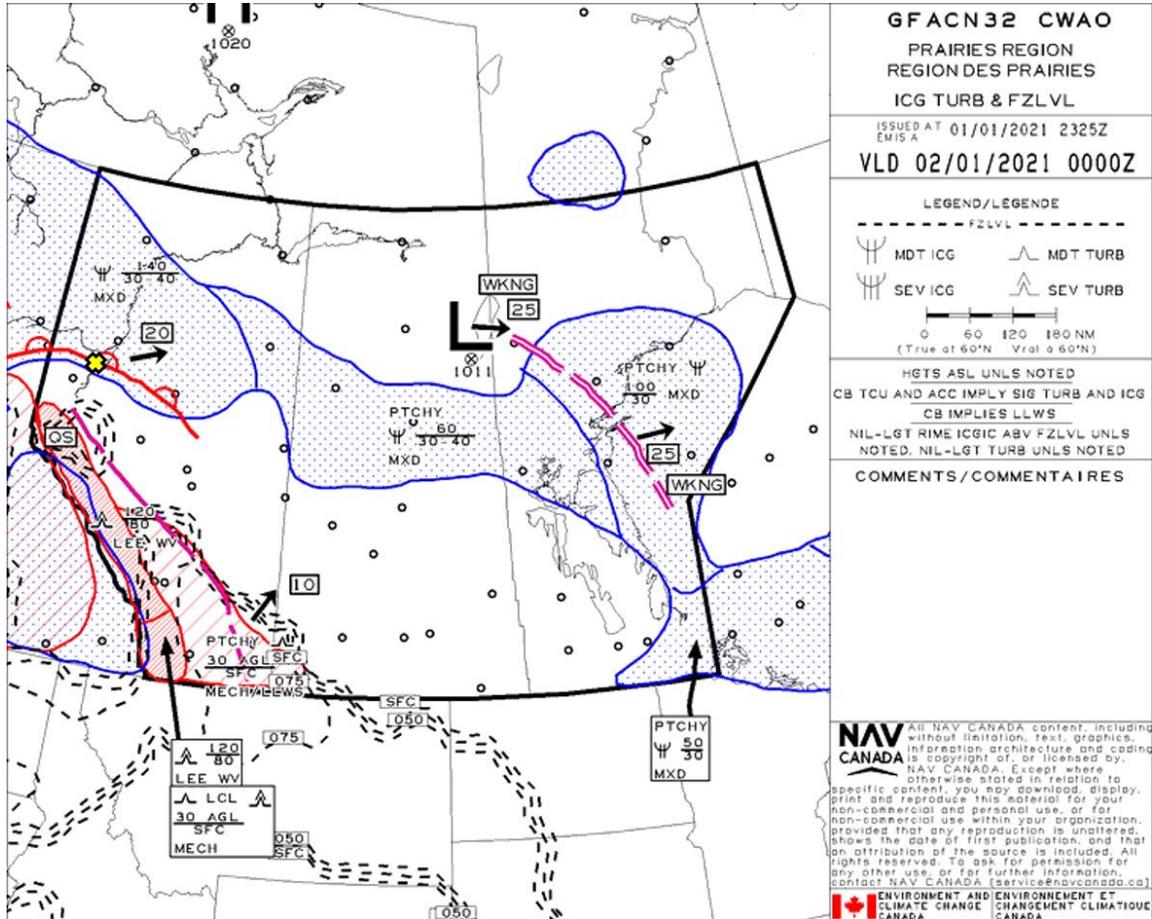
Appendix B – Graphic area forecast – Icing, turbulence, and freezing level chart valid at 1700 Mountain Standard Time on 01 January 2021 (Yellow 'X' denotes accident site)

The pilot may have also encountered precipitation. Responders on the ground observed rain, freezing rain, and snow shortly after the accident. In addition, the GFA forecast possible icing conditions in the area at altitudes slightly above the helicopter’s flight path. The helicopter was not equipped with a heated pitot static system; however, the investigation could not determine if the helicopter encountered any in-flight icing.
