# AIR TRANSPORTATION SAFETY INVESTIGATION REPORT A21F0210

## **RUNWAY EXCURSION ON TAKEOFF AND IN-FLIGHT FUEL IMBALANCE RESULTING IN DIVERSION**

Mitsubishi Heavy Industries, Ltd. CL-600-2D24 (Regional Jet  
Series 900), C-GJZV

San Diego International Airport, California, United States

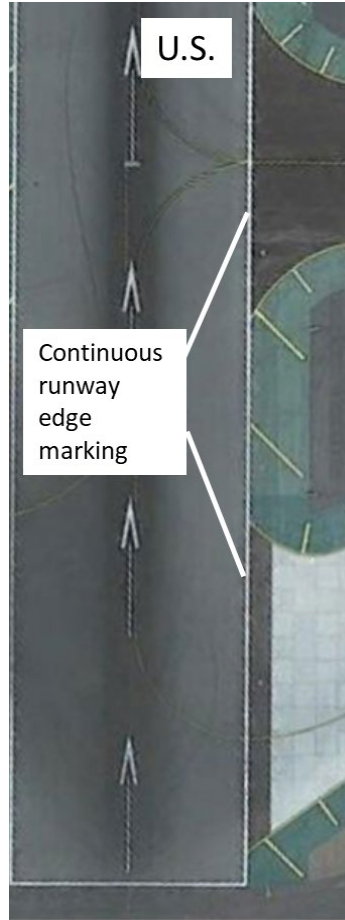
Figure 9. Runway edge markings at San Diego International Airport (Source: Google Earth, with TSB annotations)

between a runway and a taxiway (Figure 8).<sup>19,20</sup> By contrast, the U.S. standard<sup>21</sup> for runway edge markings specifies that runways shall have uninterrupted edge markings (Figure 9).

The runway edge markings at KSAN had been most recently painted in May 2020—18 months before the current occurrence. Furthermore, in June 2021, the FAA had conducted its annual safety inspection at KSAN, in which an element was the inspection of runway markings for compliance with existing standards.

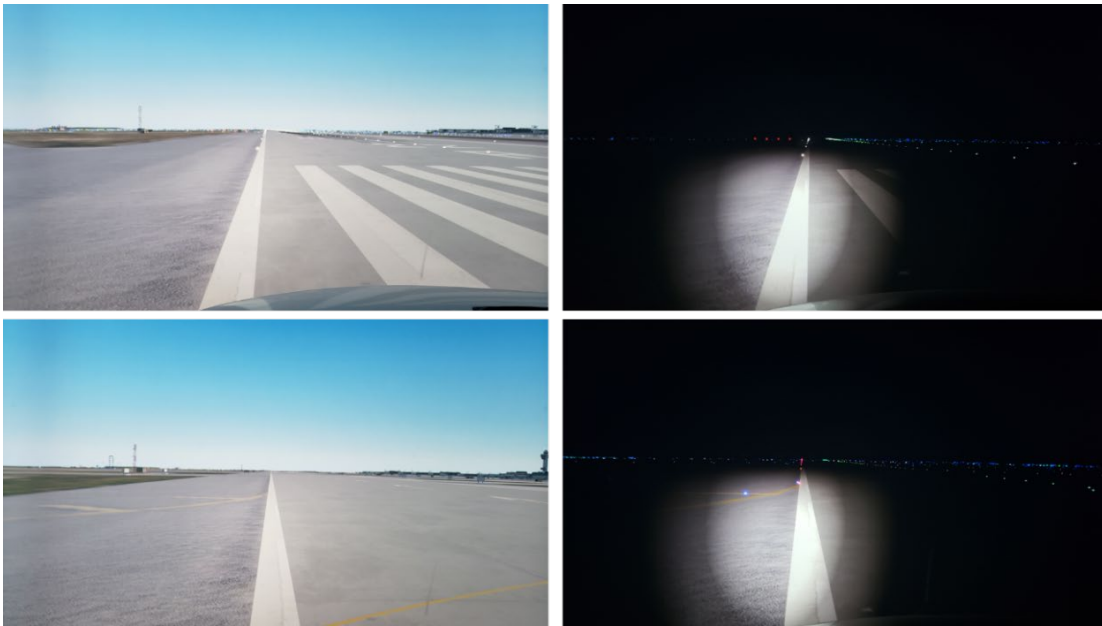
Figure 14. Simulated runway environments at the runway's left edge. Clockwise, from top left: daytime, at runway threshold; nighttime with reduced visibility, at runway threshold; nighttime, in displaced threshold area; daytime, in displaced threshold area. (Source: TSB)

simulated a representative runway model that approximated the runway shoulder, markings, and lighting at KSAN. The environmental conditions were varied between ½ SM visibility<sup>33</sup> and unlimited visibility; conditions were also varied between daytime and nighttime. Images captured from the displaced threshold area (Figure 14) demonstrated to the investigation the level of saliency of runway markings when a flight crew judges an aircraft's lateral alignment with the runway. They also showed how the paved runway shoulder contributes to the overall visual environment.
