# AIR TRANSPORTATION SAFETY INVESTIGATION REPORT A22O0060

## **Loss of control and collision with terrain**

Diamond Aircraft Sales USA Inc.  
Diamond Aircraft Industries GmbH DA 42 NG, N591ER  
London Airport, Ontario  
25 May 2022

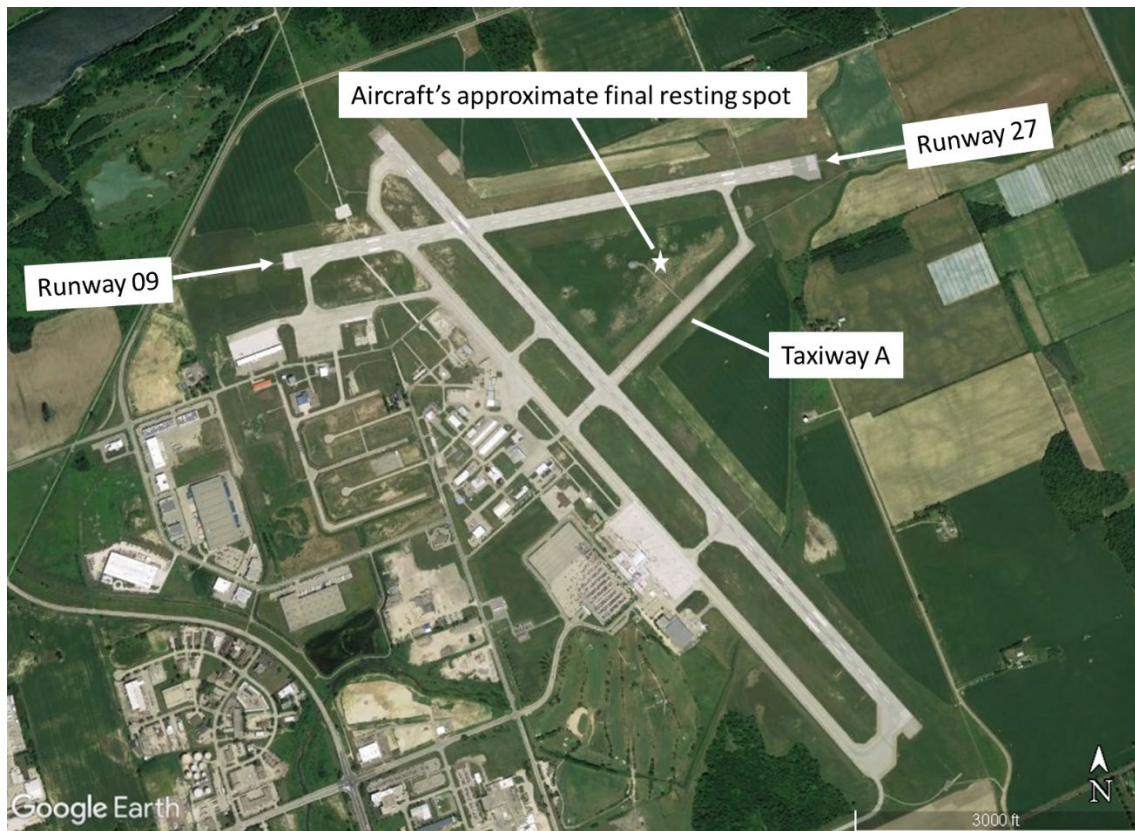
The pilot declared an emergency with air traffic control (ATC) and then intended to land on Runway 27; however, he could not regain complete control of the aircraft and instead attempted to land in a southwest direction on Taxiway A. He eventually landed on the grass between the runway and Taxiway A (Figure 1). On touchdown, the landing gear collapsed and the aircraft slid approximately 265 feet before coming to a stop.

Figure 1. Satellite image of London Airport, Ontario, showing the runways and taxiway involved in this occurrence, as well as the aircraft's approximate final resting spot (Source: Google Earth, with TSB annotations)
