MARINE TRANSPORTATION SAFETY INVESTIGATION REPORT M18P0257

CREW FALL OVERBOARD FROM RESCUE BOAT

Roll-on/roll-off passenger ferry *Spirit of Vancouver Island*
Swartz Bay, North Saanich, British Columbia
31 August 2018

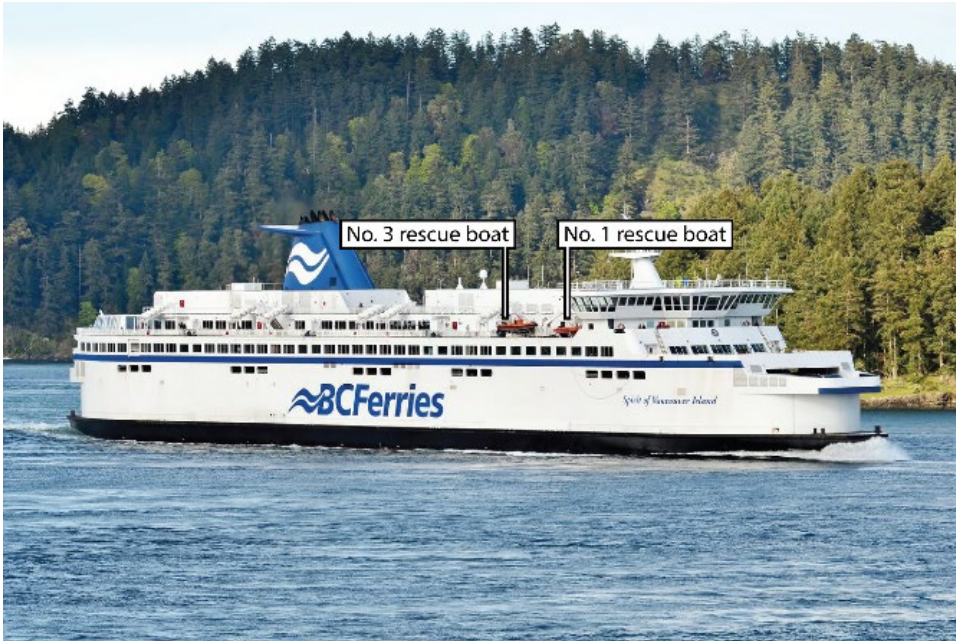
Figure 1. Spirit of Vancouver Island, with rescue boats No. 1 and No. 3 shown (Source: British Columbia Ferry Services Inc., with TSB annotations)

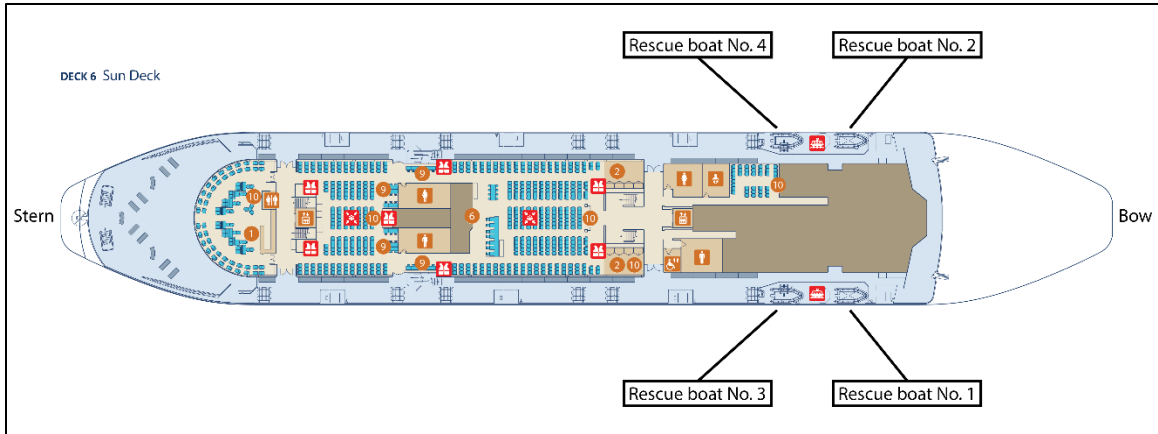
Figure 2. Diagram showing the locations of the 4 rescue boats on deck 6 of the Spirit of Vancouver Island (Source: CruiseMapper, with TSB annotations)
