MARINE TRANSPORTATION SAFETY INVESTIGATION REPORT M21P0297

LOSS OF CONTAINERS OVERBOARD AND SUBSEQUENT FIRE

Container vessel *ZIM Kingston*
La Perouse Bank, British Columbia
21 October 2021

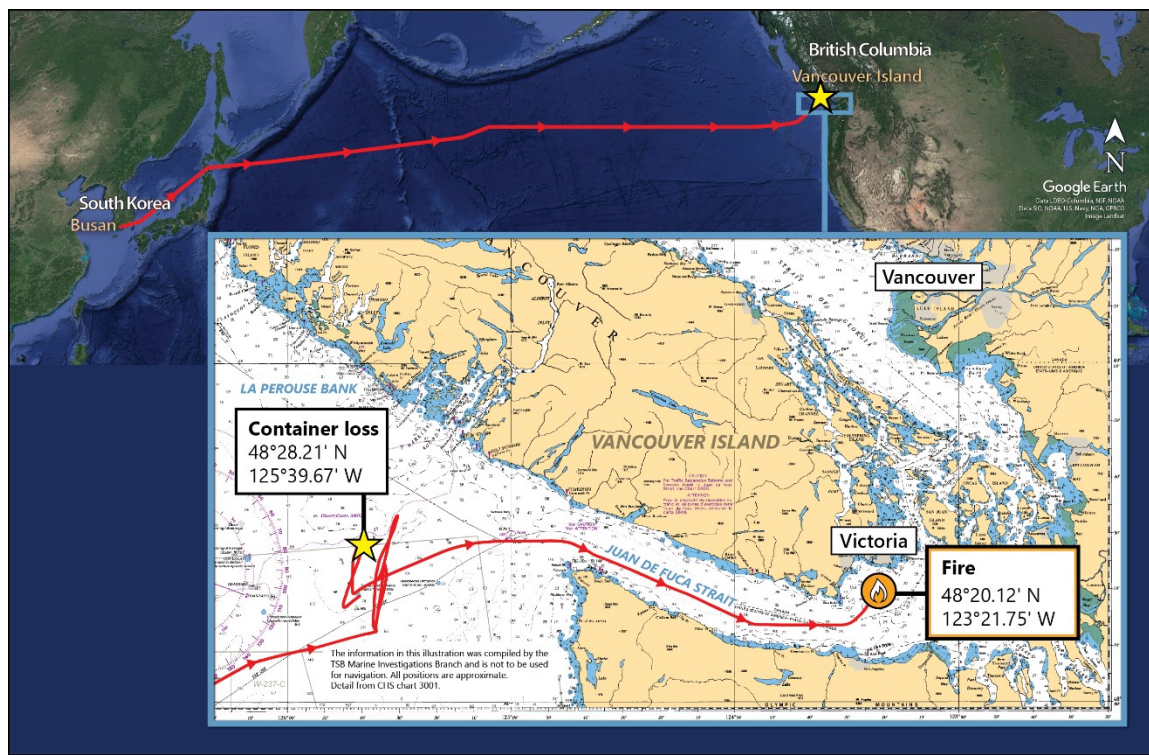
Figure 2. Satellite image and chart showing the *ZIM Kingston's* position at the time of the heavy rolling and container loss (Source of main image: Google Earth, with TSB annotations. Source of inset image: Canadian Hydrographic Service Chart 3001, with TSB annotations)

At 1800, the vessel began drifting northward for the 3rd time with the bow oriented southwesterly into the waves. The master was still on the bridge but was resting, and the third officer was the officer of the watch. At around 2229, the winds were southeasterly at 42 knots and the waves were 5 to 6 m from the southwest. The bow was oriented west-southwesterly into the waves, and the vessel was drifting northward at 2.2 knots. At this time, the vessel experienced heavy rolling and pitching that lasted for about 1.5 minutes. The vessel rolled heavily to both port and starboard approximately 4 times, with the maximum roll being 36°. The vessel was in position 48°28.21' N, 125°39.67' W at the time of the heavy rolling (Figure 2) and the crew noted that some containers had been lost.

From the bridge, it was apparent that the lost containers had fallen from bay 34. At around 2235, the master notified MCTS Prince Rupert that the vessel had lost containers. At 2238, the master made a security broadcast by VHF (very high frequency radiotelephone) to inform nearby vessels about the occurrence and to notify them of the potential hazard posed by containers that had gone overboard and were floating in the vicinity. The Canadian Coast Guard (CCG) subsequently issued a navigational warning for floating containers around the area of the occurrence.

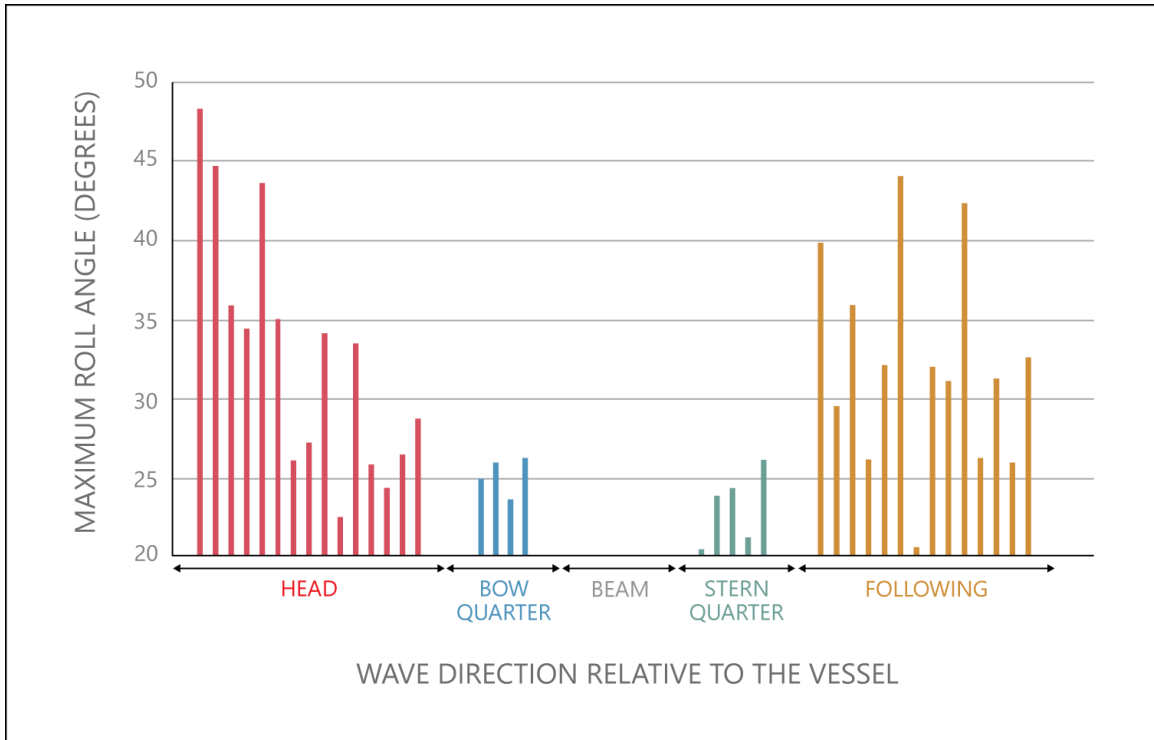
Figure 17. Test results showing roll angles greater than 20° in relation to the wave direction relative to the vessel (Source: TSB, from National Research Council of Canada data)

Out of the 114 successful tests, 38 (37%) resulted in the model developing roll motions greater than 20°. The maximum roll motions recorded were 48°. In all of the operational modes, the largest roll motions were observed when the model was in head and following sea conditions (Figure 17). No significant roll motions were observed in beam sea conditions.

Analysis of the tests that resulted in roll motions greater than 20° showed that the model’s pitching period³⁷ was approximately equal to the wave encounter period and was nearly half the roll period. The ratio of roll period to wave encounter period is a key factor for the development of parametric roll resonance and indicates that parametric rolling was the cause of the extreme rolling events during the testing. Furthermore, the testing determined the range of values for this ratio, as well as for the ratio of wave length to ship length, that were found to coincide with parametric rolling of the vessel (Table 2).

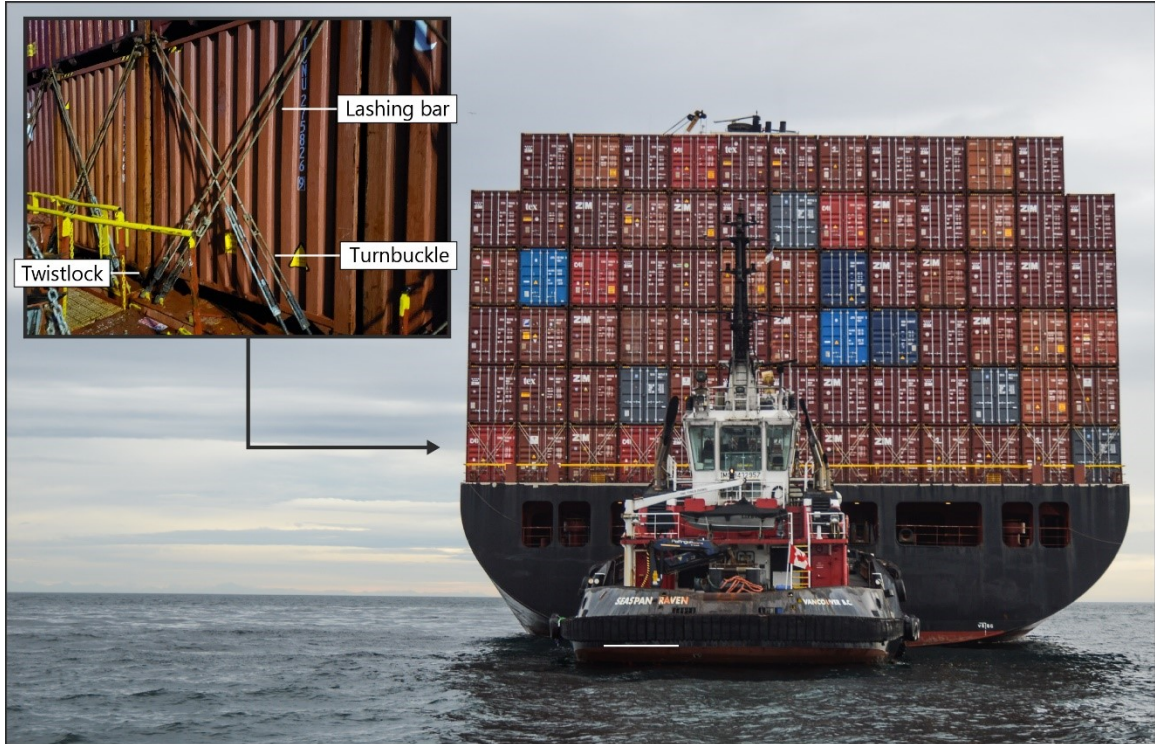
Figure 23. Lashing components used to secure containers on the *ZIM Kingston* (foundations not shown) (Source for main and inset images: TSB)

On the *ZIM Kingston*, similar to most container vessels, the 40-foot containers were secured on deck using components that included lashing bars, turnbuckles, twistlocks, and deck-mounted foundations (Figure 23). Twenty-foot containers were secured using similar components, as well as midlocks that secured the 20-foot containers end-to-end. The foundations were fixed to the deck or deck hatch covers and served as blocks on which the container stacks rested. The lashing bars were used in combination with turnbuckles and twistlocks to secure the containers on the lower 2 to 3 tiers.⁶⁴ The containers in higher tiers were secured one on top of the other using twistlocks. Containers beside each other were

not secured together, meaning that each container stack was independent of its neighbouring stacks.

Container securing components have safe working loads that are typically 50% of the components' minimum breaking strength. The minimum breaking strength is defined as the force at which the component will fail and is determined by the weakest point of the component. Most manufacturers will design components so that there is some unknown degree of strength beyond the minimum breaking strength; however, this is not guaranteed. The ratings for the container securing components in use on the *ZIM Kingston* are shown in Table 5.
