MARINE TRANSPORTATION SAFETY INVESTIGATION REPORT M22P0298

RISK OF COLLISION AND CAPSIZE

General cargo vessel *Saga Beija-Flor* and pleasure craft BC4010135
Vancouver Harbour, British Columbia
15 October 2022

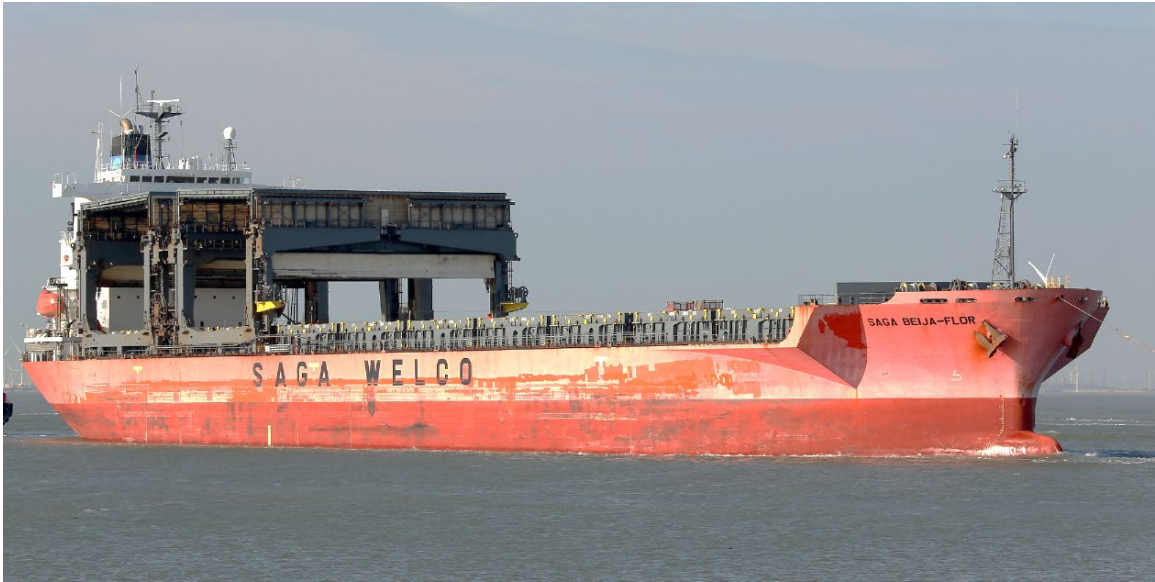
Figure 5. *Saga Beija-Flor* sailing with gantry cranes in stowed position aft (Source: Stan Muller, shipspotting.com)

With the gantry cranes in the stowed position aft (Figure 5), the view of the sea surface from the *Saga Beija-Flor's* conning position is obstructed (Figure 6).
