AIR TRANSPORTATION SAFETY INVESTIGATION REPORT A21P0107

COLLISION WITH WATER

Black Tusk Helicopter Inc.
Kaman Aerospace Corporation K-1200 (helicopter), C-FZVM
Killam Bay, British Columbia
04 October 2021

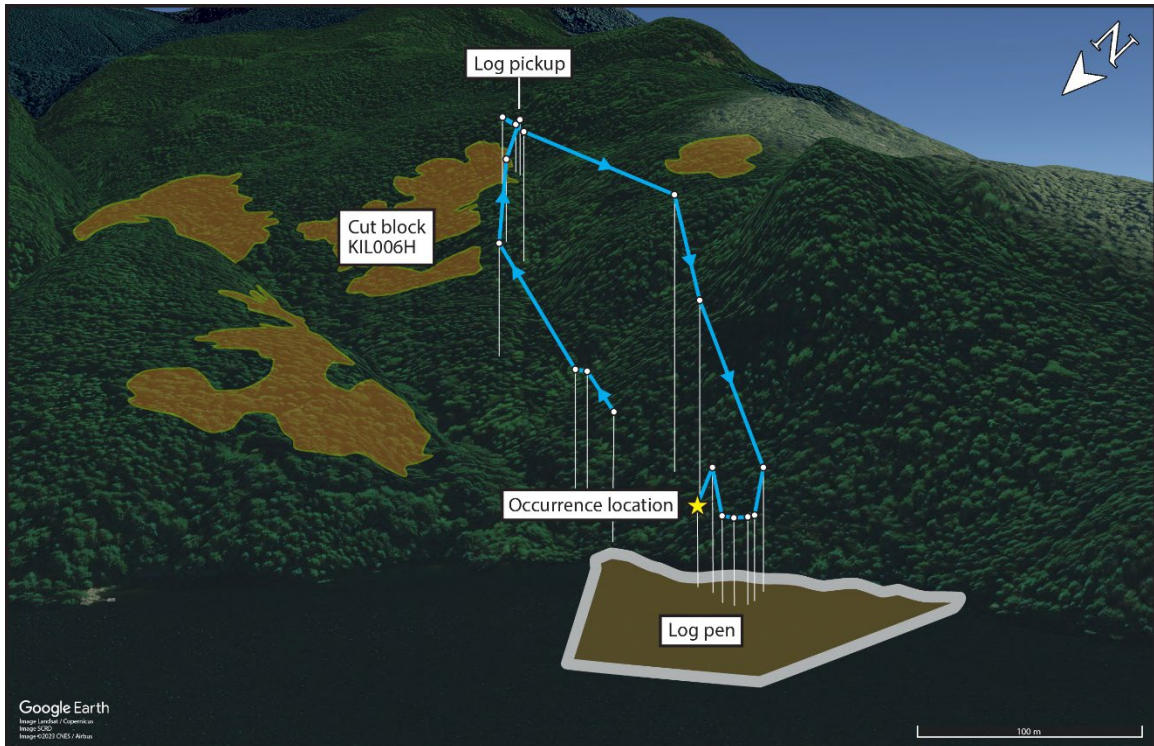
Approximately 75 seconds later, the aircraft dropped the logs into the log pen, entered a slow 180° turn and initiated a climb to return to the cut block. At 1303:42, following a routine radio transmission to the logging manager, the aircraft entered a rapid descent. It impacted the water within the log pen approximately 4 seconds later and sank (Figure 2).

Figure 2. Area map showing the occurrence helicopter flight track during the 5th turn, and the occurrence location (Source: Google Earth, with TSB annotations)

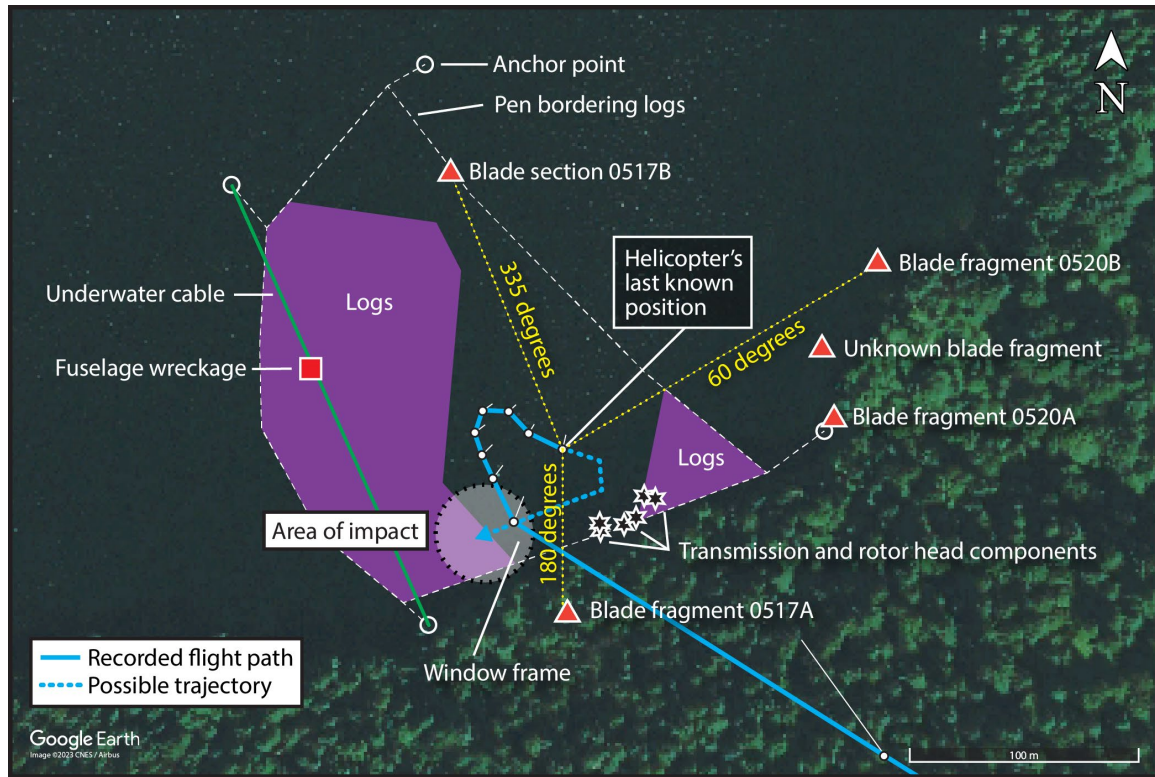
Shortly after the accident, the investigators used photographs, GPS coordinates, and visual observation to reconstruct the debris pattern and the helicopter's possible trajectory after its last known position. Helicopter debris was located over a 228° arc surrounding the last known in-flight position of the helicopter (Figure 10).

Figure 10. Image of the occurrence site at the log pen showing the helicopter's possible trajectory, the approximate shape of the pen at the time of the occurrence, and the approximate locations of the helicopter debris that was recovered (Source: Google Earth, with TSB annotations)

The large section of main rotor blade was identified as blade 0517B from the left-rotor system and was located at approximately 335° and 475 feet from the helicopter's last known position. This rotor blade impacted the log perimeter of the log pen and lodged itself in the perimeter, which provided relative certainty as to its trajectory. Two blade fragments were identified as right-rotor blades 0520A and 0520B and were found at approximately 85° and 60° respectively. A 3rd fragment was found nearby, but investigators were unable to identify which rotor blade it was from. All 3 fragment locations could only be estimated because of ocean drift.
