AIR TRANSPORTATION SAFETY INVESTIGATION REPORT A23O0046

RUNWAY OVERRUN

Porter Airlines Inc.

De Havilland Aircraft of Canada Ltd. DHC-8-402, C-GLQB

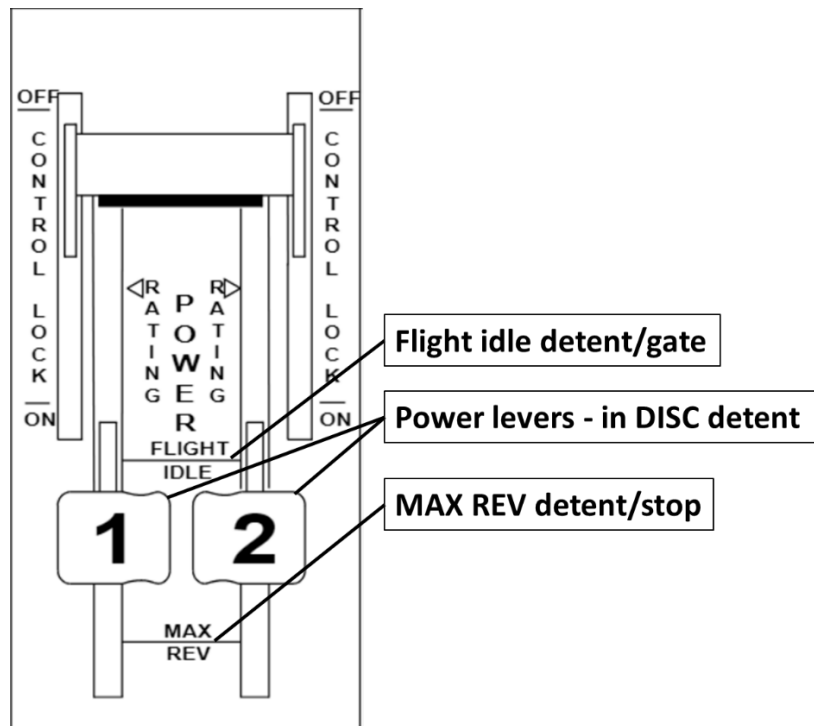
During flight, unintentional movement of the power levers below the FLIGHT IDLE setting is prevented by a detent combined with a gate on the power lever quadrant (Figure 3). The pilot must operate the release lever to permit entry of the power lever into the ground regime. There is also a detent at the DISC position, and at the MAX REV (maximum reverse) position where the travel is limited by a stop. The detent is felt by the pilot when reached or passed through. However, it does not require additional action.

Figure 3. DHC-8 Series 400 aircraft's power levers and console (Source: De Havilland Aircraft of Canada Limited, *DHC-8 Series 400 Aeroplane Operating Manual*, Revision 27 [07 March 2021], Figure 6.13-8, p. 6.13-14, with TSB annotations)
