RAIL TRANSPORTATION SAFETY INVESTIGATION REPORT R22C0065

MAIN-TRACK DERAILMENT

Canadian Pacific Railway Company
Train 301-222
Mile 97.4, Brooks Subdivision
Near Bassano, Alberta
13 July 2022

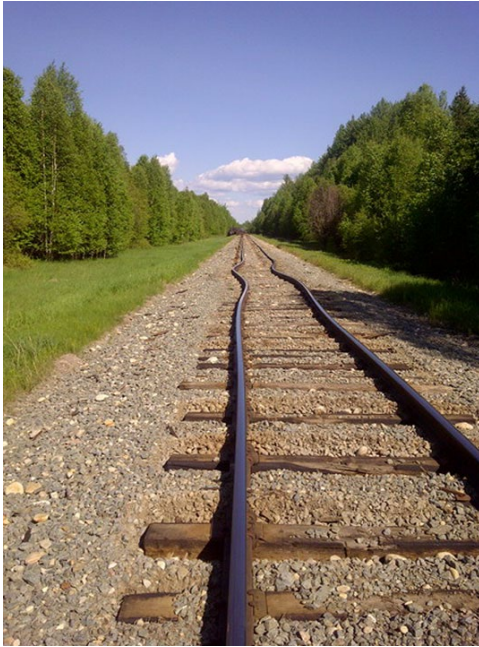
A track buckle (Figure 6) is a large lateral misalignment of the rails³⁰ that occurs when longitudinal compressive stresses build up in the rail and overcome the lateral resistance of the track structure.

Figure 6. Track buckle (Source: TSB Railway Investigation Report R14E0081)

Track buckles usually initiate at small alignment deviations. Lateral alignment defects in rails reduce the track's buckling strength.

Track buckle lengths can range from 40 to 60 feet and can result in a lateral deflection of the track by up to 30 inches. These misalignments can cause derailments because trains travelling at typical operating speeds cannot negotiate track that has shifted laterally. Both curved and tangent tracks are susceptible to buckling. Tangent track tends to buckle explosively with a large deflection, whereas the curved track may buckle progressively with comparatively smaller lateral displacements.³¹ Buckles are predominantly lateral, but may occasionally be vertical.
