# RAIL TRANSPORTATION SAFETY INVESTIGATION REPORT R24W0021

## MAIN-TRACK TRAIN DERAILMENT

Canadian National Railway Company  
Freight train G89641-05  
Mile 34.3, Rivers Subdivision  
Near Elie, Manitoba  
06 March 2024

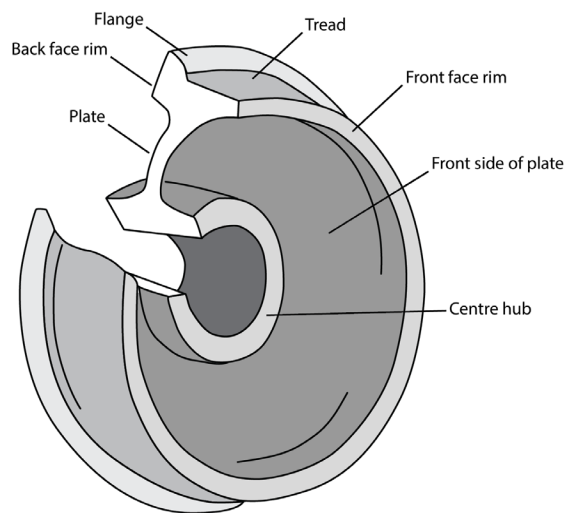
**Figure 3. Parts of a freight car wheel (Source: TSB)**

The L2 wheel had a dent (plastic deformation) to the back side of the plate, and there was a surface crack on the front side of the plate, directly opposite the dent location.

The dent was about 6 inches away from the wheel centre hub. It was 0.18 inch deep and 1 inch wide. Its length could not be determined because 1 of the wheel fragments adjacent to the dent was not found at the occurrence site.

According to the manufacturer, the dent on the back side of the plate initiated cracking on the front side. The crack then progressed by fatigue, under service loads, through the plate; turned radially through the thinner portion of the plate; and propagated into the rim until the wheel failed during operational loading.

Figure 3 illustrates the various parts of a freight car wheel.
