# AIR TRANSPORTATION SAFETY INVESTIGATION REPORT A24W0066

## FUEL STARVATION AND COLLISION WITH TERRAIN

Rocking Star Adventures Ltd.  
Cessna U206G, C-GRSA  
Haines Junction Aerodrome (CYHT), Yukon  
10 June 2024

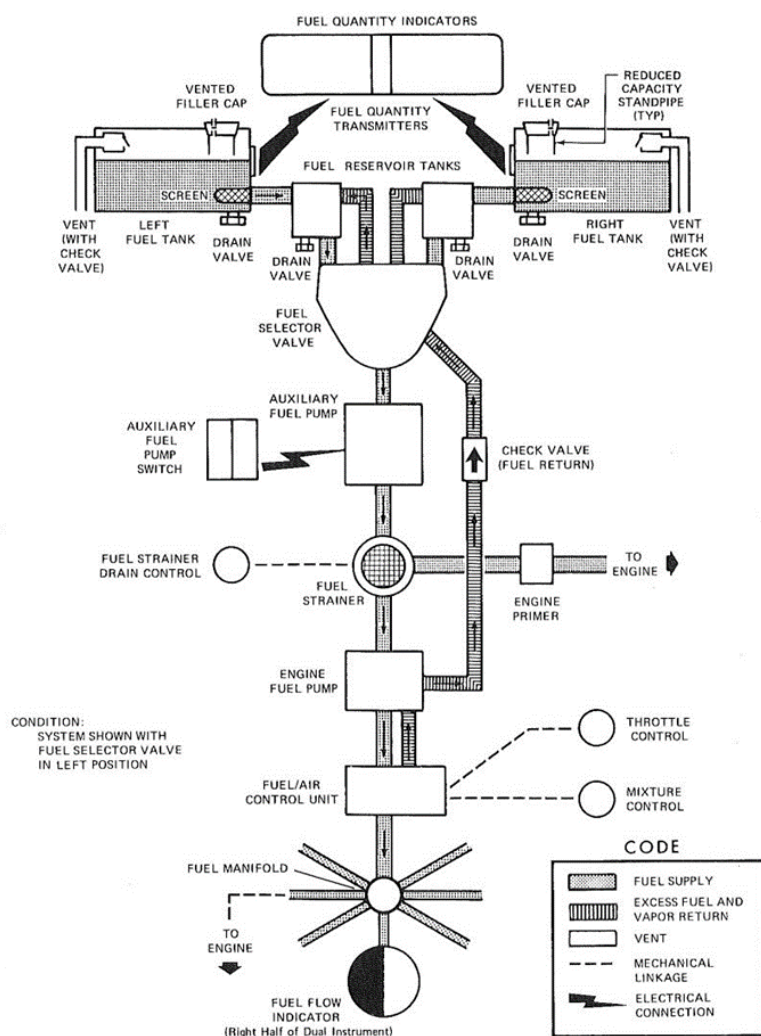
Figure 3. Cessna U206G aircraft's fuel system (Source: Cessna Aircraft Company, Pilot's Operating Handbook and FAA Approved Airplane Flight Manual – 1982 Model U206G)

The aircraft's fuel system components relevant to this occurrence include 2 vented integral fuel tanks (1 in each wing), a fuel tank selector valve, an auxiliary fuel pump, and an engine-driven fuel pump (Figure 3).
