AVIATION INVESTIGATION REPORT

A01H0003

ENGINE POWER LOSS - FORCED LANDING

PILATUS PC-6T C-GROO

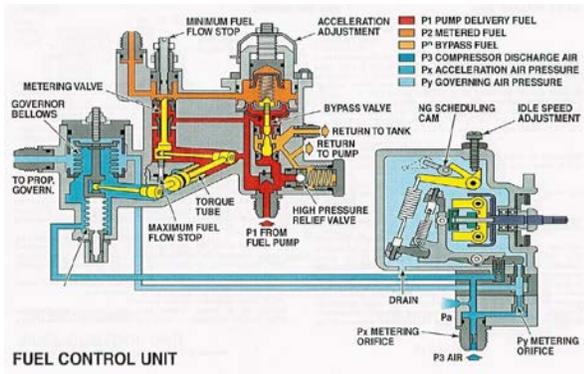
## Schematic of the PT6A Fuel Control Unit

The reason for the engine power loss, or roll-back, was a loss of vacuum of the fuel control unit (FCU) acceleration bellows, which resulted in the FCU reducing fuel going to the engine to minimum flow. The loss of the bellows vacuum was due to a breach of the bellows material at a corrosion site, at a time when the compressor discharge air was at its highest pressure--under take-off power conditions. There were no possible actions available to the pilot to restore power to the engine. There is optional equipment available, but not fitted on C-GROO, that would have permitted the restoration of sufficient engine power to maintain a climb. An emergency fuel lever, when used carefully, would have bypassed the FCU acceleration bellows control function and allowed engine operation. The analysis will focus on why the recently-overhauled FCU was being operated with the bellows in a corroded state.

1. The engine power loss occurred because the fuel control unit (FCU) bellows was breached, causing the fuel flow to the engine to be limited to minimum flow.
2. The FCU bellows was breached because of corrosion, initiated during in-service use and exacerbated by long-term, un-preserved storage. The corrosion was not detected because a complete inspection of the FCU components was not carried out during overhaul.
3. The FCU light overhaul procedure did not provide enough direction as to when the procedure may be used. Thus those using the light overhaul procedure may not detect, in sub-components such as the acceleration bellows, flaws that can be beyond safe limits.

ACCELERATION BELLOWS (EVACUATION)
