AVIATION INVESTIGATION REPORT
A03A0002

COLLISION WITH WINDROW

LABRADOR AIRWAYS LTD.
BEECH 1900D C-GLHO
ST. JOHN'S INTERNATIONAL AIRPORT
NEWFOUNDLAND AND LABRADOR
11 JANUARY 2003

Report Number A03A0002

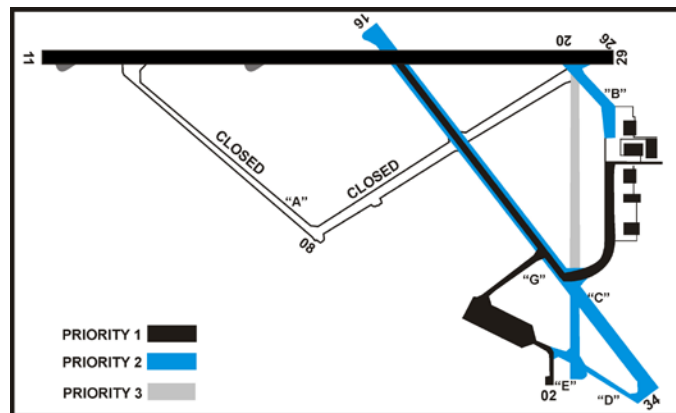
Runway 02, from Charlie taxiway to Runway 29, had not been traversed by any vehicle prior to the accident. The runway had not been cleared during the previous night, and there were no RSC reports produced for the runway. As the location of the windrow north of Charlie taxiway was well to the north of Runway 16/34, the windrow did not appear on any of the RSC reports produced that night. After the accident, Runway 20/02 north of the windrow was found to be covered with a combination of ice and patches of thin snow.

1. The aircraft was damaged when it collided with a windrow laying across its taxi path.
2. Runway 02 north of Charlie taxiway was left open throughout the period of snow removal even though it was not usable and was not required.
3. The taxi speed of the aircraft did not allow the crew sufficient time to respond once they saw the windrow, increasing the risk of collision, damage, and physical harm to the passengers.
4. The lighting conditions at the time made the windrow difficult to see.
5. The existence of the windrow, the result of snow plowing activities, had not been reported to either the night lead-hand, the ground controller, the oncoming lead-hand, or the crew of Lab Air 8333.
6. The stranded Airbus, the high airfield maintenance workload and the shift change combined to circumvent the normal procedures that would have ensured that the windrow was reported.

The St. John's Airport Authority has issued a memorandum which allows the lead hand to close Runway 02/20 when conditions require.
