**AVIATION INVESTIGATION REPORT  
A12P0136**

**COLLISION WITH TERRAIN**

**PIPER PA-30 TWIN COMANCHE C-GLGJ  
KELOWNA, BRITISH COLUMBIA, 18 NM W  
13 AUGUST 2012**

Report Number A12P0136

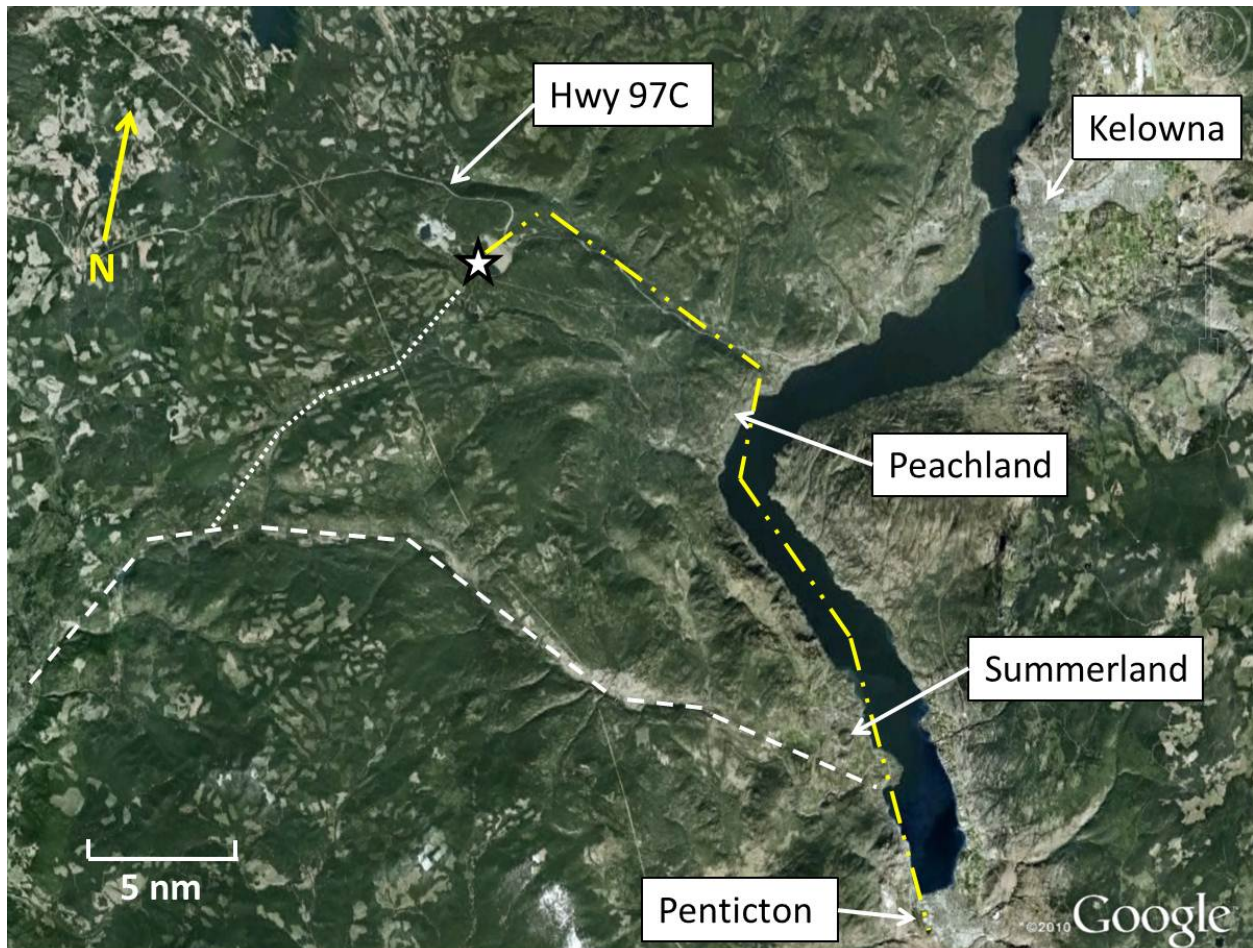
Two more persons boarded the aircraft with their baggage. Immediately before departure, the pilot advised the Penticton Flight Service Station (FSS) of the intention to depart on Runway 34 and climb to 5000 feet above sea level (asl), before turning westbound for Boundary Bay. After take-off from Penticton Airport, the pilot observed that the aircraft's climb rate was significantly lower than it had been 2 days earlier, when it had departed Penticton with only 2 persons on board. Consequently, the pilot did not turn west onto the published VFR route approximately 6 nm north of Penticton (the route taken on the previous flight from Penticton to Boundary Bay), but instead flew approximately 20 nm north, before turning west near Peachland (Figure 1).

**Figure 1.** Map showing the probable route up the lake to the accident site (dashed/double-dotted line), the published VFR route to the west of the lake (dashed line) and the low ground route connecting the two (dotted line)

The aircraft crashed on a level, treed portion of the Brenda Mines tailings dam, about 0.7 nm southwest of Highway 97C (Photo 1), at an elevation of 4595 feet asl. Though not a published VFR route, Highway 97C follows the Trepanier Creek Valley and is often used by pilots as a route when flying west from the Okanagan Valley. The Brenda Mines site is about 10 nm north of the published VFR route from Summerland to Princeton, and the valley southwest from the Brenda Mines to the published VFR route is the logical low-ground route between the two (Figure 1).
