**AVIATION INVESTIGATION REPORT
A13H0001**

**CONTROLLED FLIGHT INTO TERRAIN
7506406 CANADA INC.
SIKORSKY S-76A (HELICOPTER), C-GIMY
MOOSONEE, ONTARIO
31 MAY 2013**

Summary

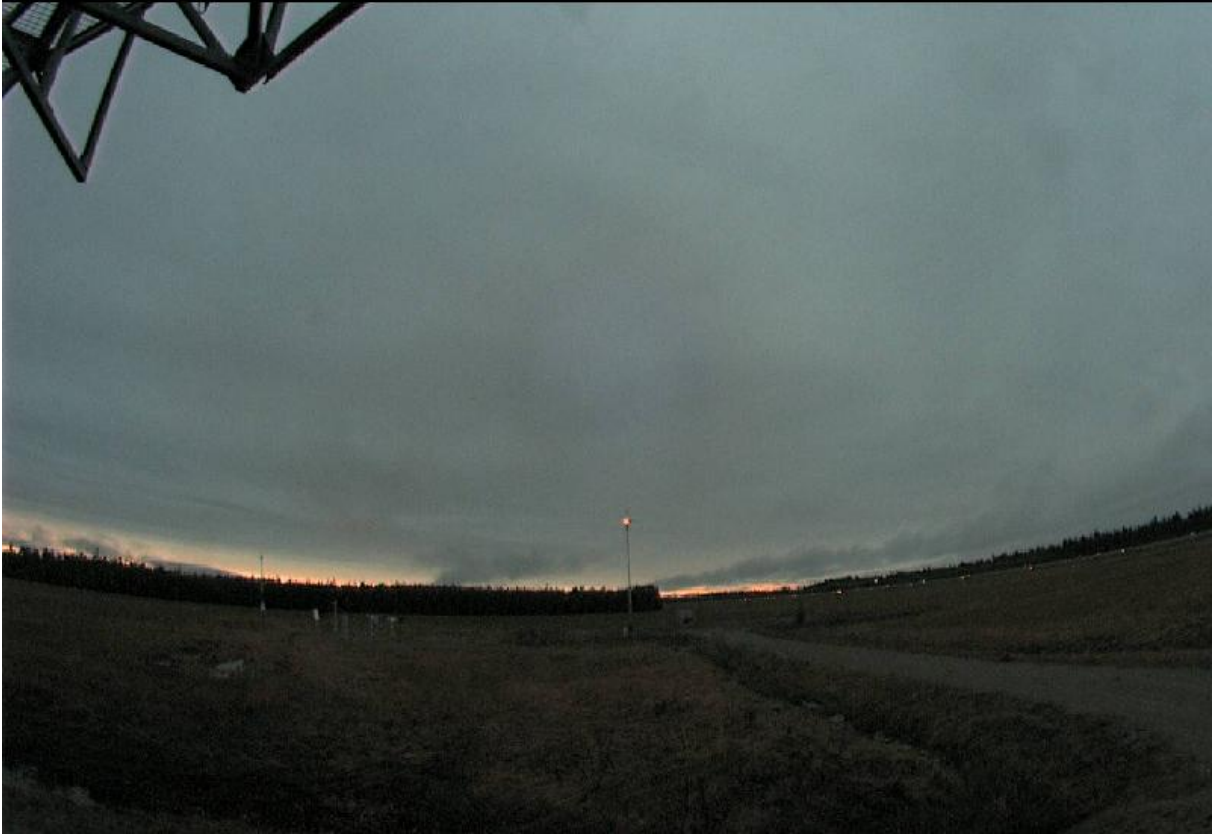
The airport is equipped with 2 weather cameras that take still images every 10 minutes. One of the cameras points to the northeast and the other points to the southwest. The camera pointing to the northeast is oriented in the general direction of Runway 06, paralleling it to the north. In the daylight image from this camera, it is possible to see a lit tower on the airfield and the treeline to the north of Runway 06. Images taken hours before the occurrence clearly show the tower and the treeline (Photo 1). In contrast, the only thing visible in a photograph from approximately the same time as the accident is the single light from the tower located on the airfield (Photo 2). No other cultural lighting, or ambient lighting from stars, is visible in the image.

Photo 1. Image taken by the northeast-oriented weather camera showing the lit tower and the treeline at Moosonee Airport at 2050 on 30 May 2013 (Source: NAV CANADA)

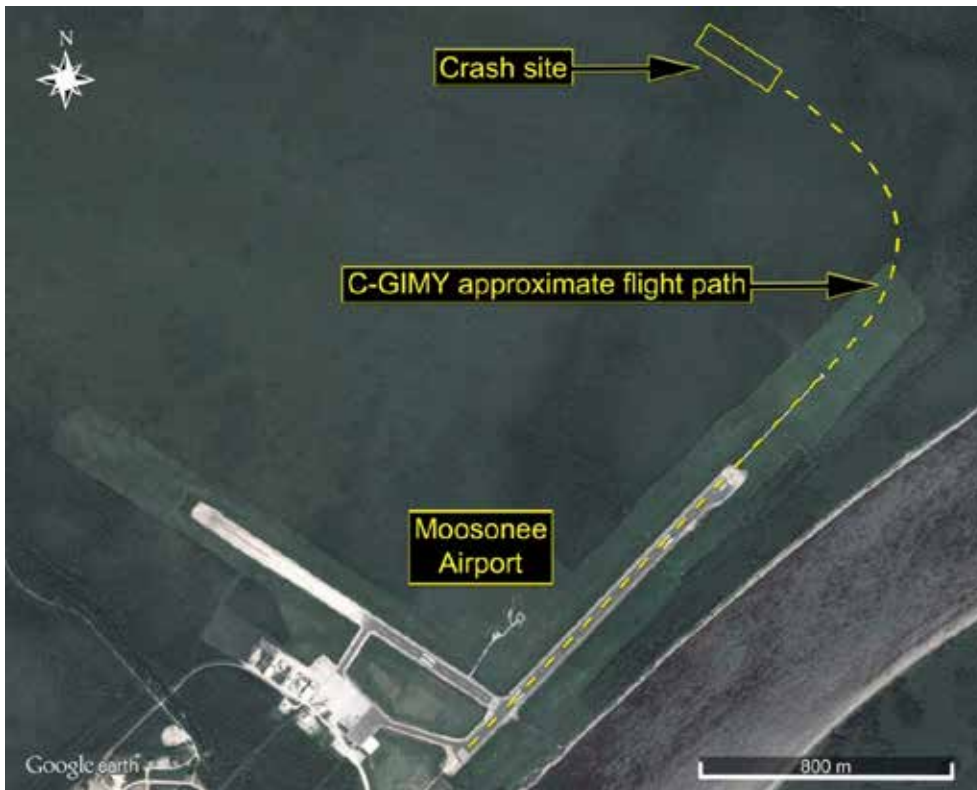
The wreckage was located in densely wooded, swampy terrain approximately 0.8 sm from the end of Runway 06, on a bearing of 020°M (Figure 1). Based on damage to surrounding trees and ground scars, investigators determined that the aircraft collided with the ground in a steady, shallow descent angle (approximately 9 degrees), in a left-banked (approximately 20 degrees) attitude (Figure 2 and Figure 3). Although it was not possible to determine the exact speed of the helicopter at the time of the accident, the damage to the surrounding terrain and trees, length of the wreckage trail, and extent of aircraft breakup during the impact sequence indicated a high-energy state (consistent with the helicopter being at or near cruise speed) upon impact with the ground.

Figure 1. Approximate flight path of the occurrence helicopter, C-GIMY (Source: Google Earth, with TSB annotations)

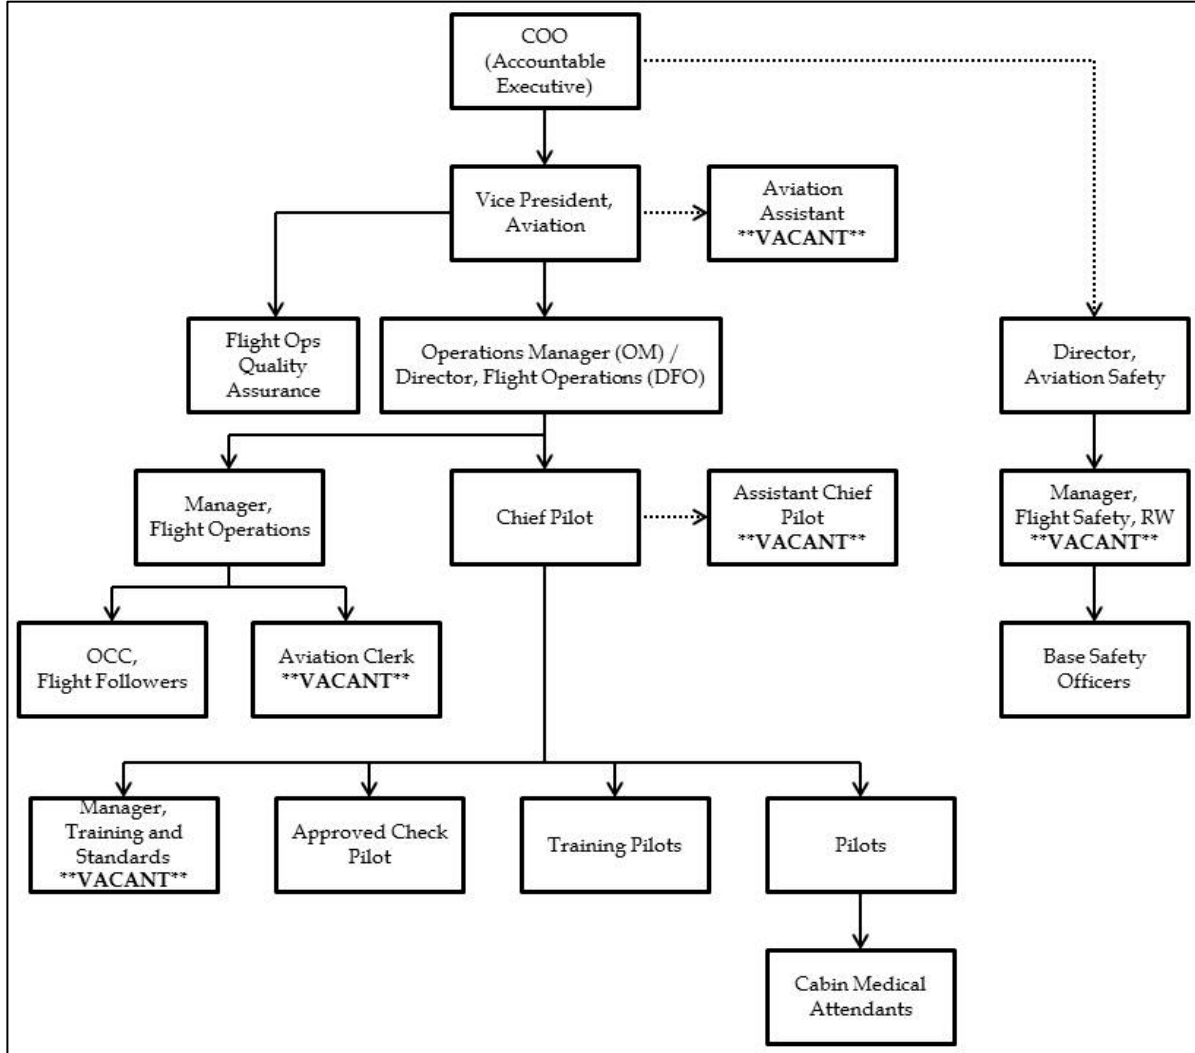
At the time of the accident, Ornge RW's organizational structure was as shown in Figure 7.

Figure 7. Ornge Rotor-Wing's organizational structure at the time of the accident (Source: Ornge RW, *Company Operations Manual*, with TSB annotations)

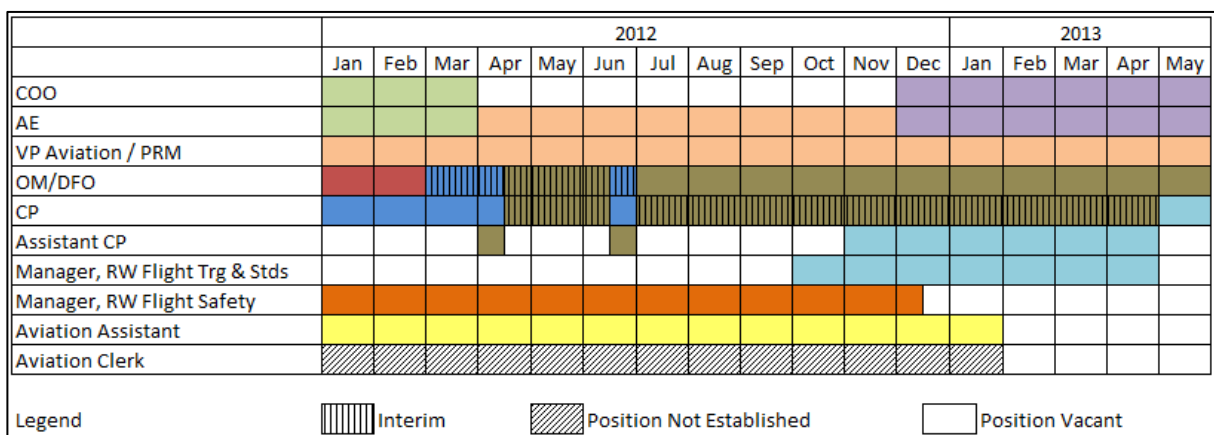
In December 2012, a new COO/AE was hired. During the period of April 2012 to December 2012, in the absence of a COO/AE, the Vice President (VP) of Aviation, acting as the AE, reported directly to the Acting CEO. Then in January 2013, a CEO/President was hired. Figure 8 depicts the staff changes within some of the key management positions at Ornge RW. Each colour represents a different individual. Interim positions are represented by vertical stripes.

Figure 8. Timeline of staff changes at Ornge Rotor-Wing
