**AVIATION INVESTIGATION REPORT
A13Q0021**

**LOSS OF CONTROL DURING HYDRAULIC PRESSURE
FAILURE TRAINING
EUROCOPTER AS350 BA HELICOPTER, C-GPHN
HÉLI-EXCEL INC.
SEPT-ÎLES AIRPORT, QUEBEC
03 FEBRUARY 2013**

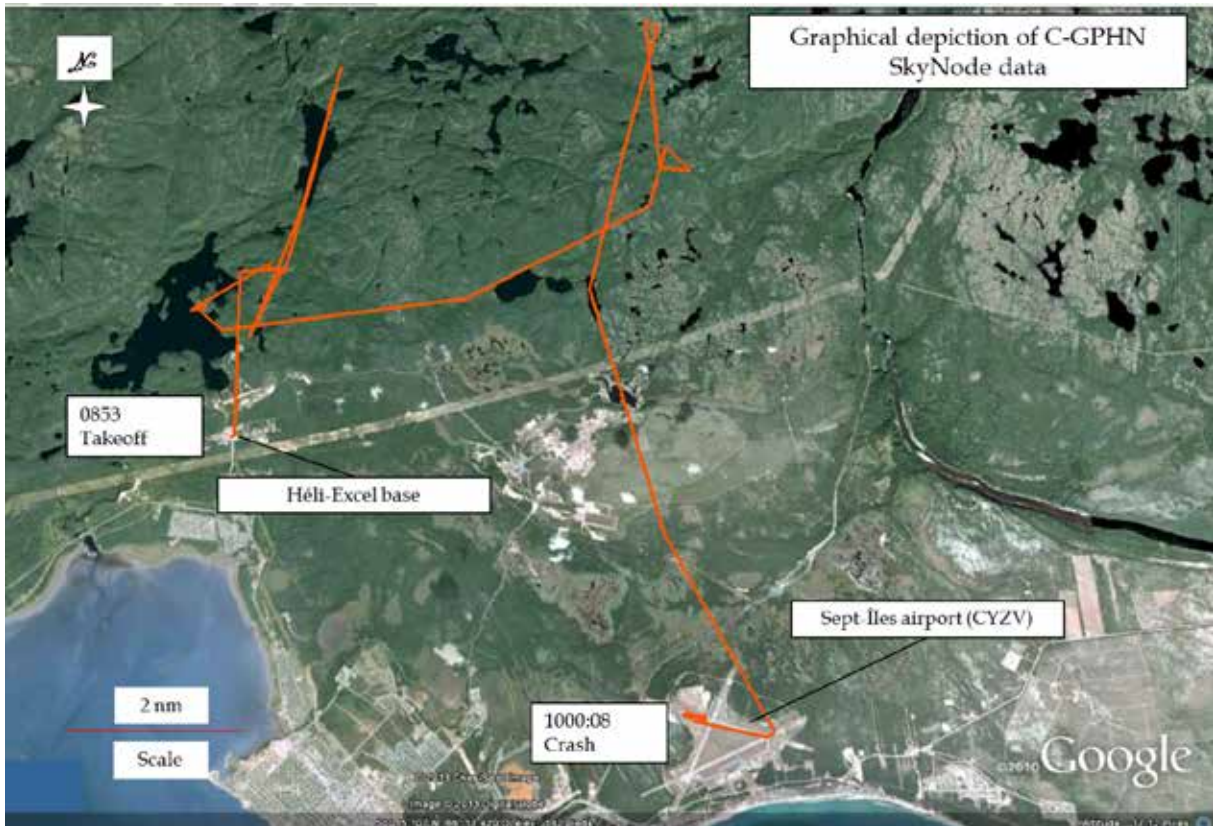
Figure 1. Aircraft flight path (Source: Google Earth, with TSB annotations)

At 0954, after completing drills for engine failure at the hover at the threshold of Runway 27, the helicopter took off to carry out hydraulic failure drills on Runway 31. Shortly after

takeoff, the flight instructor engaged the HYD TEST switch. The horn sounded; the pilot in training saw the HYD light illuminate and confirmed the hydraulic failure. The pilot in training did not notice any flight control loads and set the indicated airspeed at between 40 and 60 knots. After the flight instructor turned the HYD TEST switch to the OFF position, the pilot in training pushed the HYD CUT OFF switch at which point the flight controls stiffened. While close to the ground, the aircraft slowed to the point where the pilot in training felt that the loads on the flight controls prevented him from controlling the aircraft to make a safe landing.

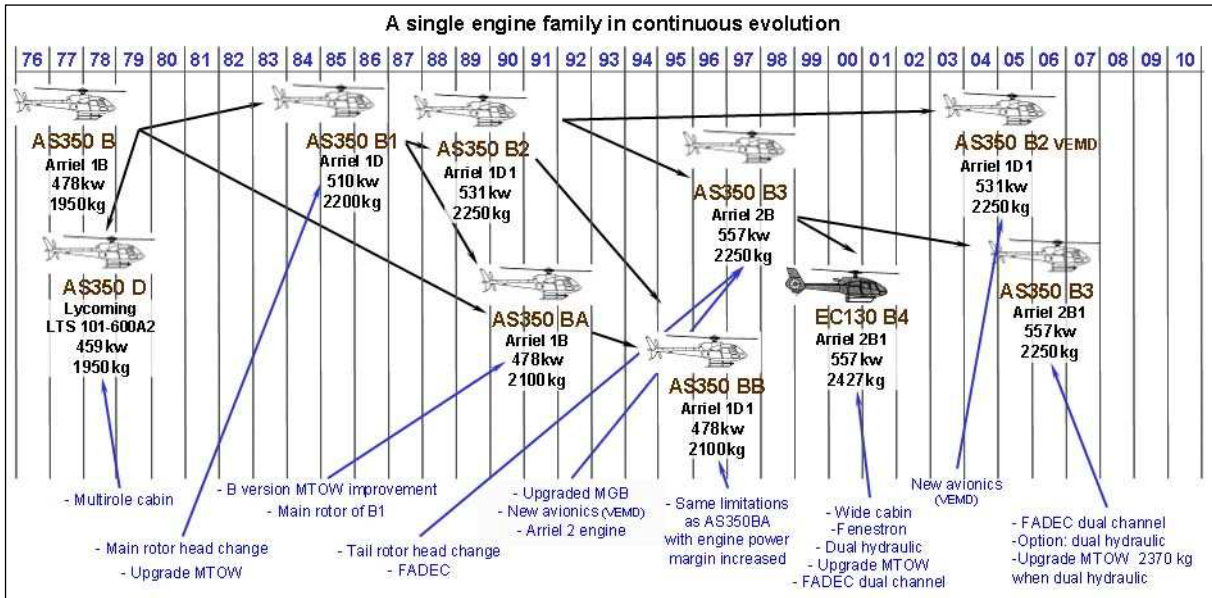
Figure 3. Illustration of the AS350's evolution and changes (Source: Eurocopter)

C-GPHN was originally manufactured as an AS350 D in 1980 by Aérospatiale (Figure 3). On 16 May 2001, the aircraft was converted into an AS350 BA as per Eurocopter service bulletins. At the same time, modifications were made as per Apex Aerospace, Inc.'s Transport Canada-approved SH02-15 supplemental type certification (STC). These changes reduced fuel consumption and increased the helicopter's internal gross weight to that of the AS350 B2, i.e. 2250 kg (4961 pounds). Operators commonly refer to the AS350 BAs that have been modified as per the Apex SH02-15 STC as AS350 BA+ to distinguish them from the other models.

Given that the AS350 BA+ and the AS350 B2 have the same internal gross weight, the drive train systems of models BA, BA+ and B2 were compared. Similarities were noted, except that the AS350 B2 is equipped with a yaw channel load compensator to counter the high forces on the pedals during a hydraulic failure. It was also noted that the torque limits and shaft horsepower of the BA and BA+ are similar, whereas those of the B2 are higher.

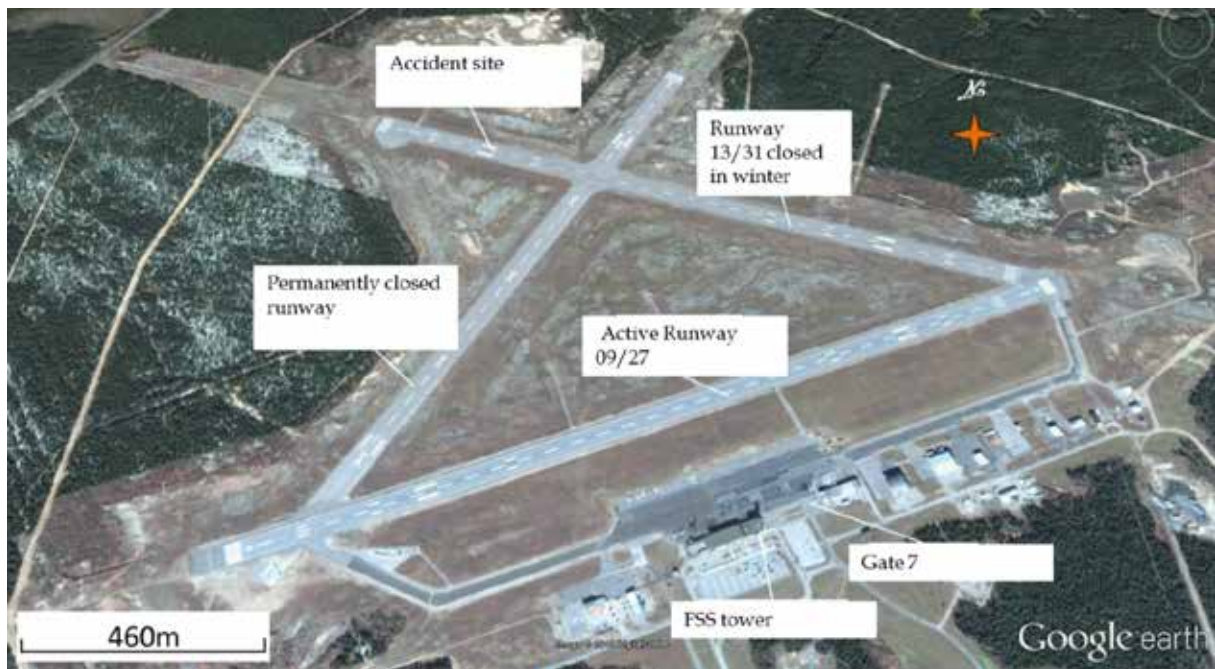
Figure 6. View of the Sept-Îles Airport (Source: Google Earth, with TSB annotations)

The Sept-Îles Airport is certified, operated and maintained by TC. The airport has a flight service station (FSS) operated by NAV CANADA. Its reference altitude is 180 feet above sea level (asl). The airport has 2 runways: Runway 09/27 and Runway 13/31 (Figure 6). The elevation of the Runway 31 threshold is 173 feet asl. At the time of the occurrence, Runway 27 was the active runway.

Runway 13/31 had been closed since 31 January 2013. Its paved surface was covered with ice and patches of snow. Communications between the helicopter and the FSS revealed that the crew reported no problems and did not declare an emergency situation before or after the crash.

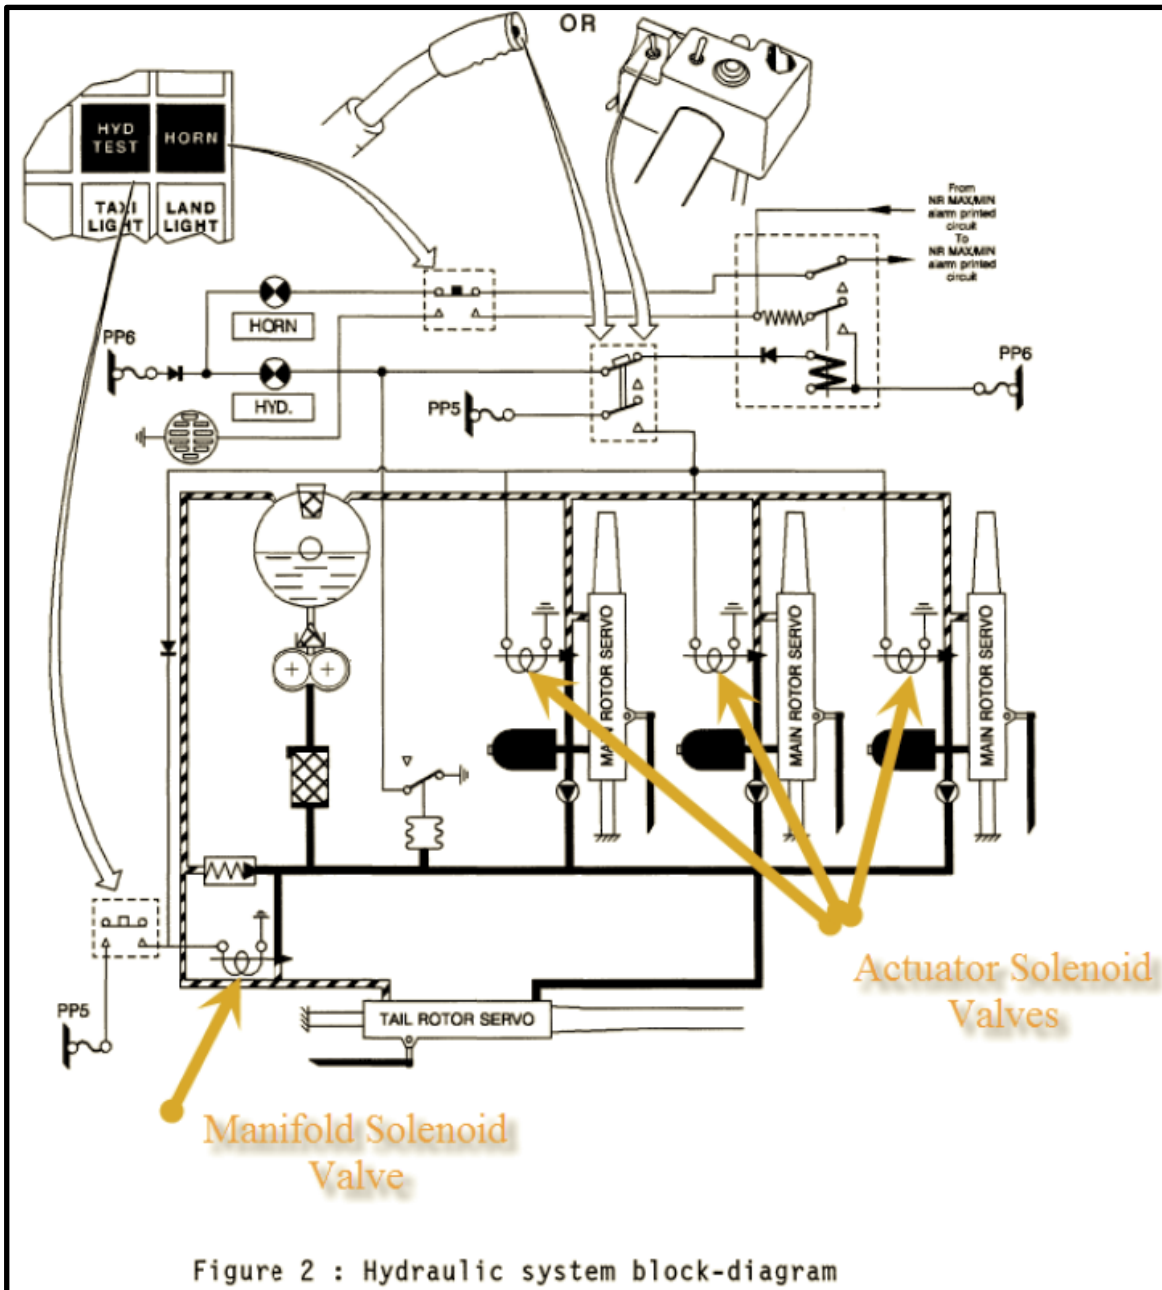
The helicopter is equipped with 4 servoactuators, 3 of which actuate the stationary swashplate: 1 servoactuator for pitch control, and 2 servoactuators for roll control (Appendix B). The fourth servoactuator is in the tail rotor. In order to offset excessive loads in the event of a hydraulic system failure at high speed, a safety unit consisting of an accumulator, a non-return valve and a solenoid valve was installed on each servoactuator. The hydraulic pressure provided by the accumulators allows the pilot to safely reduce the airspeed to a value at which the manual control forces are manageable without hydraulic pressure assistance. The AS350 BA is not equipped with a control channel load compensator on the tail rotor.

Activation of the HYD TEST switch opens the manifold solenoid valve and depressurizes the hydraulic system.

Activation of the HYD CUT OFF switch opens the actuator solenoid valves of each servoactuator accumulators and depressurizes the accumulators for flight without hydraulic pressure assistance.
