AVIATION INVESTIGATION REPORT

A16Q0119

Loss of control and collision with terrain

Cessna U206F, C-FWBQ

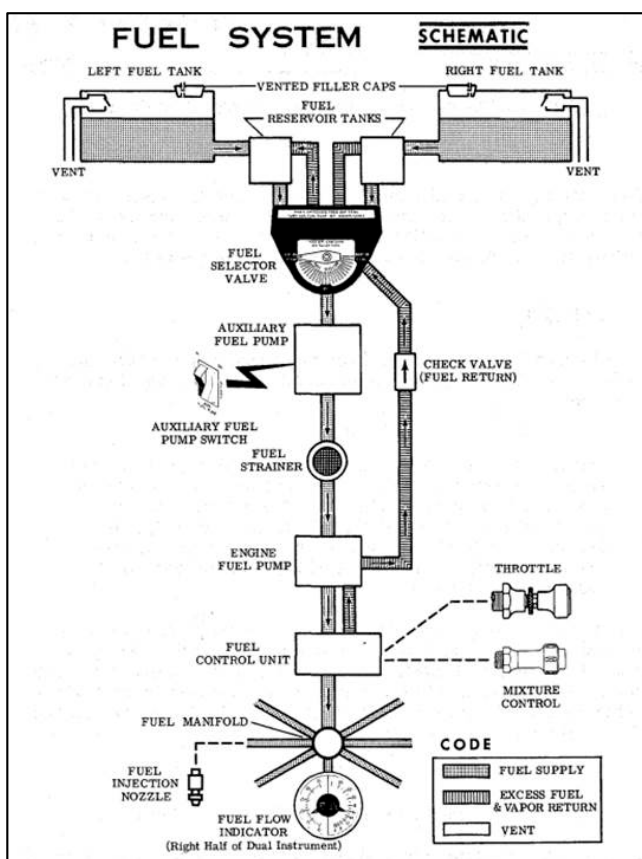
Figure 2. Fuel circuit schematic (Source: 1975 Cessna Stationair Owner's Manual)

Fuel is supplied to the engine from two tanks, one in each wing [Figure 2]. [...] Fuel from each wing flows through a fuel reservoir tank [located under the cabin floor] to the fuel selector valve. Depending upon the setting of the selector valve, fuel from the left or right tank flows through a by-pass in the electric auxiliary fuel pump (when it is not operating) and fuel strainer to the engine-driven fuel pump. From here, fuel is distributed to the engine cylinders via a fuel control unit and manifold.

According to the manufacturer, sudden failure of an engine-driven fuel pump would result in the engine shutting down almost immediately.

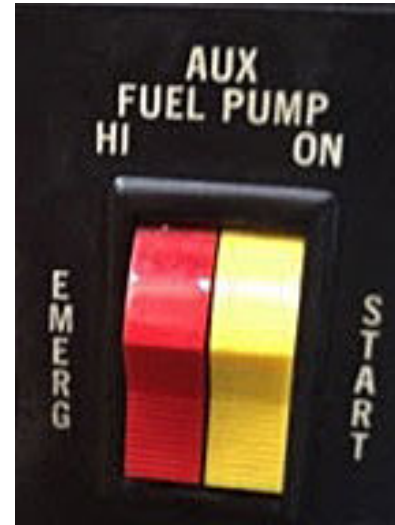
Figure 3. Auxiliary fuel pump switch
(Source: Maurice Gunderson)

The flight manual states that “the auxiliary fuel pump switch is located on the left side of the instrument panel and is a yellow and red split-rocker type switch”¹⁸ (Figure 3).

The right switch (yellow) is labelled START, and the ON position is used for various functions, including normal startup and continued engine operation if the engine-driven fuel pump fails.¹⁹ If this pump fails, the auxiliary fuel pump provides sufficient capacity to allow the engine to operate during cruising, descent, landing, and taxiing.

The red left half of the switch is labelled EMERG, and its upper HI position is used in the event of an engine-driven fuel pump failure during take-off or high-power operation. [...] Maximum fuel flow is produced when the left half of the switch is held in the spring-loaded HI position. In this position, an interlock within the switch automatically trips the right half of the switch to the ON position. When the spring-loaded left half of the switch is released, the right half will remain in the ON position until manually returned to the off position.²¹
