AIR TRANSPORTATION SAFETY INVESTIGATION REPORT A18Q0030

RUNWAY OVERRUN ON LANDING

Strait Air (2000) Ltd.
Beechcraft King Air A100, C-GJXF
Havre St-Pierre Airport, Quebec
26 February 2018

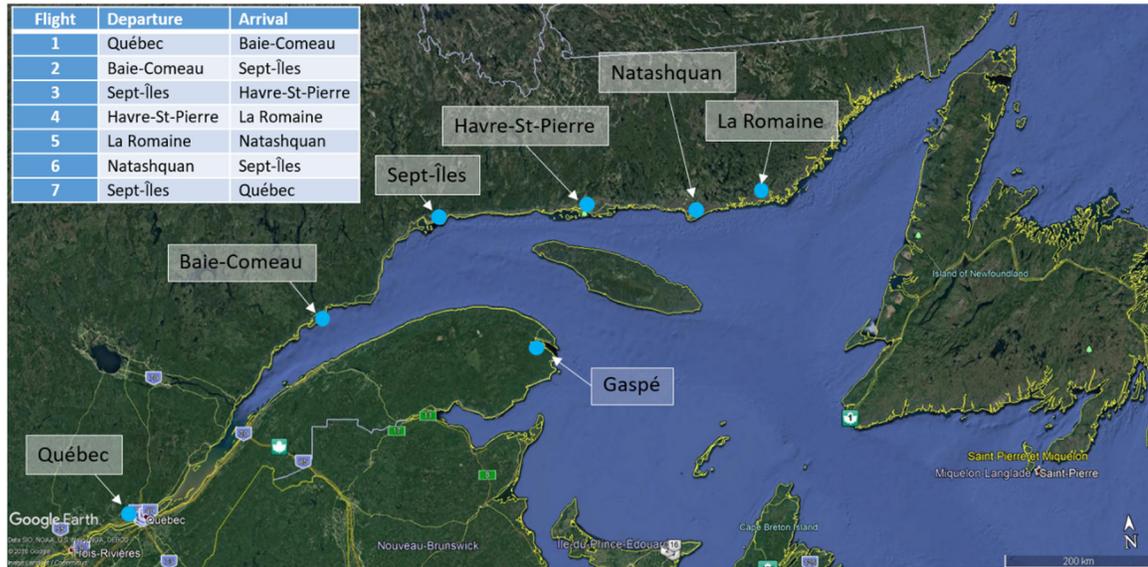
Figure 1. Flights operating as NUK107 on the occurrence date (Source: Google Earth, with TSB annotations)

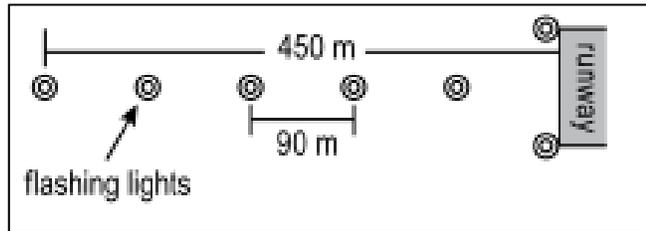
Given the presence of a sensitive environmental area, a lake that is home to endangered species, the 5 lights on the extended centreline of the Runway 08 ODALS at CYGV extend over a distance of 419.8 m rather than 450 m, pursuant to an exemption from regulatory requirements issued by TC.³⁰

Figure 4. Omnidirectional approach lighting system (Source: Transport Canada, Transport Canada Aeronautical Information Manual, AGA – Aerodromes [12 October 2017], section 7.5.1)

The ODALS was serviceable at the time of the occurrence, and was turned on automatically when the pilot activated the ARCAL.

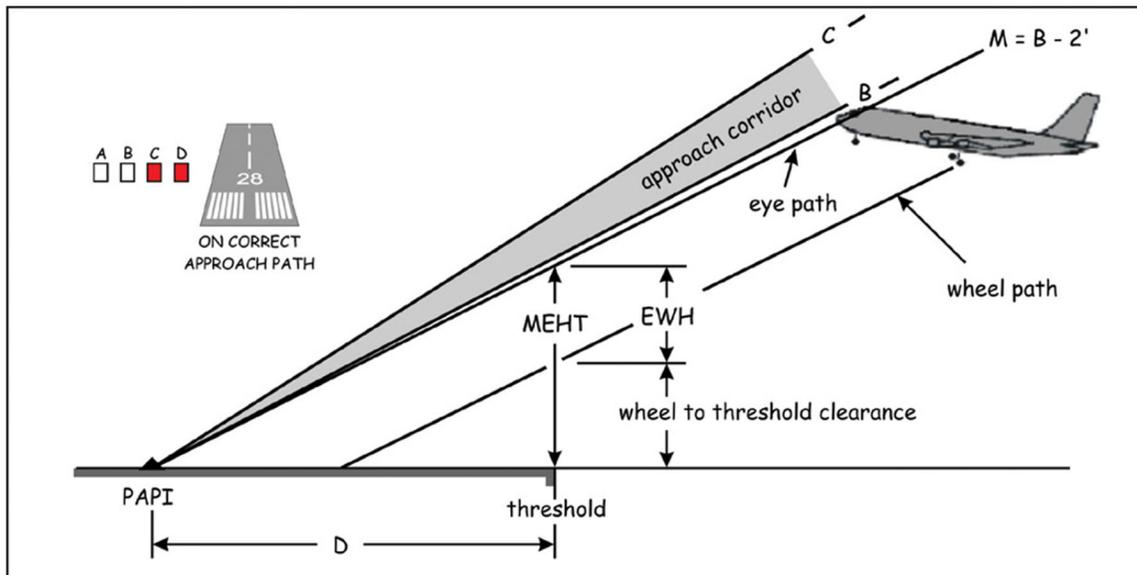
Figure 5. Precision approach path indicator: pilot eye path to wheel path (Source: Transport Canada, Transport Canada Aeronautical Information Manual, AGA – Aerodromes [12 October 2017], section 7.6.4.3)
