Air Transportation Safety Investigation Report A20P0080

COLLISION WITH TERRAIN

Aberdeen Helicopters Ltd.
Airbus Helicopters AS 350 B2 (helicopter), C-FAHC
Stewart, British Columbia, 45 NM NNW
17 August 2020

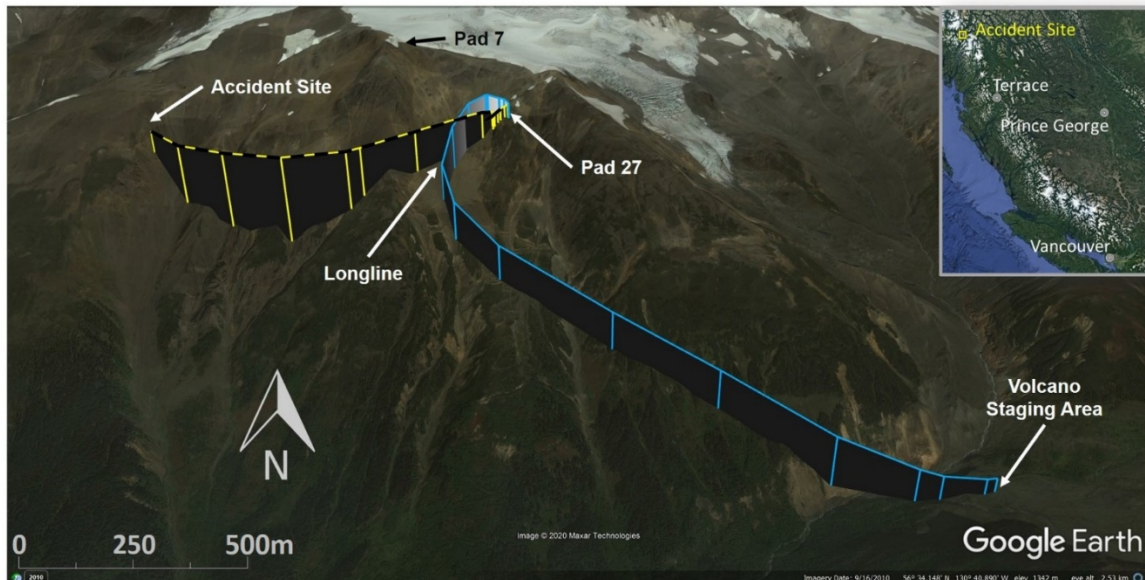
Figure 1. View of Nickel Mountain with the global positioning system track of the helicopter's path before its final arrival at Pad 27 (solid line) and shortly before the accident (dashed line) (Source: Google Earth, with TSB annotations)

At 1022, the pilot returned to Pad 27 to move the last piece of the drill rig. After the drill foreman had hooked the load up to the helicopter's longline, the pilot communicated that poor weather was approaching and that he was unable to take the load. The load was disconnected and the helicopter hovered in place for approximately 1 minute. At 1024, the pilot backed away from the drill pad downslope (southwestward) at a ground speed of between 1 and 2 knots and stopped approximately 200 feet away. He then moved back toward the pad, and the drill crew asked if they should remove the longline. The pilot said it was not necessary, and at 1025:40, he turned and began to accelerate on a southwestward track. Heavy rain began at this time.

Over the next 30 seconds, global positioning system (GPS) data showed that the helicopter continued southwest and accelerated to a ground speed of approximately 70 knots at GPS altitudes of between 5600 feet above sea level (ASL) and 5500 feet ASL. At 1026:02, the pilot released the longline from the helicopter onto the hillside about 800 feet west of Pad 27 and, 9 seconds later, the helicopter began to track to the right in a turn at approximately 5° per second. The change in altitude during this turn was less than 100 feet. The turn continued until just after 1026:27, when the helicopter collided with terrain.
