AIR TRANSPORTATION SAFETY INVESTIGATION REPORT A21A0024

STALL AND COLLISION WITH TERRAIN

Forest Protection Limited
Air Tractor, Inc. AT-802, C-GJJX
Popple Depot, New Brunswick
11 August 2021

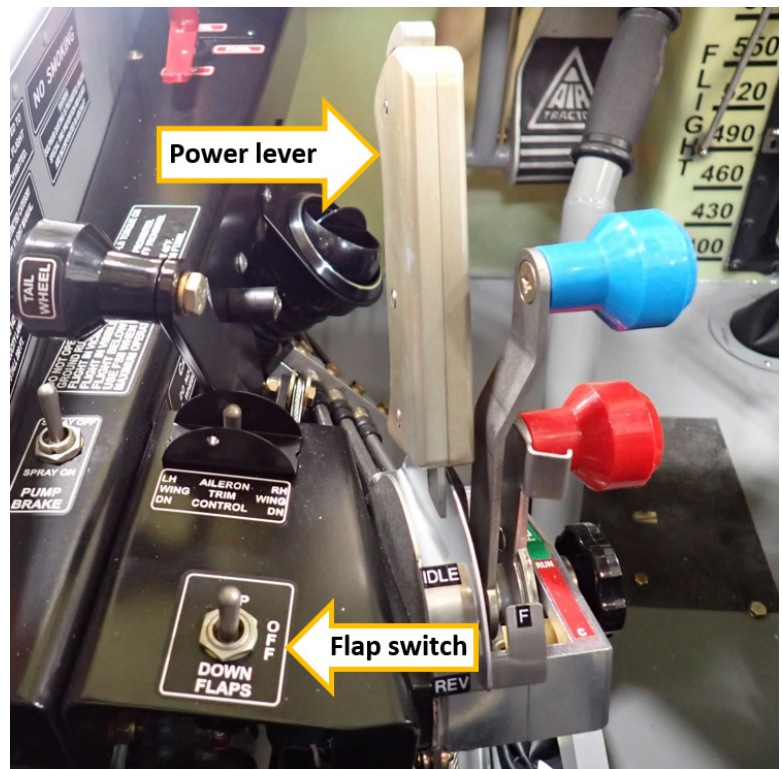
Figure 5. The power lever and flap switch of an exemplar aircraft (Source: Air Tractor, with TSB annotations)

centre OFF position. The flap switch is adjacent to the power lever on the left side of the cockpit (Figure 5). The pilot must remove his or her hand from the power lever to operate the flap switch.

The pilot adjusts the flap position by holding the spring-loaded switch forward to the UP position while retracting the flaps, or by holding the switch back to the DOWN position while extending them. They are adjusted by aligning one of the flap indicators (black lines), located on the left flap, with the trailing edge of the wing (Figure 6). To set the flaps to a specific setting, the pilot needs to look out the window at the flap indicator; there is no haptic, visual, or audio feedback in the cockpit informing the pilot of the flap level selected. It normally takes 2 seconds to move the flaps through each 10° of movement (6 seconds to move flaps from fully extended to fully retracted, or vice versa).

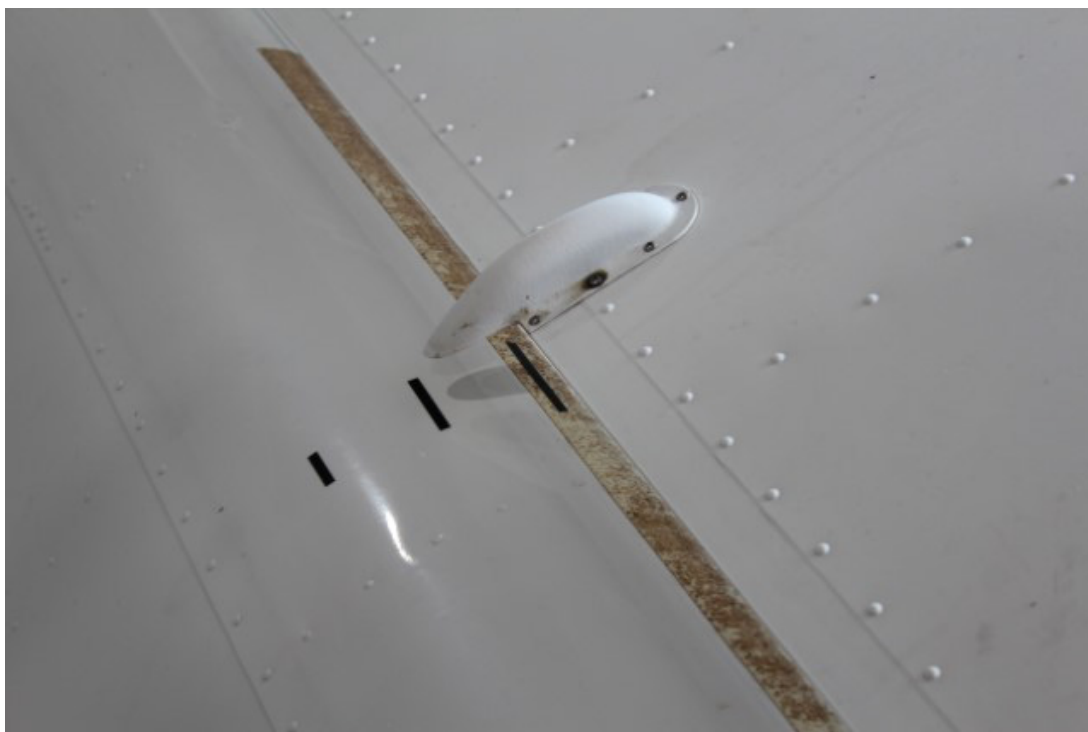
Figure 6. The 10°, 20°, and 30° flap indicator markings on the left wing of an exemplar aircraft. The flap position shown is indicating 30°. (Source: TSB)

It is recommended that 10° of flap be used during the approach and load release phase, which creates a very stable approach condition. Note that 10° is the first mark seen on the flap leading edge as the flaps are being lowered.¹⁹
