AIR TRANSPORTATION SAFETY INVESTIGATION REPORT A22O0146

RUNWAY INCURSION

Greater Toronto Airports Authority
Maintenance Vehicle 31
Toronto/Lester B. Pearson International Airport, Ontario
15 October 2022

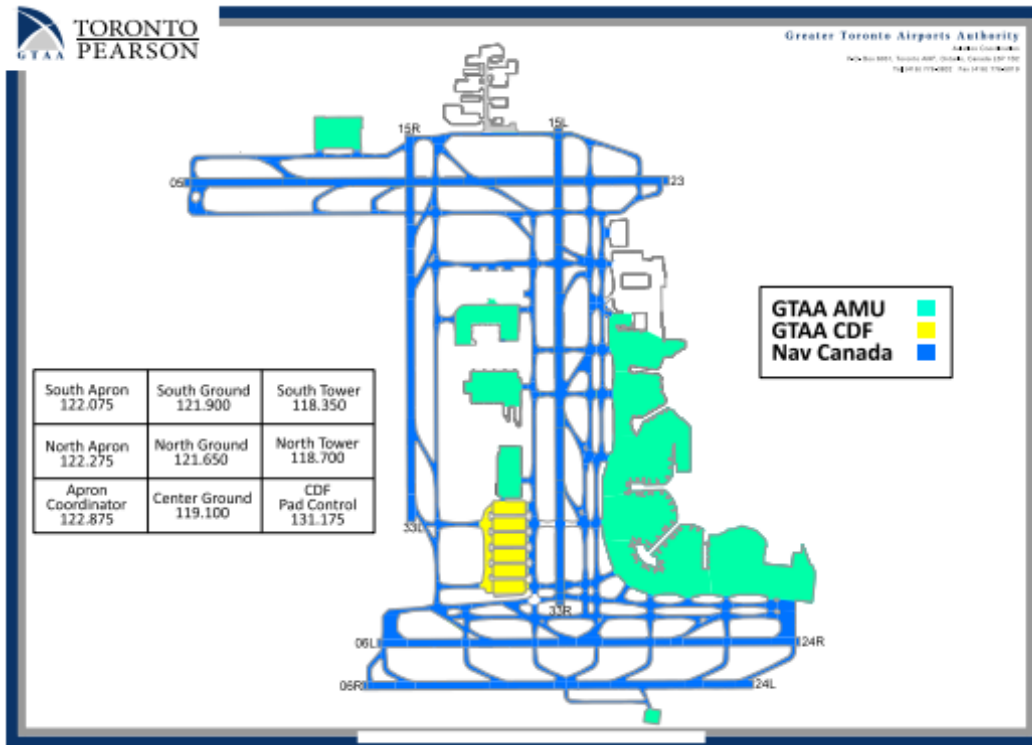
Figure 2. Air and vehicle traffic service providers at Toronto/Lester B. Pearson International Airport (Source: Greater Toronto Airports Authority, Airside Activity Program, Version 3.3 [2021], Appendix C, p. 26)

NAV CANADA is the provider of air and vehicle traffic services on the manoeuvring areas at the airport, while the GTAA provides these services for the Apron Management Unit (AMU) and the Central De-icing Facility (CDF) (Figure 2).
