## Aviation Investigation Report

### In-Flight Fire Leading to Collision with Water

McDonnell Douglas MD-11 HB-IWF

Report Number A98H0003

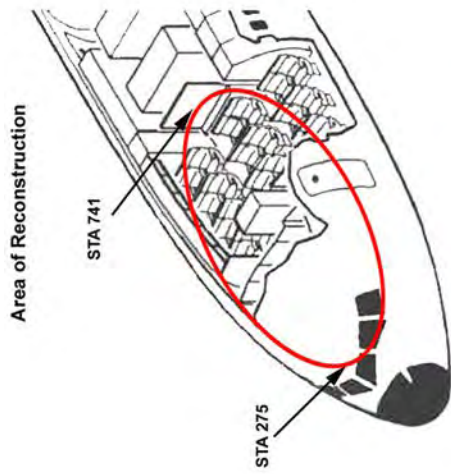
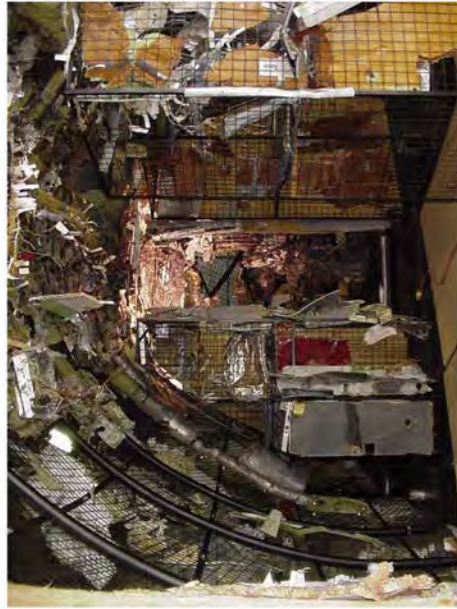
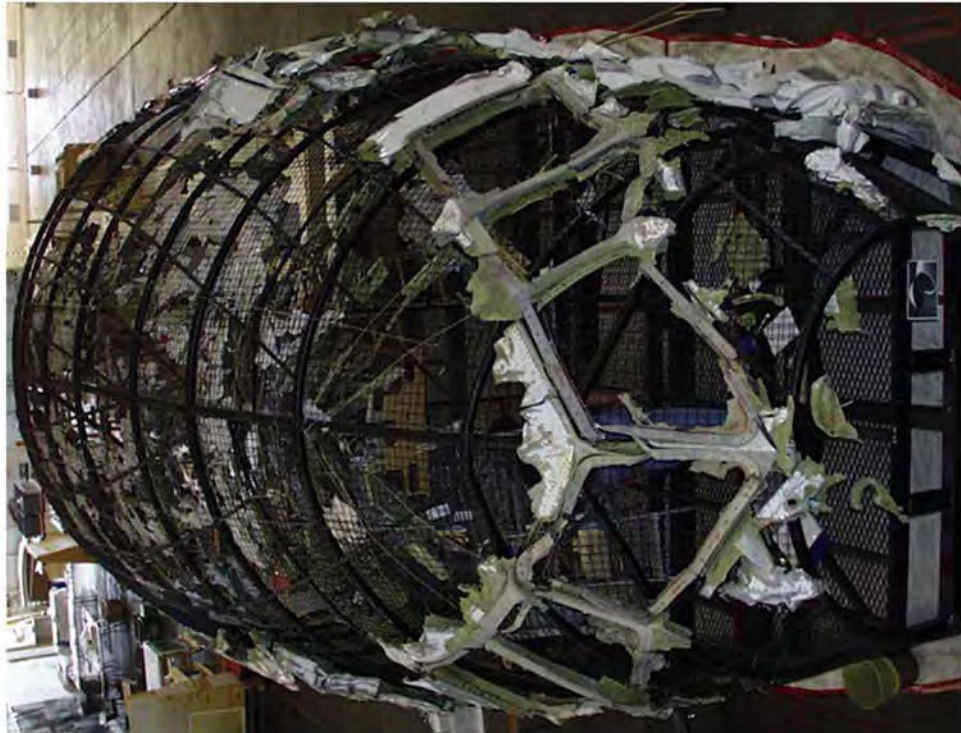
**Figure 19:** Reconstruction mock-up

The aircraft wiring was severely damaged by the forces of impact. Additional mechanical damage could have occurred to some of the wiring during recovery operations. Many of the wire segments had been broken into segments between 10 and 100 cm (4 and 39 inches) long.

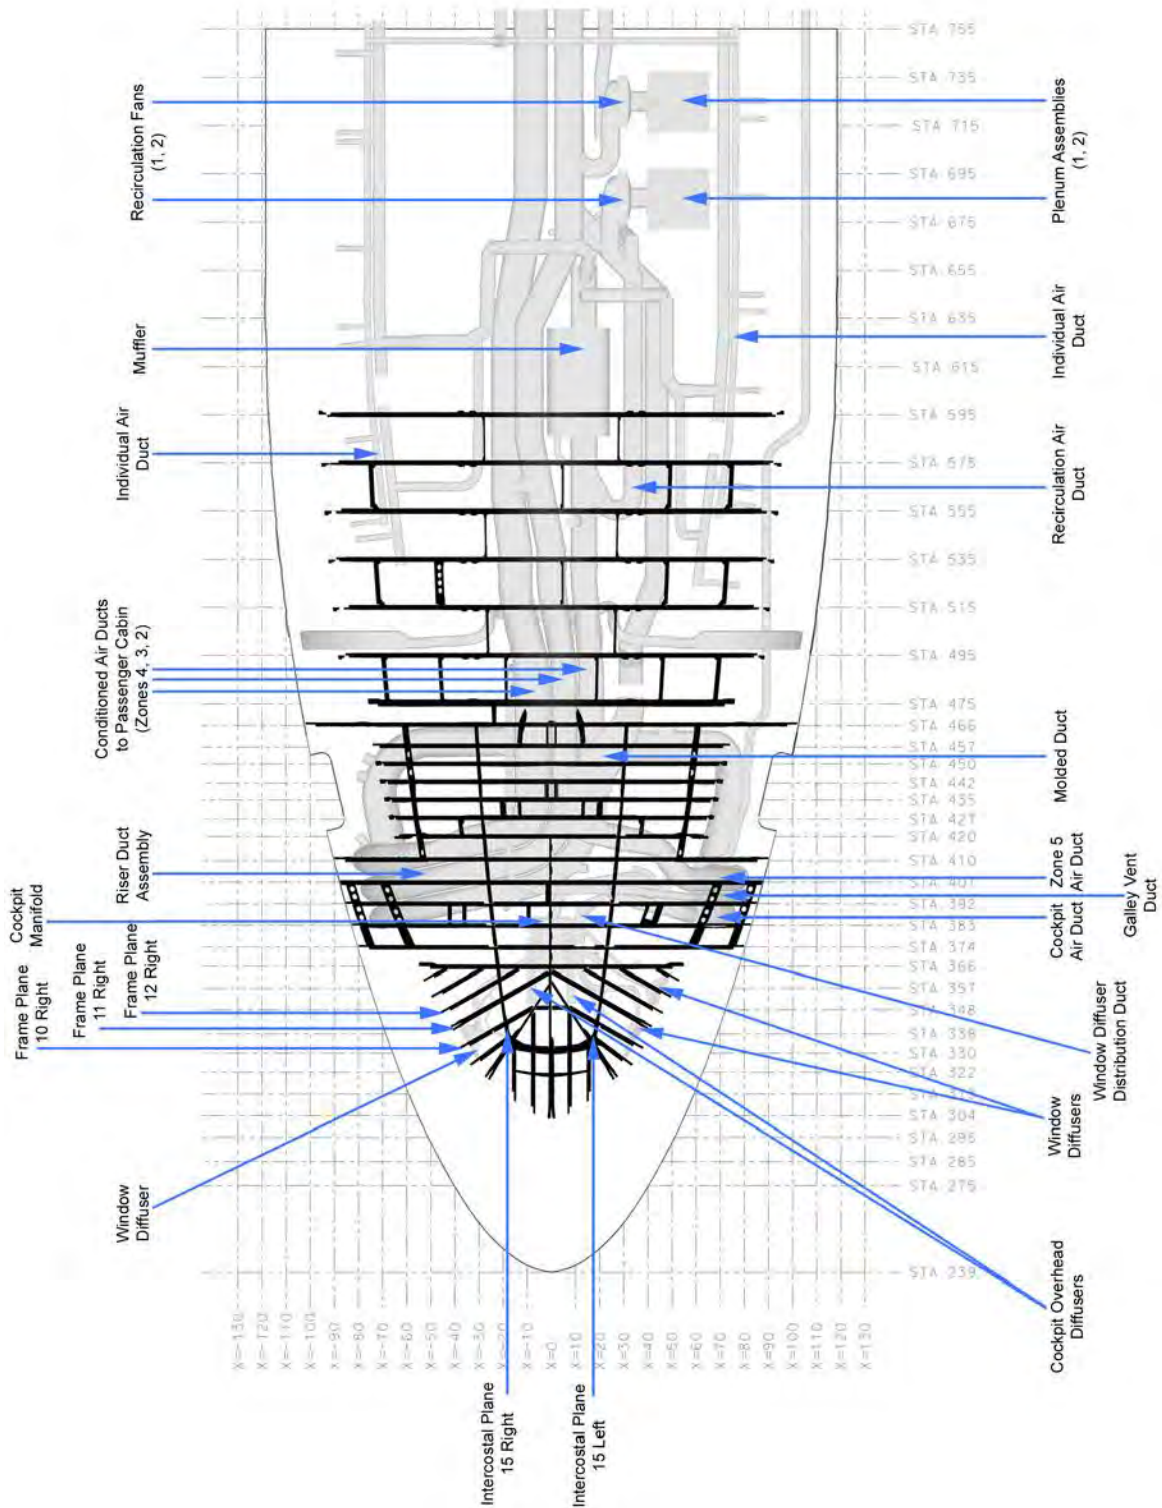
Figure 24: Airframe structure and air distribution system

There was bare-metal heat damage on the ducts behind the cockpit air diffusers from STA 350 aft to STA 402, primarily between the plane 15 left and right intercostals. The exception was the window diffuser distribution duct, which had bare-metal heat damage along STA 392 to  $X = 32$ . The heat damage to the recovered portions of the diffusers varied, with higher heat on the upper surfaces and lower heat on the lower surfaces adjacent to the cockpit ceiling liner.

Damage to the riser duct assembly ranged from no heat damage to bare-metal heat damage. The vertical portion of this assembly had no heat damage. The first area of bare-metal damage to the riser duct assembly started at intercostal plane 15 right, where the lower surface had a region of bare-metal heat damage from  $X = -30$  inboard to the joint at  $X = -20$ . This was in the vicinity of the Galley 2 vent end cap. There was bare-metal damage from approximately STA 395 to STA 442 between  $X = 25$  and  $X = -10$ . A section of molded duct was installed in that area from STA 420 to STA 442 between  $X = 5$  and  $X = 25$ . No portions of this molded duct were identified in the wreckage.

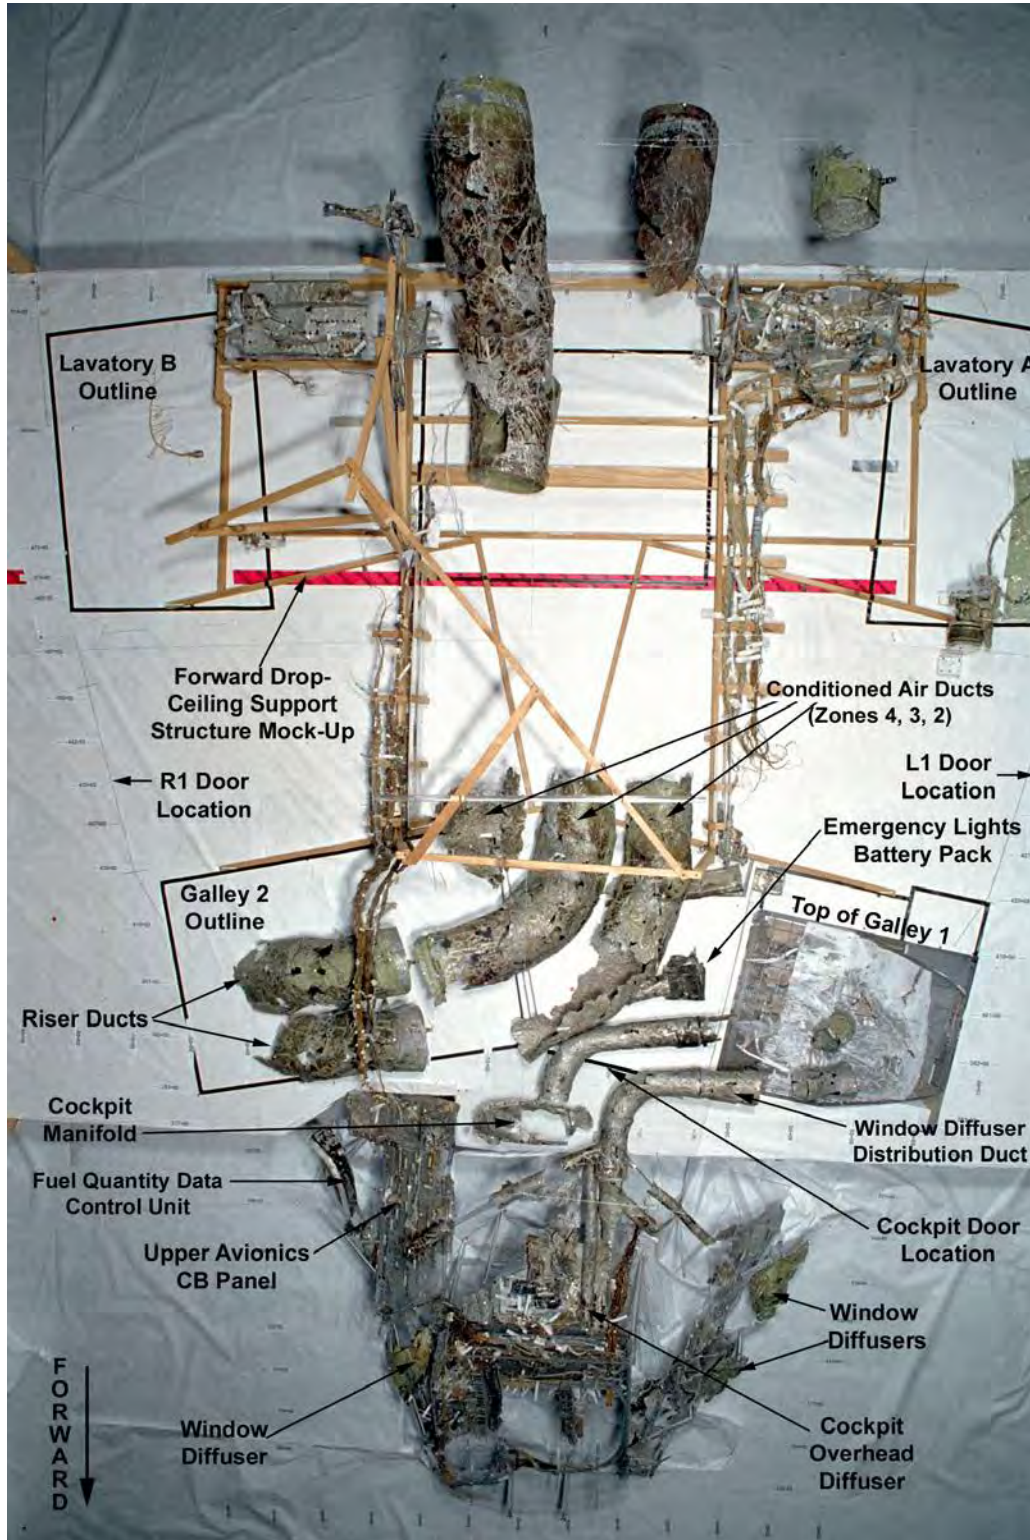
Figure 27: Cockpit attic and forward cabin drop-ceiling areas mock-up

About 75 per cent of the upper and lower CB panels were identified, reconstructed, and placed in the reconstruction mock-up (see Figures 27 and 28). The most forward sections of the upper and lower CB panels were not recovered. The upper avionics CB panel had been exposed to heat coming from both the front and back sides. The lower CB panel did not show any heat damage. The heat damage pattern on the front face of the upper CB panel was shown by the change in colour of the paint. Parts of the panel displayed damage consistent with temperature reference exemplar coupons exposed to temperatures from 430°C to 620°C (800°F to 1 150°F) for 10 minutes.<sup>67</sup> Discolouration and heat damage was present on the back side of this panel on some electrical components and on some bare-metal surfaces. Although there were similarities at some locations, the damage pattern on the back side was less than on the front

side, particularly on those pieces near the forward end of the panel where the front side of the panel showed considerably more heat damage than the back side. Individual CBs showed soot on the white indicator ring; soot could only have been deposited if the CB had tripped and subsequently been exposed to combustion by-products. Details concerning the CBs on the avionics CB panel and wiring in the vicinity are included in separate sections of this report.

Examination of the battery pack showed that, although it was extensively heat damaged, the heat occurred from the outside in (see Figure 27). This indicates that the fire did not start from a heat condition, such as thermal heating, within the battery pack.

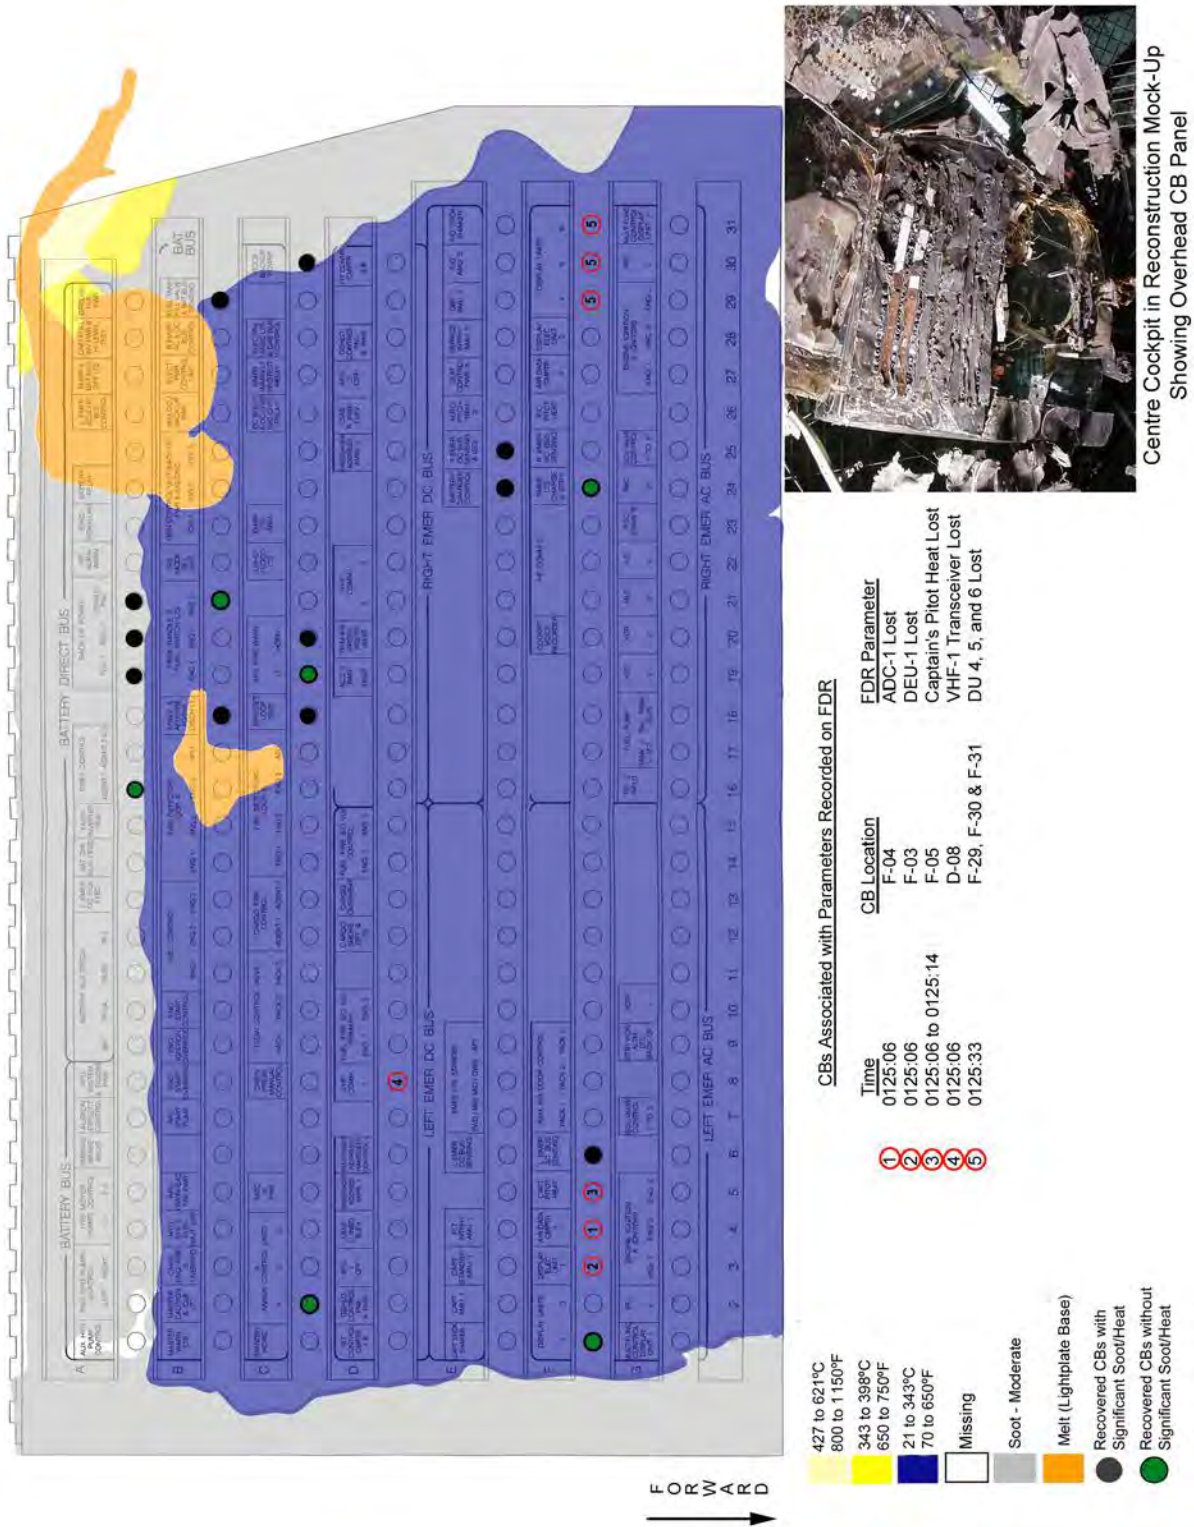
Figure 29: Heat damage – overhead CB panel

Most of the CB panel was identified, reconstructed, and placed in the reconstruction mock-up (see Figures 27 and 29). On the cockpit-facing surface, approximately two thirds of the polycarbonate lightplate base on Row A had been melted and folded back over onto itself, forming a fused mass of material near the top right corner of the panel. Part of the right end of the lightplate base on Row B was also melted and fused into this mass. The top right corner of the panel where the paint was missing had heat damage consistent with temperature reference coupons that were exposed to temperatures from 427°C to 621°C (800°F to 1 150°F) for 10 minutes, and the area where the paint was discoloured had heat damage consistent with temperature reference coupons that were exposed to temperatures from 343°C to 398°C (650°F to 750°F) for 10 minutes. The rear surface of the panel also showed signs of localized high-heat damage at the top right corner.
