MARINE INVESTIGATION REPORT

M00N0009

STRIKING OF ICE AND SUBSEQUENT SINKING

THE FISHING VESSEL "BCM ATLANTIC"

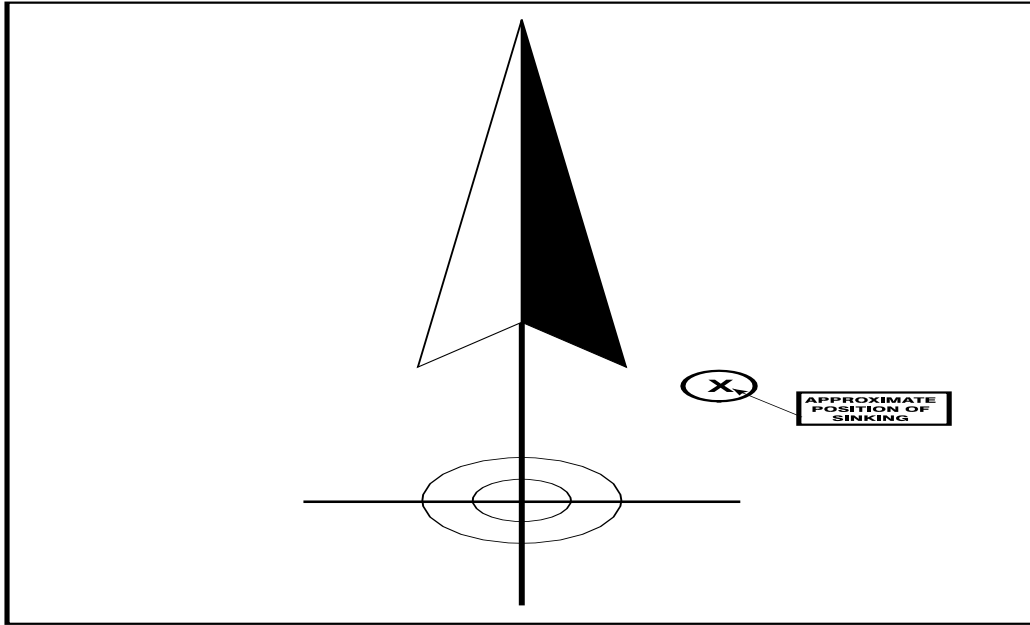
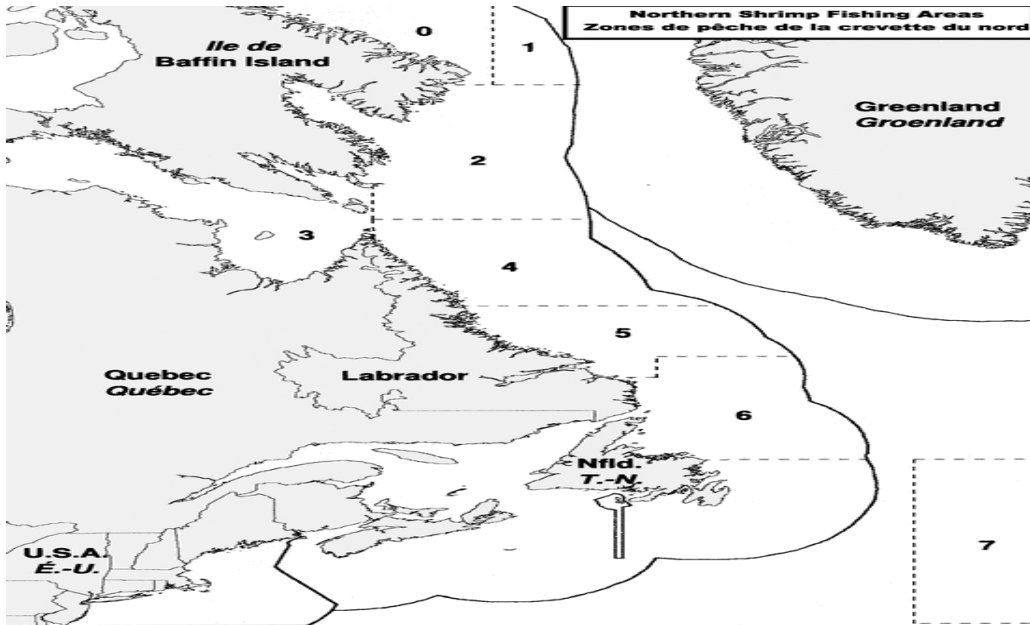
Appendix C - Location of Ice Damage

hull. In this occurrence, the vessel speed of six to seven knots—required to shoot the trawl off the deck—was sufficient to fracture the shell plating in the area of strengthening in the ice belt zone.

- I. While swinging to starboard at six to seven knots, exposing the port side to ice contact, the vessel struck ice and was holed on the port side shell plating near the common bulkhead between the engine-room and the cargo hold.
- II. The speed required to shoot the trawl off the deck was considered sufficient to fracture the shell plating at the point of contact with the type of ice encountered.
- III. The impact with ice was noticed immediately and, within a minute, a hole in the engine-room was discovered.
