**MARINE INVESTIGATION REPORT
M13L0123**

COLLISION

**BULK CARRIER *HELOISE* AND TUG *OCEAN GEORGIE BAIN*
PORT OF MONTRÉAL, QUEBEC
03 AUGUST 2013**

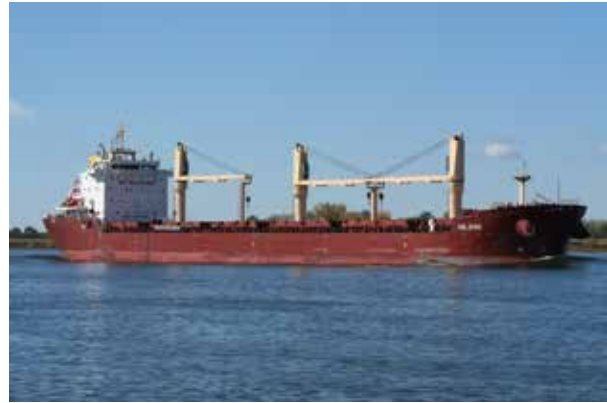
Photo 1. The *Heloise* (Photo: Marc Piché)

The *Heloise* is a dry bulk cargo vessel of steel construction, with machinery space and accommodation located aft (Photo 1). The vessel has 7 cargo holds and hatches that are serviced by three 36-tonne electric-hydraulic cranes mounted on the centreline of the vessel. The bridge is fitted with a navigation console that is offset from the vessel's centreline (Appendix A). Depending on the position of an observer on the bridge, the view out of the bridge windows can be obstructed by the cranes (Photos 2 and 3).

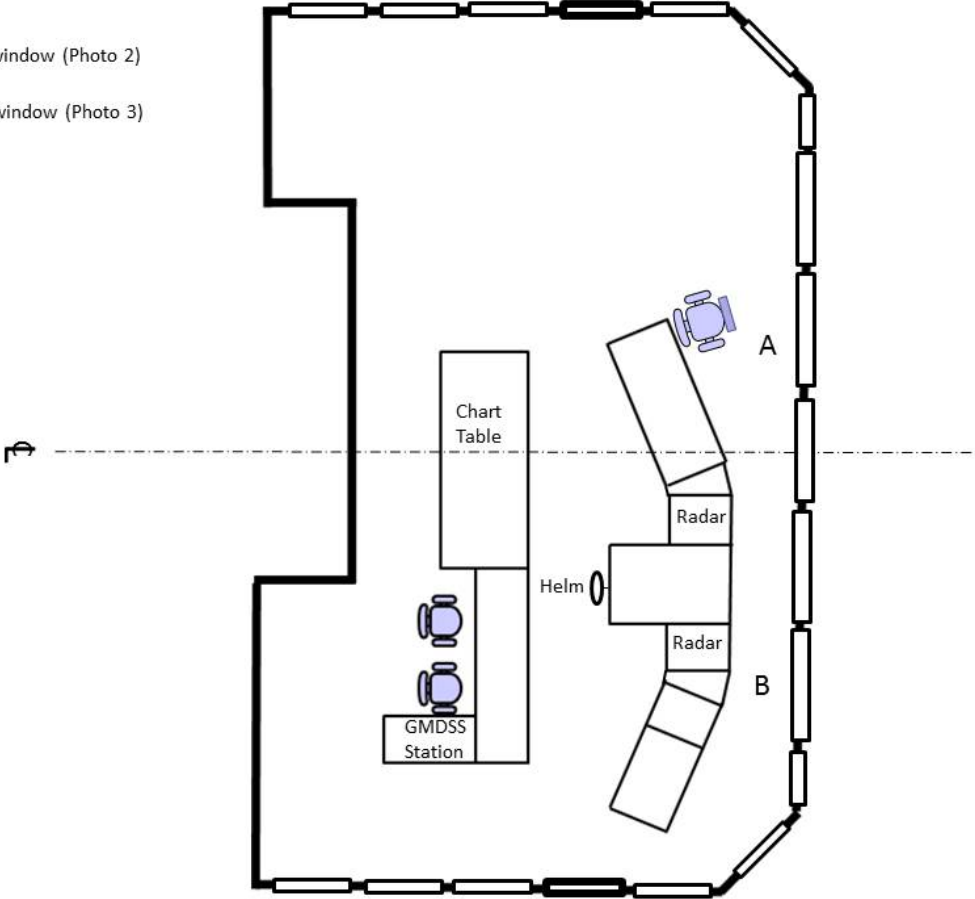
Appendix A – Arrangement of the MV Heloise bridge

- A : View from window (Photo 2)
- B : View from window (Photo 3)
