MARINE TRANSPORTATION SAFETY INVESTIGATION REPORT M17A0391

Lifeboat release hook failure

Passenger ferry *Northern Ranger*
Nain, Newfoundland and Labrador
11 October 2017

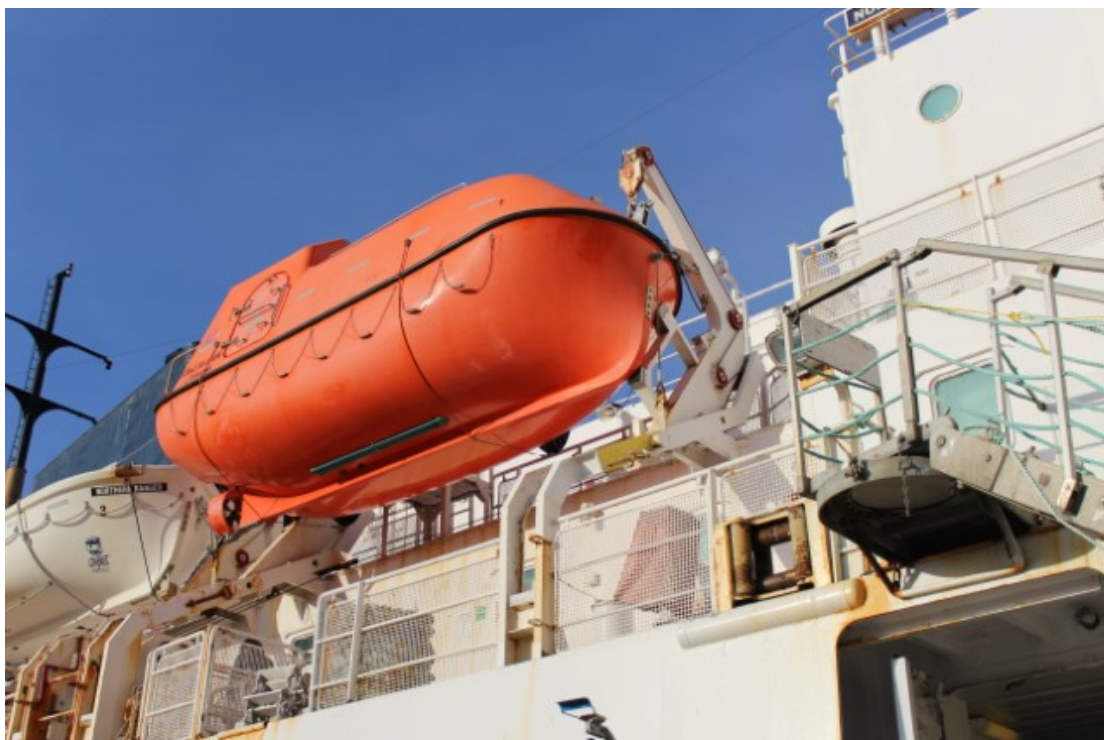
Figure 2. The Northern Ranger's starboard lifeboat, forward of the starboard rescue boat (Source: TSB)

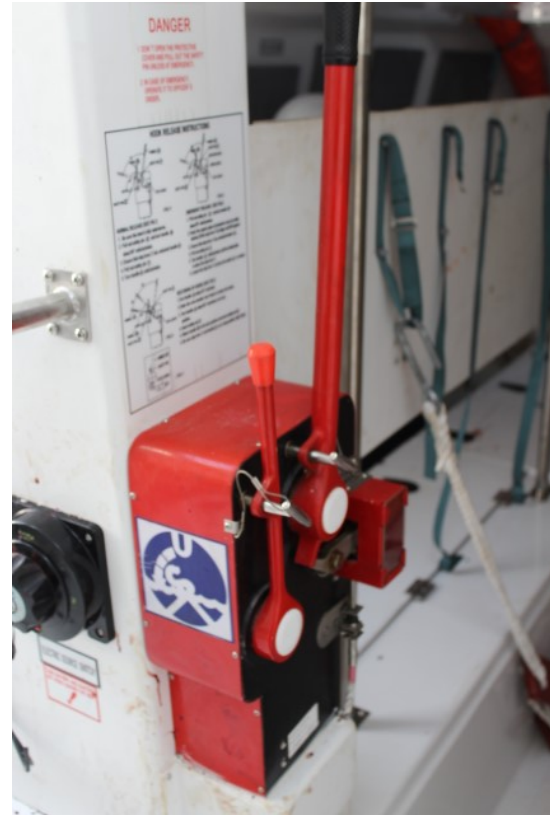
Figure 5. On- or off-load release mechanism and instructions in the Northern Ranger's starboard lifeboat (Source: TSB)

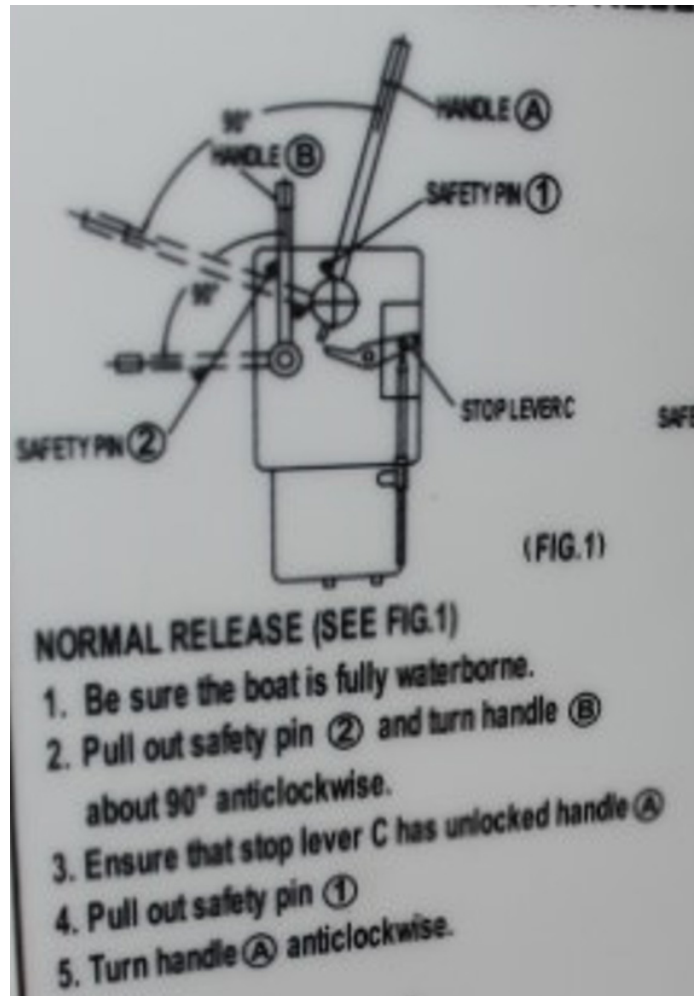
To open both release hooks, the on- or off-load release mechanism operator must first remove the safety pin (Figure 6, pin 2), holding the secondary release handle (Figure 6, handle B).

The operator then removes the primary safety pin (Figure 6, pin 1, handle A). Next, the on- or off-load release mechanism operator moves the primary release handle counter-clockwise, which lowers the raised locking plate (Figure 7 and Figure 8) within each release hook, releasing each hook's tail and allowing each release hook to open.

Figure 6. Posted instructions for on- or off-load release mechanism (Source: TSB)

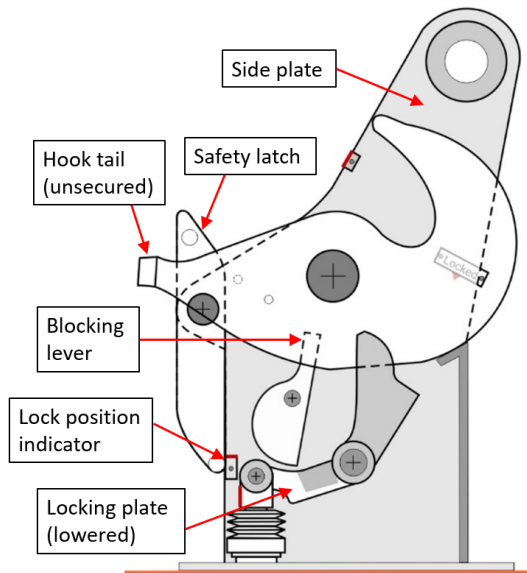
Figure 7. Diagram of lifeboat release hook assembly in the open position (Source: TSB)

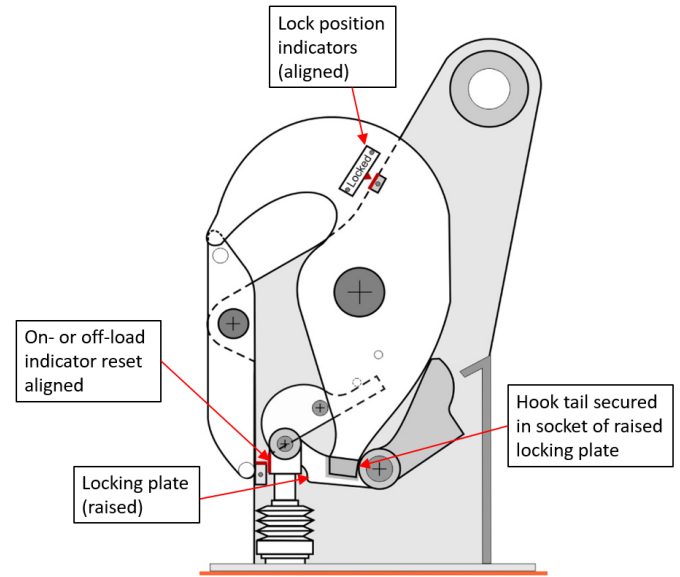
Figure 8. Diagram of lifeboat release hook assembly in the reset position (Source: TSB)

The on- or off-load release mechanism operator can now rotate the primary release handle clockwise to the reset position, which raises each hook's locking plate, securing each hook in the socket of its locking plate (Figure 8, Figure 10, and Figure 12). Safety pin 1 is then inserted.

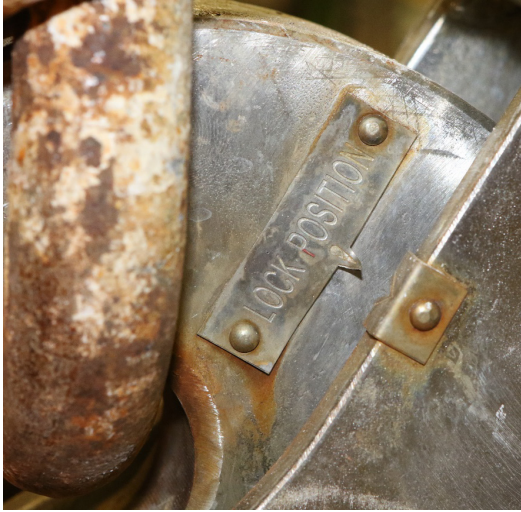
When both sets of indicators are aligned, each hook is in the reset and locked position (Figure 11 and Figure 12).

Figure 11. Close-up of forward release hook lock-position indicator (aligned in reset and locked position) (Source: TSB)

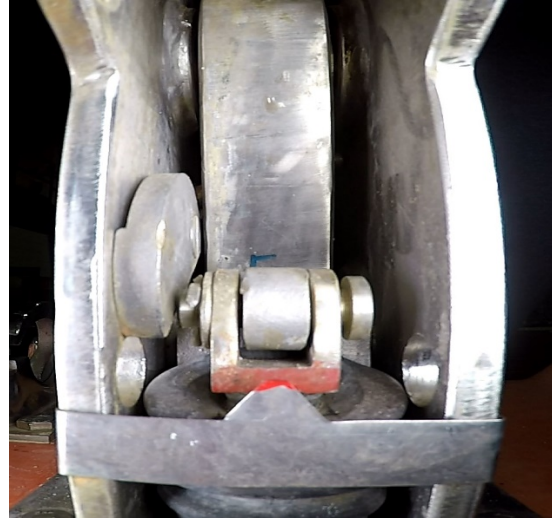
Once the on- or off-load release mechanism is reset, each release hook operator checks his or her respective release hook's lock-position indicator at the bottom of the hook assembly to verify alignment. A thin metal strip is attached between the side plates of each hook and is marked in its middle with a red indicator arrow. When the on- or off-load release mechanism is in the reset position, this arrow aligns with an indicator mark on the raised locking plate between the side plates (Figure 10 and Figure 12).

Figure 12. Close-up of on-or off-load release mechanism lock-position indicator (aligned in reset and locked position) (Source: TSB)

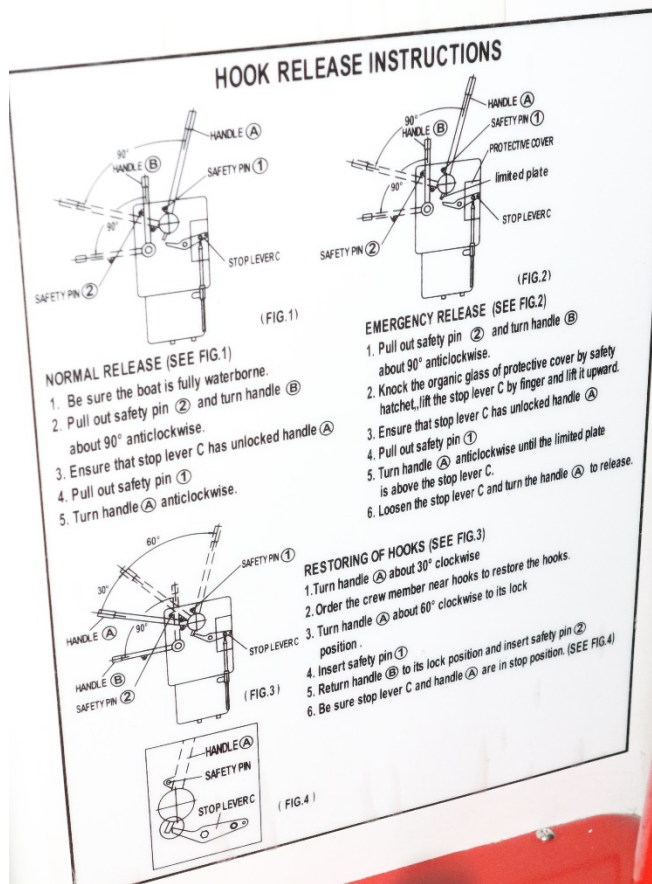
The procedure to release and reset the starboard lifeboat's hooks and on- or off-load release mechanism when launching and retrieving the lifeboat, and during emergency release, is displayed on a placard mounted by the manufacturer beside the on- or off-load release mechanism (Figure 14). The crew relied on these instructions to operate the on- or off-load release mechanism and release hooks. The chief officer was given an on-the-job training session by the company that installed the lifeboat on the *Northern Ranger*. This training session relied on instructions provided on the placard in the lifeboat.

Figure 14. Placard displaying on- or off-load release mechanism and hook operation instructions, posted in the lifeboat (Source: TSB)
