## **MARINE TRANSPORTATION SAFETY INVESTIGATION REPORT M18P0087**

### **UNCONTROLLED FALL OF RESCUE BOAT**

*Queen of Cumberland*  
Swartz Bay, British Columbia  
18 April 2018

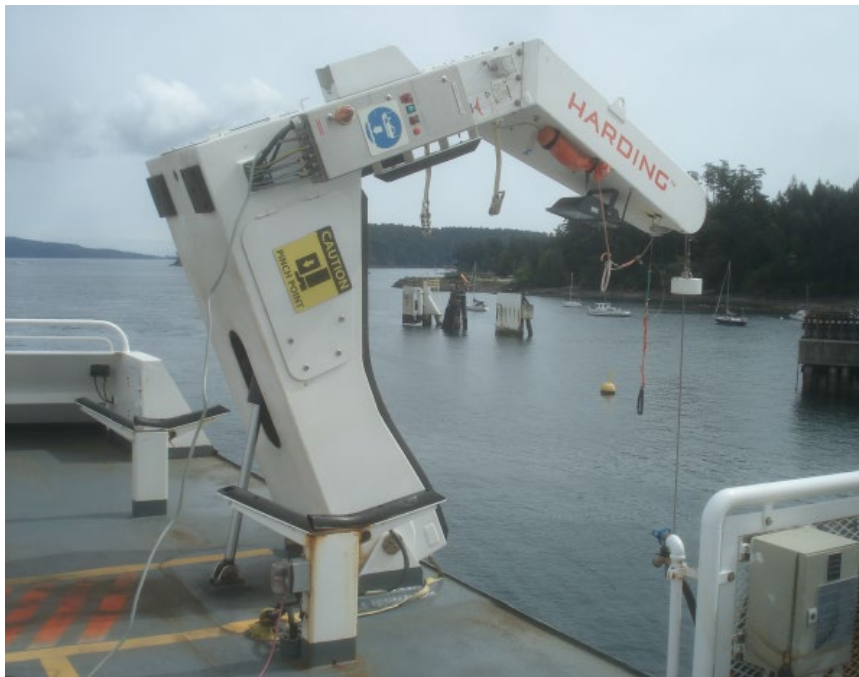
Figure 3. Pivoting davit (Source: TSB)

The rescue boat sustained damage from the impact of the fall, particularly to the acrylic wind screen forward of the console. In addition to the parted hoist cable, the davit sustained damage to the cable keeper and the sheave flange on one side.

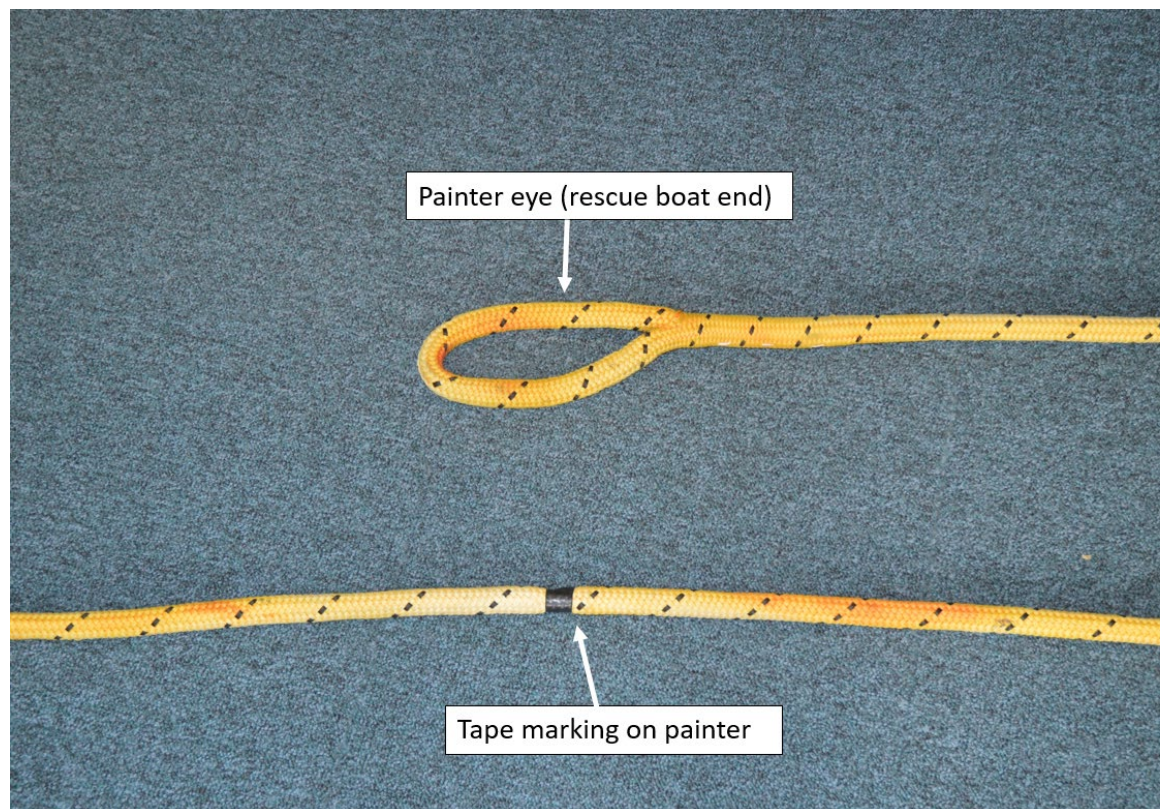
Figure 12. Painter in use on the *Queen of Cumberland* (Source: TSB)

The painter was marked in 2 spots with black tape. One mark was approximately 16 m from the eye, and the other was approximately 20.5 m from the eye. It could not be determined when the tape markers had been added or by whom. The markers coincided with the approximate working length of painter necessary when the rescue boat was at the waterline under the hoist cable (16 m) and when the rescue boat was being raised/lowered or was in the stowed position (20.5 m).

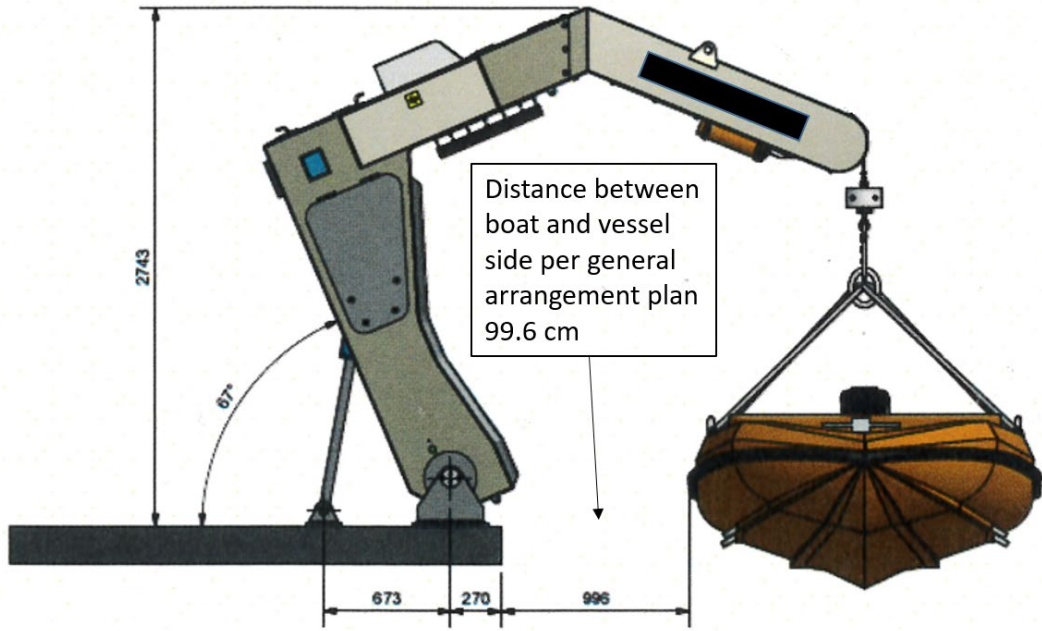
Figure 14. General arrangement plan for the davit (Source: third party, with permission, with TSB annotations)

The general assembly drawing for the smaller davit depicted a distance of 99.6 cm between the deck edge and the side of the rescue boat while launching (Figure 14), with the hinge pin installed 27 cm from the deck edge. On the *Queen of Cumberland*, the davit was installed further inboard, with the hinge pin welded approximately 43 cm from the deck edge. The clearing distance between the deck edge and the rescue boat was approximately 84 cm. The vessel's rubbing strake extended approximately 41 cm from the deck edge (Figure 15). This meant that the distance needed for the rescue boat to clear the rubbing strake when the vessel was in an upright condition was 43 cm.

The rescue boat crew needed to regularly use boat hooks to fend the rescue boat off the side of the vessel to ensure that the rescue boat cleared the rubbing strake during lowering and hoisting.

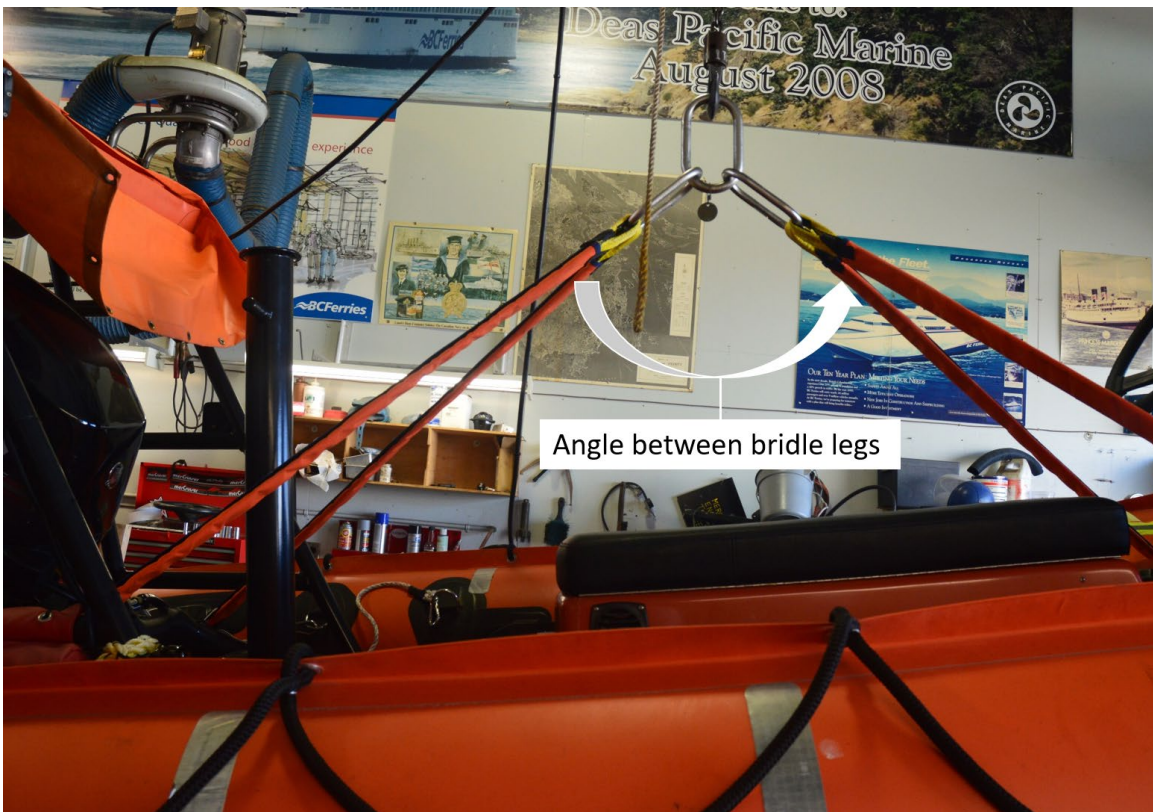
Figure 16. Optimized length of rescue boat bridle legs (Source: TSB)

When the new davit was installed, it was noted that the rescue boat was unsteady when suspended, as a result of the angle between the forward and aft legs of the bridle. The angle was larger than it had been with the previous davit because the clearance above the new, smaller davit limited the length of the legs when the rescue boat was in its stowed position (Figure 16). To try to make the rescue boat steadier when suspended, the technicians at the BC Ferries Fleet Maintenance Unit (FMU) adjusted the bridle to optimize the length of the forward and aft legs, given the available clearance. The forward legs were adjusted to approximately 1.55 m long and the aft legs to 1.42 m long.
