**PIPELINE INVESTIGATION REPORT
P09H0083**

NATURAL GAS PIPELINE RUPTURE

**TRANSCANADA PIPELINE LIMITED
762-MILLIMETRE-DIAMETER PIPELINE
LINE 100-1 – MAIN LINE VALVE 111A-1
FROM KILOMETRES 11.12 TO 11.16
NEAR MARTEN RIVER, ONTARIO
26 SEPTEMBER 2009**

Report Number P09H0083

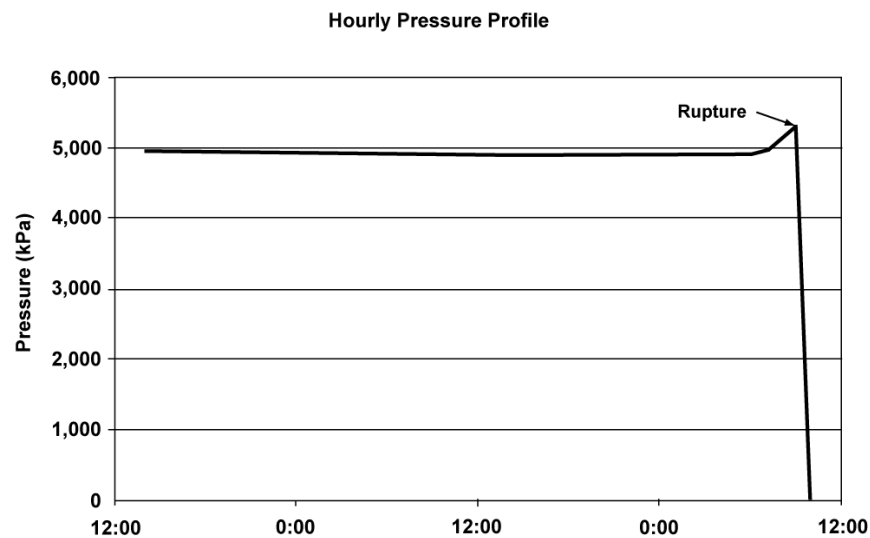
Figure 1. Line 100-1, hourly pipeline pressures before the occurrence.

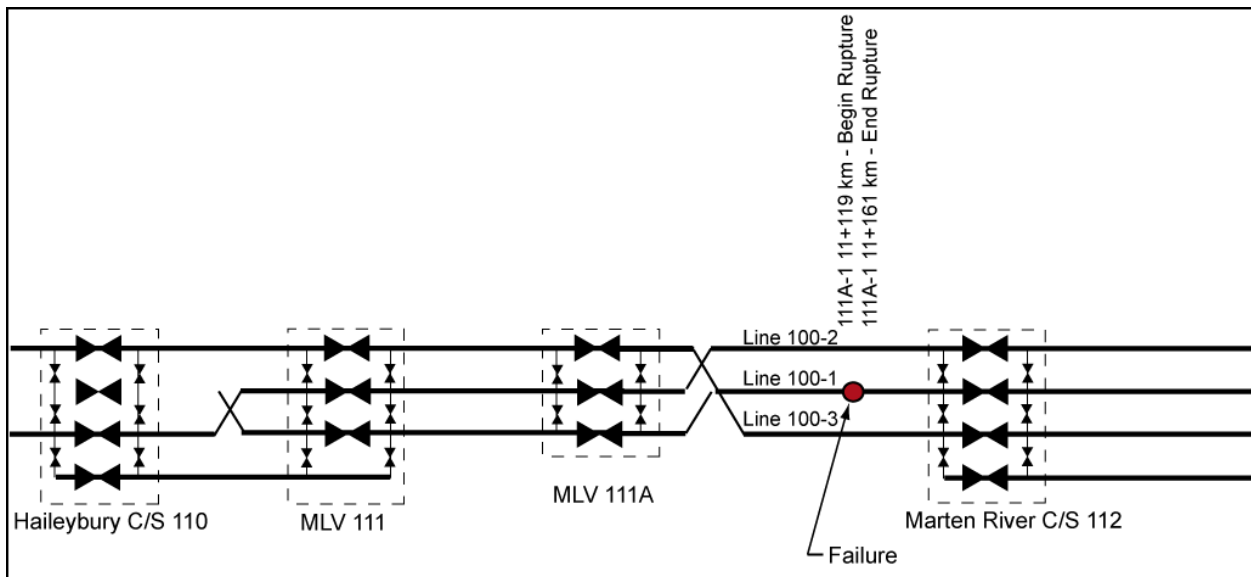
The operator then initiated the remote command feature “ISOLATE ALL” via the SCADA system to Station 112, and did the same for Station 110 a moment later. The SCADA telemetry confirmed the isolation of MLVs between compressor stations 110 and 112 for lines 100-1, 100-2, and 100-3 (see Figure 3). These pipelines were also isolated from each other as the tie-over valves between the pipelines closed (the tie-over valves allow for the movement of natural gas between the pipelines when required). Gas Control then dispatched regional personnel to isolate all the lines in the area of the occurrence.

Figure 3. Schematic of the pipeline failure relative to the compressor stations and valves.
