**PIPELINE INVESTIGATION REPORT
P11H0011**

**TRANSCANADA PIPELINES LIMITED
914.4 -MILLIMETRE-DIAMETER PIPELINE
LINE 100-2 - MLV 76-2 + 09.76 KM
NEAR BEARDMORE, ONTARIO
19 FEBRUARY 2011**

Natural Gas Pipeline Rupture

Report Number P11H0011

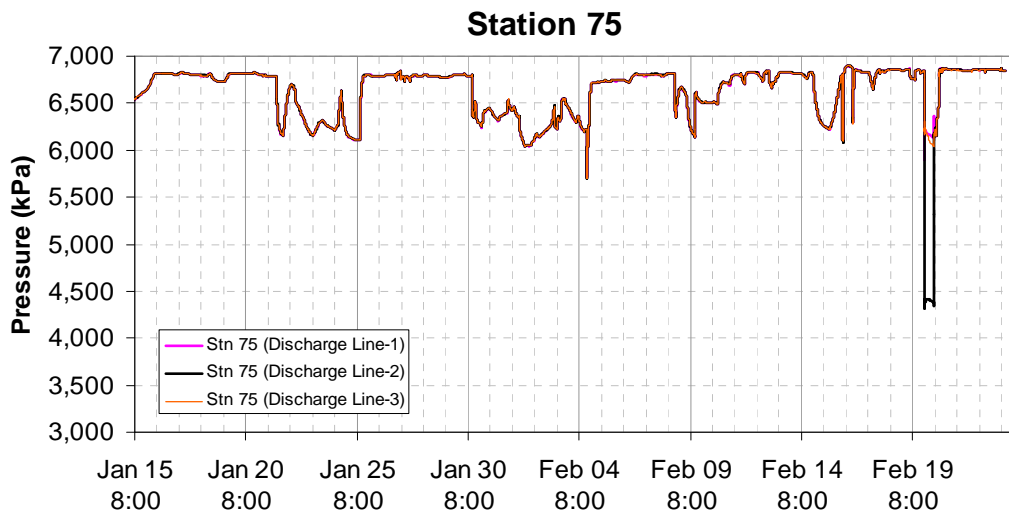
Figure 2. Discharge pressures at Compressor Station 75

The real-time discharge pressure at Compressor Station 75 for lines 100-1, 100-2 and 100-3 was reviewed for the period from 15 January 2011 to the date of the occurrence. Under normal operating conditions, Compressor Station 75 typically discharges into all three downstream lines, so similar operating pressures were expected. For the 2-week period before the occurrence, no unusual operating conditions were identified and discharge pressure was consistent for each line until 19 February when deviations occurred (Figure 2). Any pressure variances were part of normal day-to-day operations.

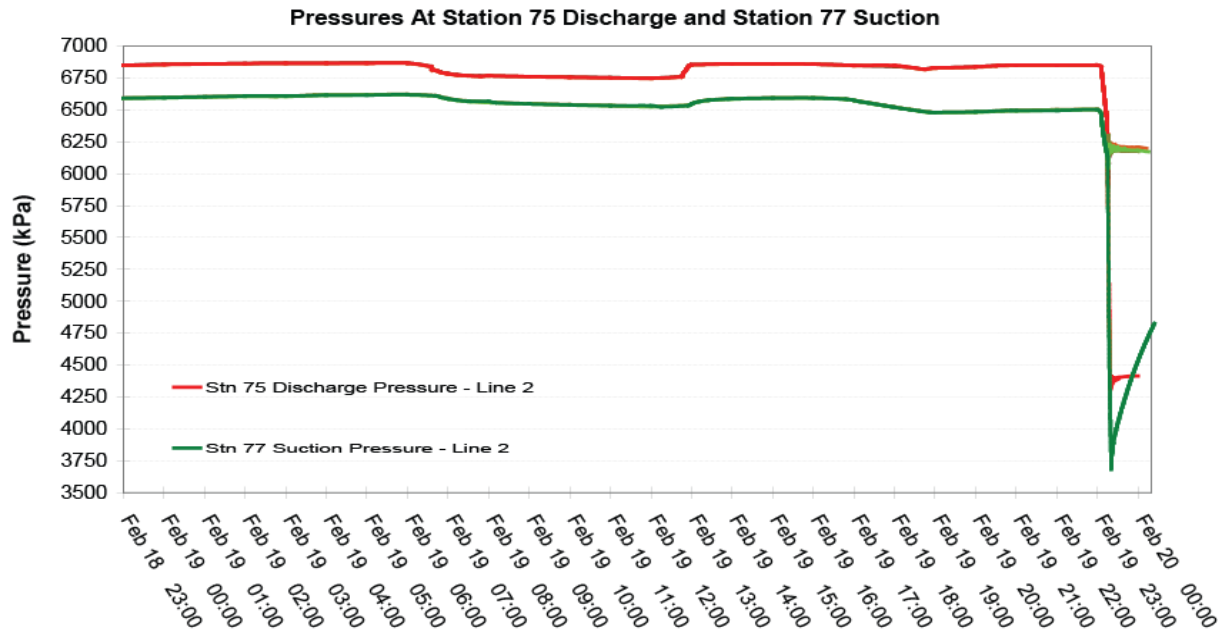
Figure 3. Discharge pressures 24 hours before the occurrence

For the 24-hour period before the occurrence, the SCADA trend logs for compressor stations 75 and 77 indicated that the pipeline was not experiencing any unusual events in the vicinity of the occurrence. A graphical representation of the SCADA record for the discharge and suction pressures at these two compressor stations is provided in Figure 3.
