**PIPELINE INVESTIGATION REPORT
P12H0103**

**WESTCOAST ENERGY INCORPORATED, CARRYING ON
BUSINESS AS SPECTRA ENERGY TRANSMISSION**

**IGNITION AND FIRE IN ISOLATION VALVE MOV-0409
ENCLOSURE**

**COMPRESSOR STATION N4
NEAR WONOWON, BRITISH COLUMBIA**

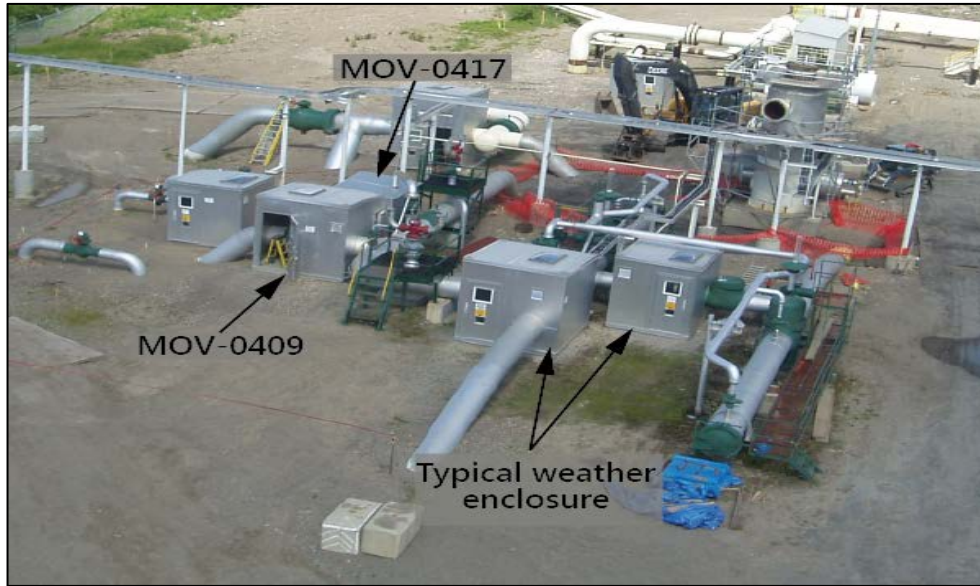
Figure 2. Aerial view of weather enclosure structures

The accident took place within the weather enclosure structure that was housing MOV-0409 (Figure 2). This motor-operated valve controls the 91.44-cm (36-inch) loop discharge pipeline for the compressor station.
