PIPELINE TRANSPORTATION SAFETY INVESTIGATION REPORT P18H0088

Pipeline rupture and fire

Westcoast Energy Inc.
36-inch transmission south mainline loop
Kilometre post 29.838
Prince George, British Columbia
09 October 2018

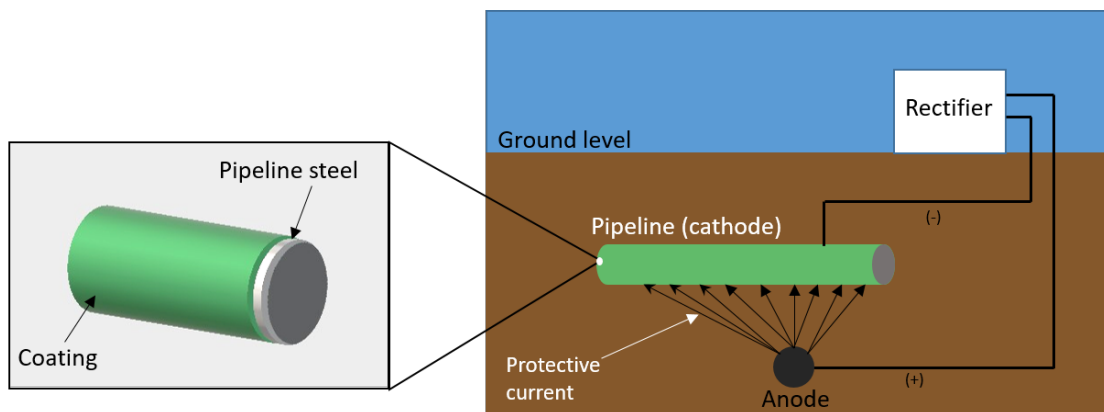
Figure 6. Image showing the configuration of a pipeline coating and cathodic protection (Source: TSB)

Controlling the external corrosion of a buried pipeline system is normally done using a dual system of external coating and cathodic protection (CP). The primary purpose of the external coating is to protect the pipe surface from its external environment. If the external coating degrades or otherwise fails, the CP system is designed to protect the pipe from corrosion (Figure 6).
