RAILWAY INVESTIGATION REPORT

R02D0113

MAIN-TRACK DERAILMENT

HIBBARD, QUEBEC

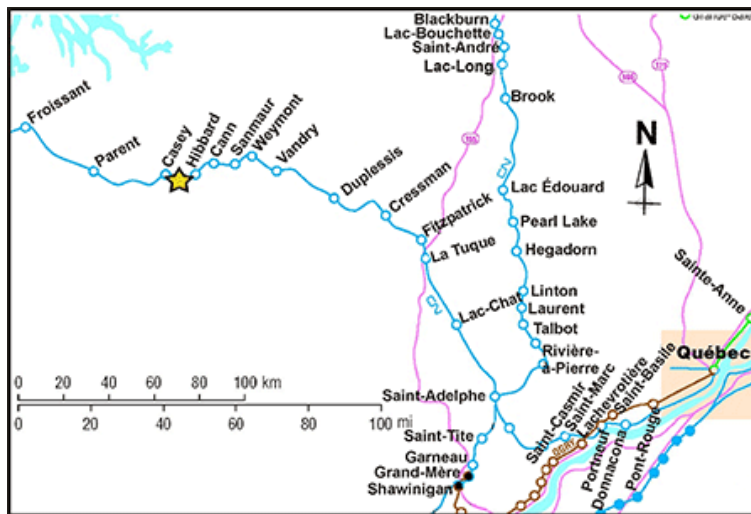
At Mile 86.43, near Hibbard, Quebec, (see Figure 1) the train experienced an undesired emergency brake application. The train crew followed the emergency procedures. The conductor inspected the tail end and found that 6 cars (102nd to 107th cars) loaded with copper ore had derailed when coming out of a left-hand curve in the direction of movement. The weather was cloudy, it was snowing lightly, and the temperature was -1 °C.
