**RAILWAY INVESTIGATION REPORT
R07T0270**

COLLISION AND TRAIN DERAILMENT

**CANADIAN NATIONAL YARD ASSIGNMENT YWCS60-17
AND
CANADIAN NATIONAL FREIGHT TRAIN M33931-17
MILE 0.00, HALTON SUBDIVISION
MACMILLAN YARD, TORONTO, ONTARIO
17 SEPTEMBER 2007**

Report Number R07T0270

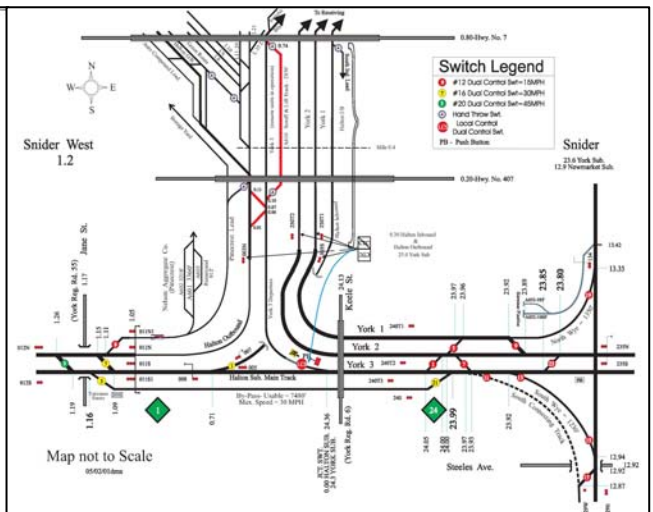
Figure 5b. CN diagram entrance to MacMillan Yard

MacMillan Yard knowledge was not tested during training and qualification. There were no maps included in the training material. There were no maps of the yard in the yard manual. Conductors were given little direction and were left to learn the layout of the yard as they worked on the job. Some conductors adapted by making their own hand-drawn sketches (see Figure 5a) or by making copies of other employees’ sketches. This is in contrast to mainline operations, where crews are provided with timetables, illustrated train-handling guides and track diagrams (see Figure 5b).
