**RAILWAY INVESTIGATION REPORT**  
**R09T0151**

**MAIN-TRACK DERAILMENT**

**CANADIAN PACIFIC RAILWAY**  
**FREIGHT TRAIN NUMBER 235-04**  
**MILE 174.41, BELLEVILLE SUBDIVISION**  
**OSHAWA, ONTARIO**  
**05 JUNE 2009**

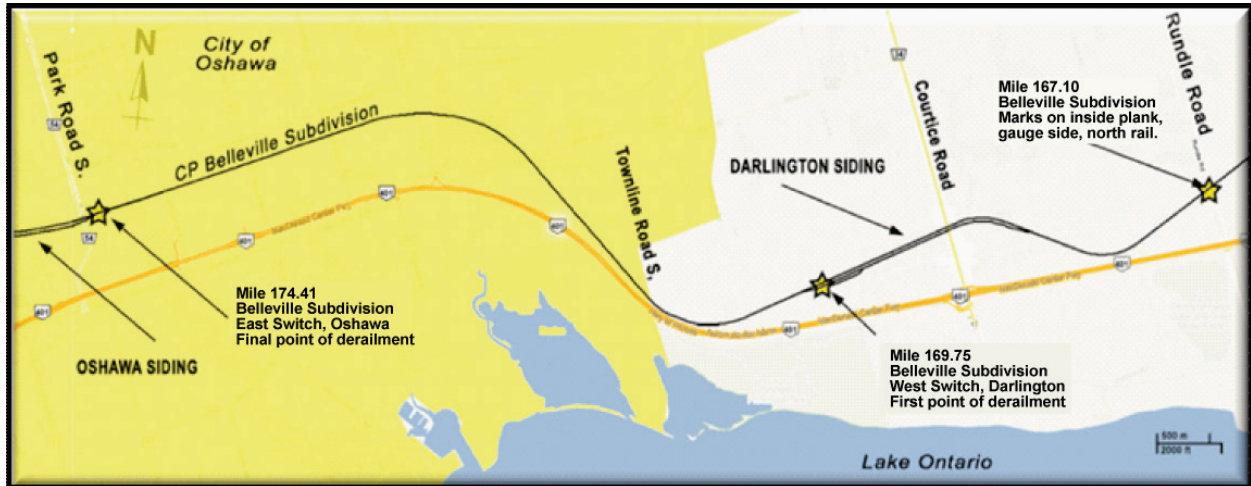
Figure 2. Derailment area

The trip was uneventful until the approach to Oshawa, Ontario. According to the locomotive event recorder (LER), between 1358:00 and 1402:00, with the train operating in throttle positions 5 to 8, the third locomotive, CP 4652 experienced continuous wheel slip (Mile 163.50 to 165.70). However, the wheel slip was not sufficient to trigger a warning alarm in the lead locomotive. At 1408:26, the train was travelling at 47 mph with the throttle in position 2 near Mile 169.76, in the vicinity of Courtice Road, approaching the west Darlington Siding switch (see Figure 2). The throttle was gradually advanced from position 2 to 8 as the train entered an ascending grade.

Meanwhile, a motorist driving on the road alongside the main track observed a large column of smoke originating from one of the locomotives. The motorist made a 911 call, stating that the leading wheels on the fourth locomotive were on fire, with flames reaching the height of the locomotive. The call was routed to the local fire department, which contacted CP Police. CP locomotive 4652 was fourth in the consist with its leading end approximately 200 feet from the cab of the leading unit.

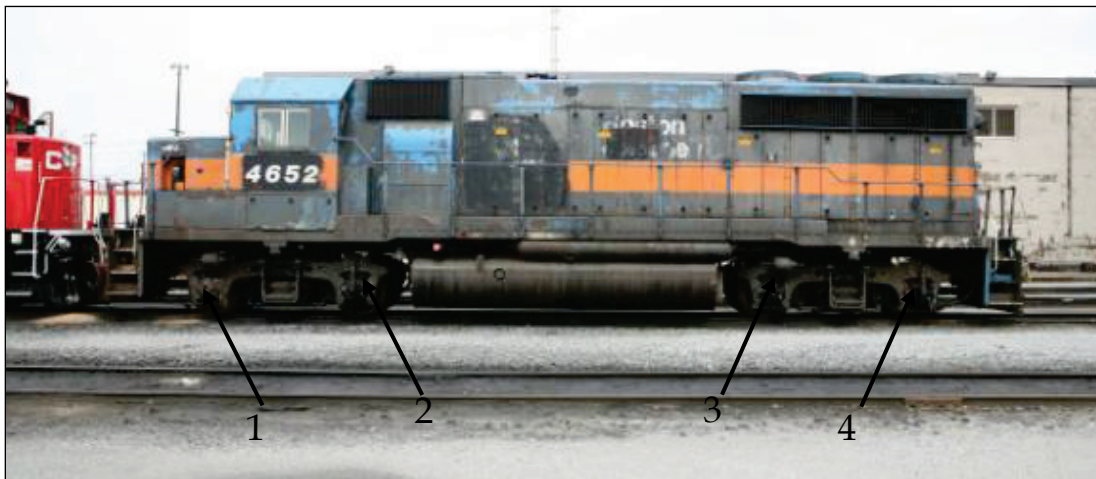
**Photo 3.** Left side view of CP 4652 showing traction motor assembly position numbering

CP 4652 (see Photo 3) is a 3000 horsepower, 4-axle GP40-2 locomotive built in 1977 by General Motors (GM) Electro-Motive Division. It is 1 of 665 locomotives in CP’s fleet that operate with TMs equipped with plain friction-type brass and babbitt suspension bearings (suspension bearings). The 665 locomotives represent approximately 53% of CP’s total locomotive fleet of 1250 units. On-board suspension bearing temperature monitoring systems are available for these locomotives; however, none of these CP locomotives are so equipped.

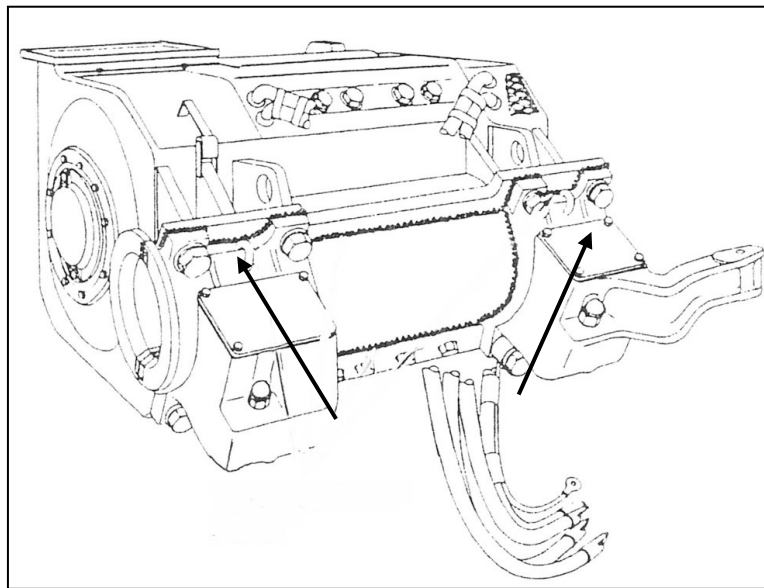
TMs are suspended from locomotive axles on bearings located on each side of a TM (see Figure 3). The suspension bearings allow the free rotation of the axle while TM torque is applied to the locomotive wheel set through a pinion gear to a bull gear which is press mounted on the axle, inboard of a wheel. The gear side of the axle has historically proven to be more susceptible to failure primarily due to the torque focussed at that location.

**Figure 3.** Traction motor (the arrows point to the location of the suspension bearings)
