**RAILWAY INVESTIGATION REPORT
R12T0038**

**MAIN-TRACK DERAILMENT
VIA RAIL CANADA INC.
PASSENGER TRAIN NO. 92
MILE 33.23, CANADIAN NATIONAL OAKVILLE SUBDIVISION
ALDRSHOT, ONTARIO
26 FEBRUARY 2012**

Report Number R12T0038

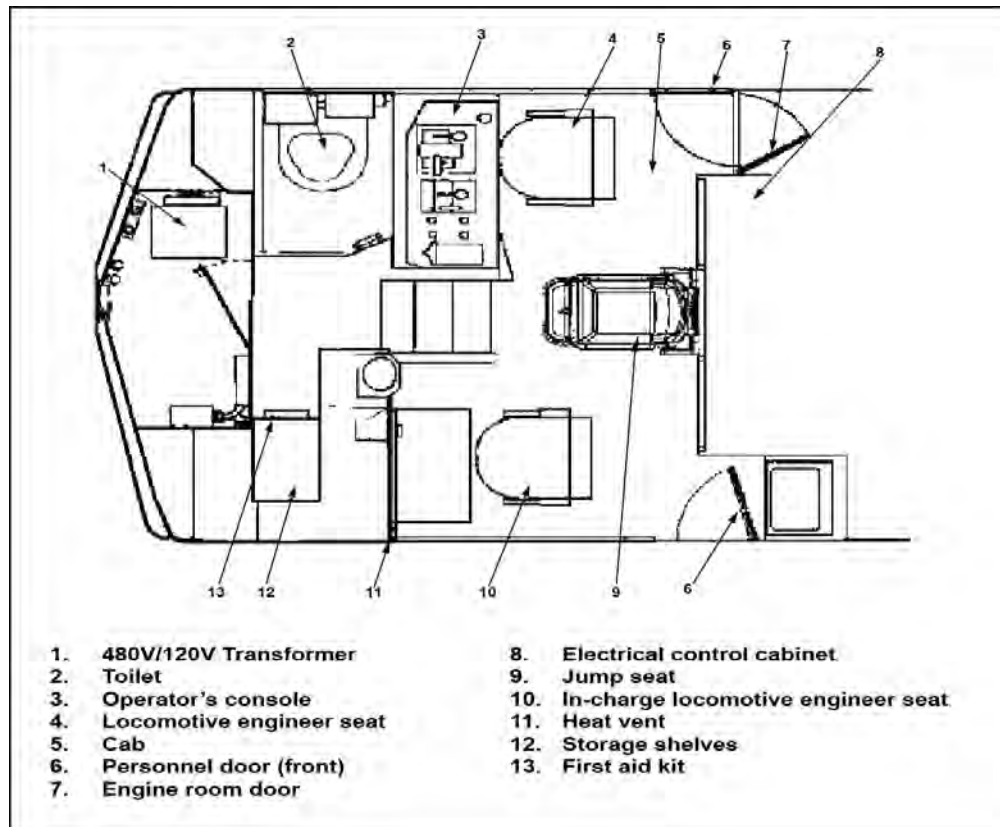
Figure 1. Schematic of locomotive VIA 6444 cab layout

VIA trains are normally operated by 2 qualified locomotive engineers located in the lead locomotive. The operating locomotive engineer (LE) sits at the controls on the right side of the locomotive cab while the in-charge locomotive engineer (ICLE) sits on the left side of the cab and performs the duties of the conductor (see Figure 1).

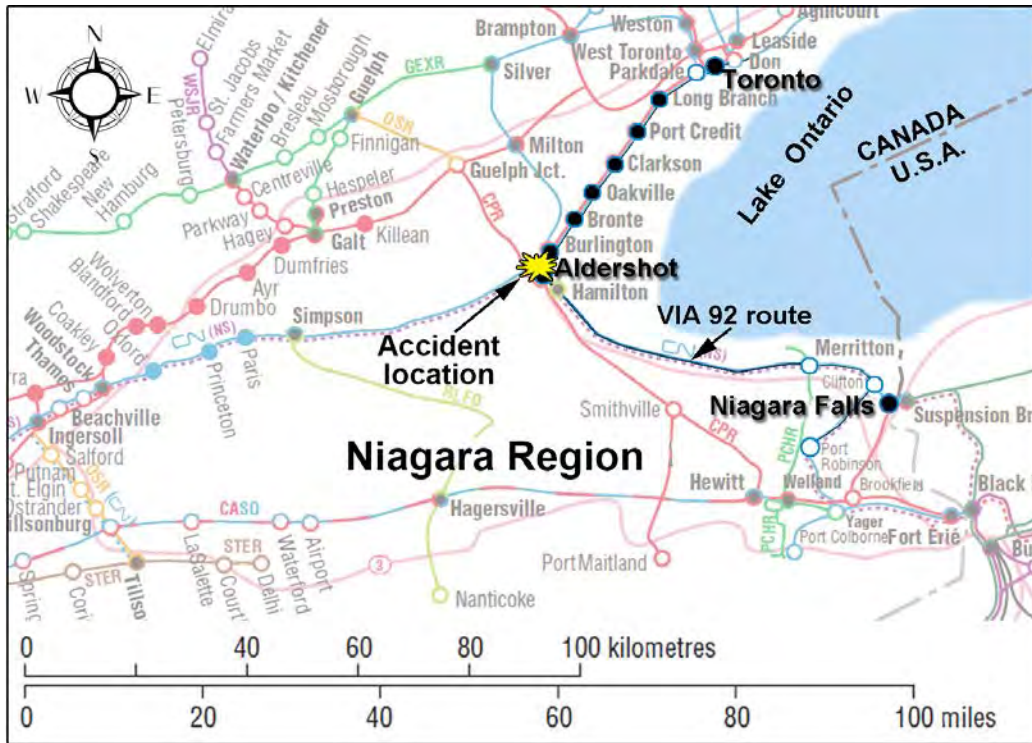
Figure 2. Train route and accident location (source: Railway Association of Canada, *Canadian Railway Atlas*)

At 1404:40, VIA 92 left Niagara Falls on time destined for Toronto (see Figure 2). VIA 92 was routed on the Grimsby Subdivision from Clifton, Ontario (Mile 2.60), to Hamilton, Ontario (Mile 43.70), where it entered the Oakville Subdivision.² On the Oakville Subdivision, VIA 92

travelled on the north track from Hamilton (Mile 39.30) to Bayview, Ontario (Mile 36.90), where the train was routed eastward on track 2 past Aldershot Station (Mile 34.60) all the way to signal 333T2. This route required VIA 92 to pass controlled signal 364T2 (Mile 36.40) at Snake and advance signal 348T2 (Mile 34.80) at Waterdown on its approach to the Aldershot Station.

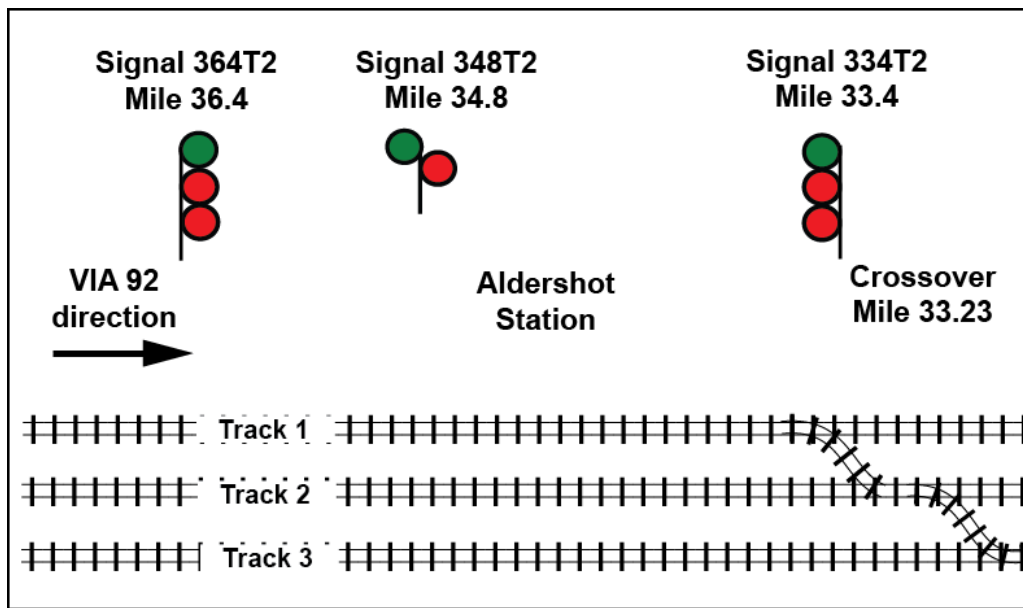
Figure 4. Aspects displayed when train is lined straight through on track 2

When the crossover at Mile 33.23 is lined straight through on track 2, with no speed restrictions in place and permissive signals displayed at Aldershot East (Mile 33.40) and Burlington West (Mile 32.40), the signal progression is as follows (see Figure 4):

- Signal 364T2 displays a Clear signal (Rule 405) indication with aspects Green over Red over Red (G/R/R) – proceed at track speed;
- Signal 348T2 displays a Clear signal (Rule 405) indication with aspects G/R – proceed at track speed; and
- Signal 334T2 displays a Clear signal (Rule 405) indication with aspects G/R/R – proceed at track speed.

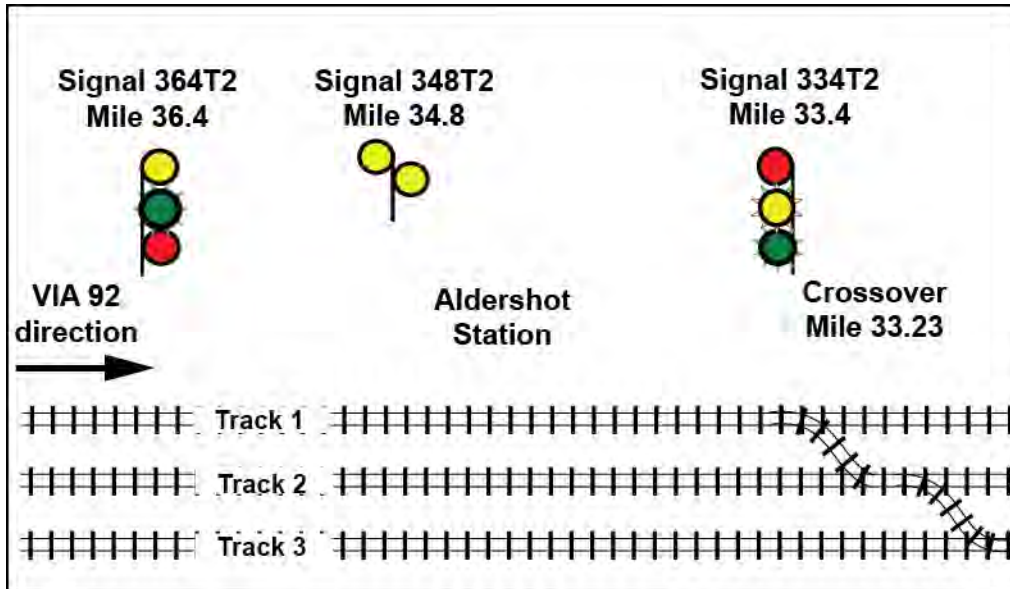
Figure 5. Aspects displayed when the crossover at Mile 33.23 is lined to bring a train from track 2 to track 3

When the crossover at Mile 33.23 is lined to bring a train from track 2 to track 3, the signal progression (see Figure 5) is as follows:

- Signal 364T2 displays a Clear to Limited signal (Rule 406) with aspects Yellow over Flashing Green over Red (Y/FG/R) – proceed, approaching next signal at limited speed (not exceeding 45 mph);
- Signal 348T2 displays a Clear to Slow signal (Rule 409) with aspects Yellow over Yellow (Y/Y) – proceed, approaching next signal at slow speed (not exceeding 15 mph); and
- Signal 334T2 displays a Slow to Limited signal (Rule 432) with aspects Red over Flashing Yellow over Flashing Green (R/FY/FG) – proceed, slow speed (not exceeding 15 mph) passing the signal and through turnouts, approaching next signal at limited speed (not exceeding 45 mph). For eastbound VIA trains between Niagara Falls and Burlington West, this signal combination can only be displayed at Signal 334.

The electronic circuits for Signal 334T2 are such that the signal cannot display an Advance Clear to Limited (Rule 412) aspect (FY/FG/R). However, train crews would only be concerned with and focussed on aspect display and would not know specific details of circuitry.

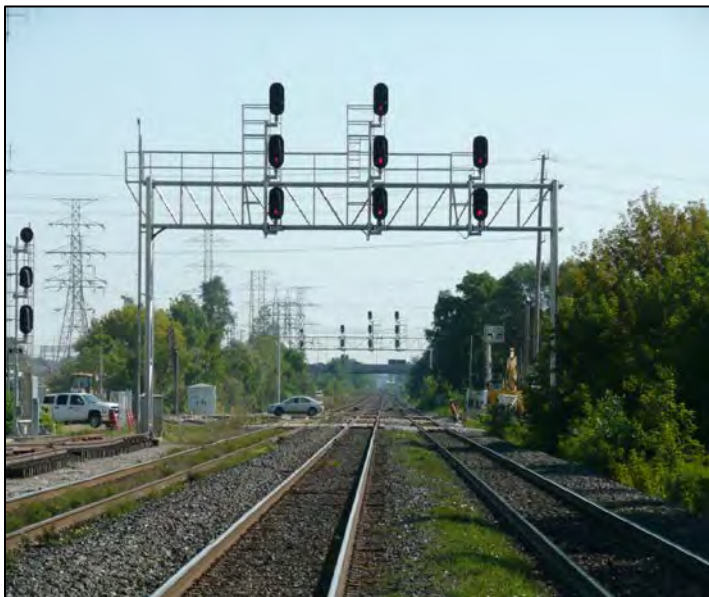
Photo 6. Looking eastward at signals located at Mile 33.40 of CN's Oakville Subdivision (source: TSB)

Inside each aspect assembly, there are 3 lights positioned one over the other with a total of 9 lights for signals 334T1 and 334T2, and 6 lights for signal 334T3. Incandescent bulbs behind each coloured lens display the proper combination of red, yellow and/or green lights. Only one light in each assembly can be lit at one time. Attempts to activate 2 lights in one assembly would force the signal to its most restrictive state (red). The individual signals face oncoming traffic and are mounted on an aluminium gantry located above the right-of-way, positioned directly over the track that they govern (see Photo 6).

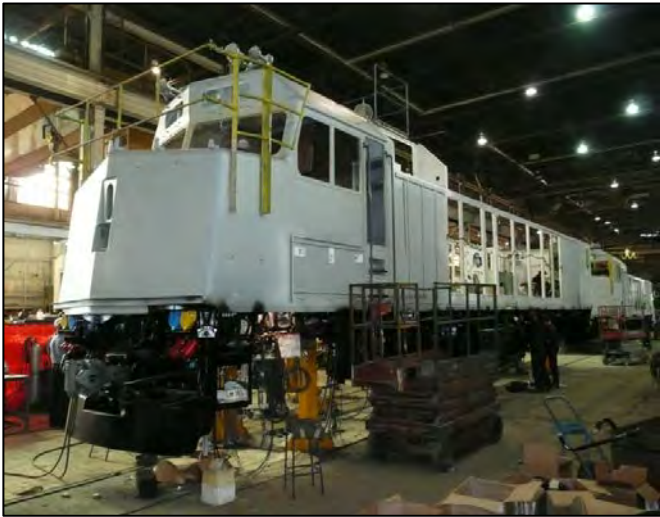
Photo 7. Stripped down VIA GM F40PH-2D locomotive
(source: TSB)

In 2007, VIA contracted CAD Industries in Montréal, Quebec, and commenced a rebuild program for the GM F40PH-2D fleet during which each locomotive was stripped down to its frame (see Photo 7) and rebuilt from top to bottom (see Photo 8). The rebuild work for VIA 6444 was completed in December 2009 and it was returned to service.

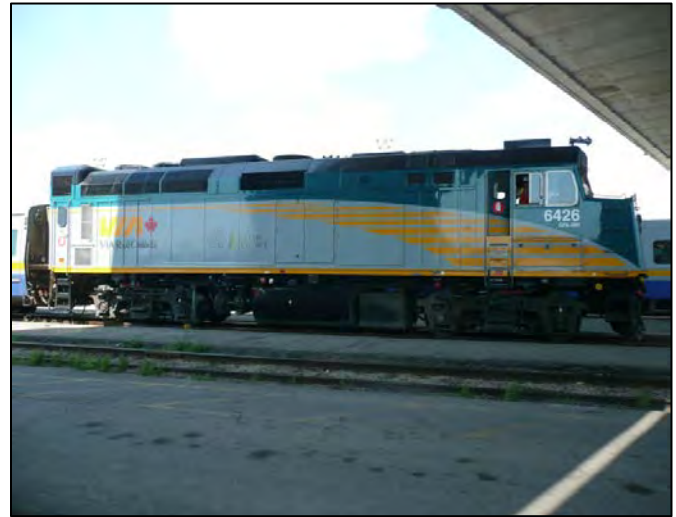
Photo 8. Rebuilt VIA GM F40PH-2D locomotive
(source: TSB)

The GM F40PH-2D locomotives were rebuilt with technical upgrades for improved operating efficiencies and reliability. These upgrades included improvements to the trucks, to the locomotive motor and to the generator that powers the passenger cars. In addition, a new crashworthy LER was installed in accordance with TC-approved *Railway Locomotive Inspection and Safety Rules (Locomotive Safety Rules)* and the cab roof structure was modified to accommodate an air conditioner. The original fuel tanks were repaired if necessary, painted and re-installed.

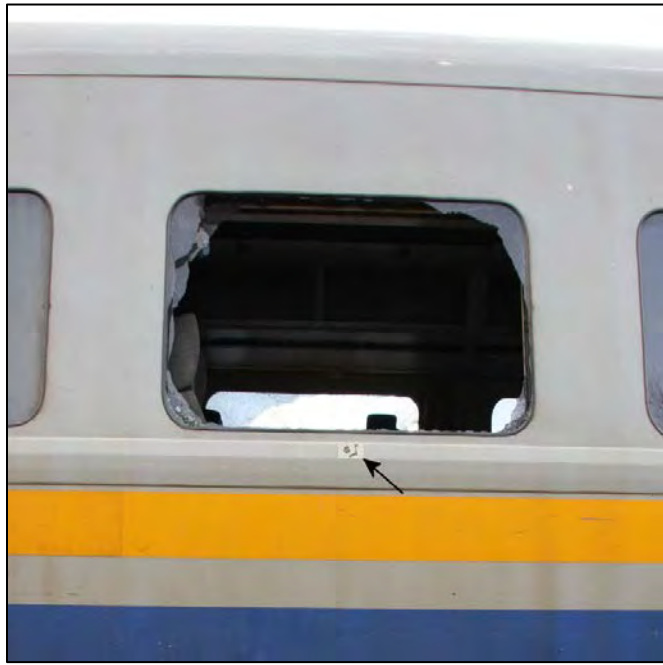
With the first coach lying on its side, the single emergency window exit used for evacuation was located at the top, about 10 feet up, making it difficult to access from the interior cabin. The signs identifying the emergency window exits were comparatively small, inconspicuous and not visible from the ground with the coach on its side (see Photo 11).

Photo 11. Exterior marking on an emergency window exit (source: TSB)
