RAILWAY INVESTIGATION REPORT R15H0021

Main-track train derailment

Canadian National Railway Company

Gogama, Ontario

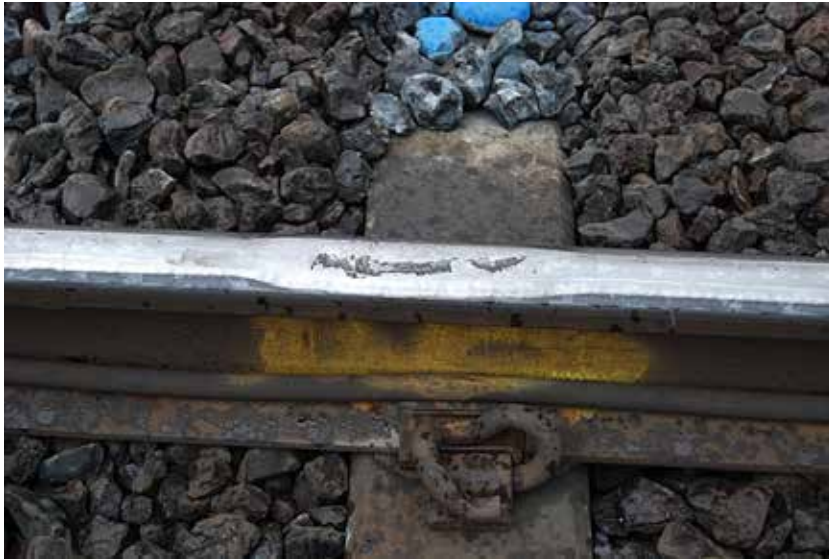
A localized surface collapse is characterized by plastic metal flow, leading to the flattening out and deformation of the rail head above the plane of the rail head / web fillet (Figure 12). A crushed head (CH) is similar to a localized surface collapse (LSC) with the exception that CH deformation of the rail head extends to below the plane of the rail head /web fillet. LSCs and CHs are normally caused by mechanical interaction from repetitive wheel loadings. They can result in high contact stresses and can lead to or accelerate the development of other rail defects such as a transverse detail defect (TDD) or a vertical split head (VSH) which can fail rapidly and result in a derailment.

Figure 12. Photograph of a typical localized surface collapse
