RAILWAY INVESTIGATION REPORT

R16M0026

Crossing accident

Canadian National Railway Company

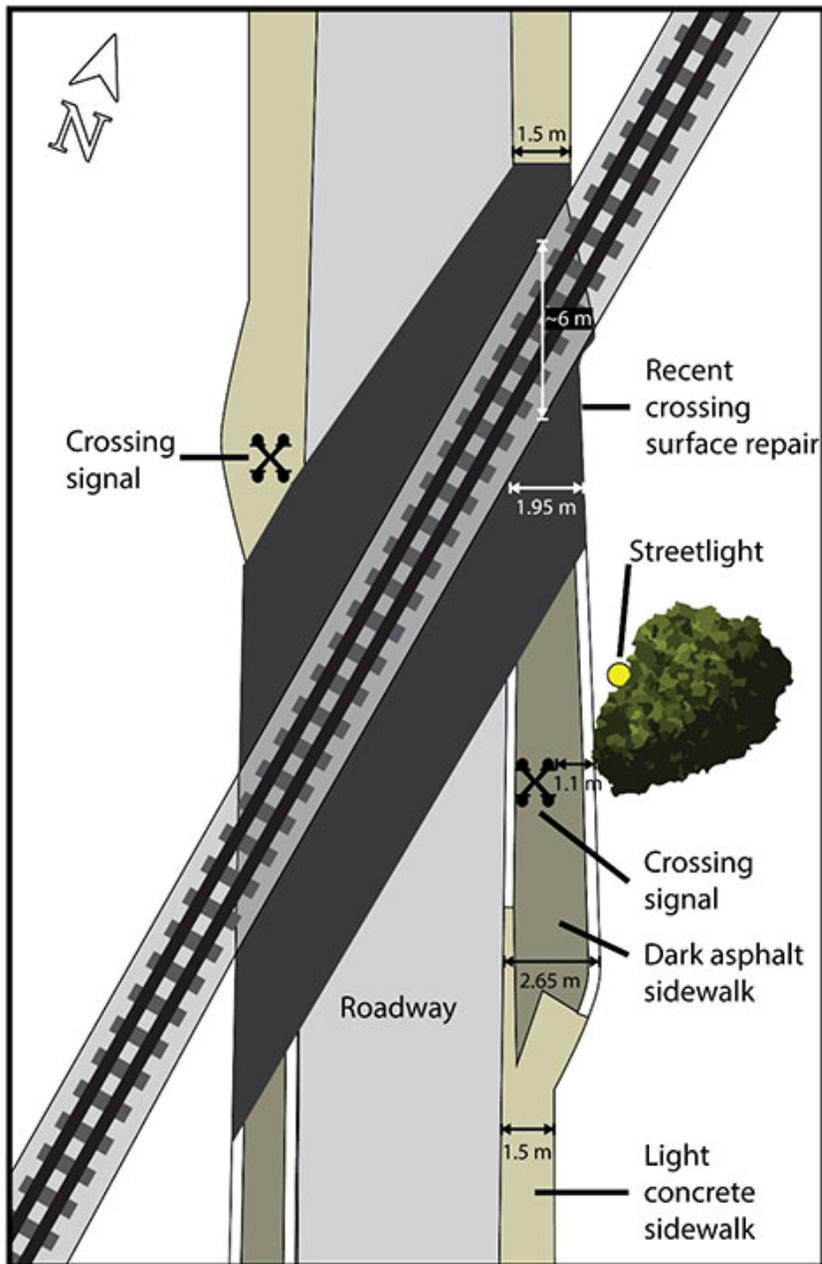
Figure 3. Schematic of Robinson Street crossing

Robinson Street is a 2-lane asphalted roadway approximately 24 feet wide curb to curb and is bordered with a sidewalk on each side. The street has a north–south orientation and crosses the railway track at an angle of 34 degrees (Figure 3). On average, about 2000 vehicles use this crossing each day.³ There are 2 streetlights in the vicinity of the crossing: one located in the southeast quadrant of the crossing and the other in the northwest quadrant, approximately 110 feet past the crossing.

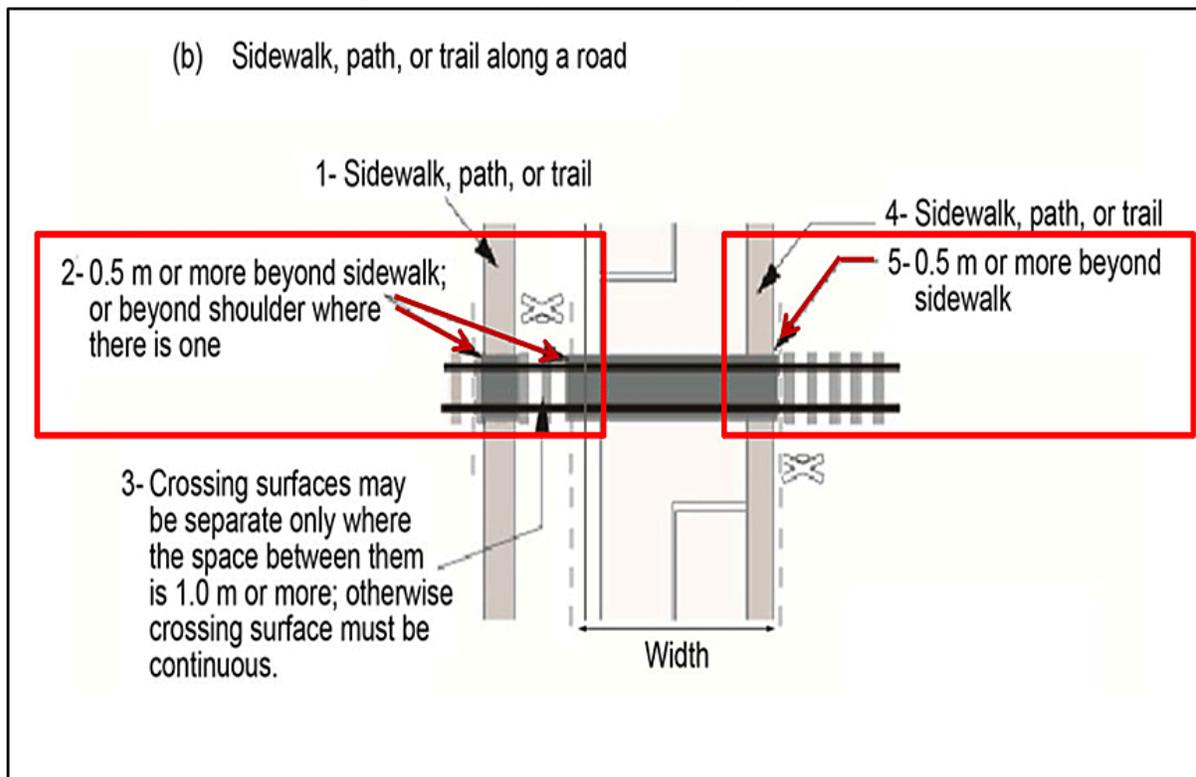
Figure 10. Requirement for crossing surface to extend 0.5 m beyond width of sidewalks and roadways (Source: Transport Canada, *Grade Crossings Standards* (July 2014), Part C, Figure 5-1(b), with TSB annotations)

Part C, Figure 5-1(b), of the GCS indicates that the sidewalk crossing surface should extend at least 0.5 m past the sidewalk (Figure 10).

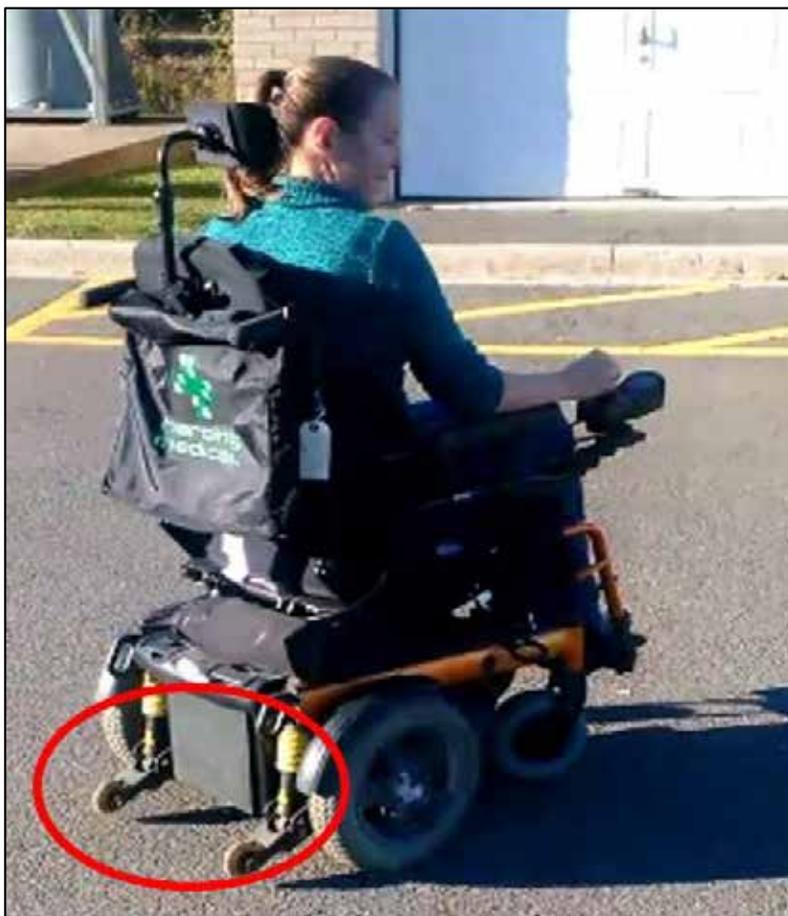
Figure 12. Motorized wheelchair similar to the occurrence wheelchair, with the anti-tippers circled

In this occurrence, the motorized wheelchair had 6 wheels: 2 large drive shaft wheels (14 × 3 inches), 2 front caster wheels (8 × 2¼ inches), and 2 rear stability wheels, called anti-tippers (3 × 1¼ inches). The anti-tippers were set approximately 16 inches apart (Figure 12). The weight of the wheelchair, including the battery, was about 275 pounds. The total weight of the occupied wheelchair (i.e., with the pedestrian and all the peripherals) was about 500 pounds.

This model of wheelchair is typically set up to provide 75 mm (3 inches) or more of ground clearance for the footboard at the front. The anti-tippers are pre-set at the factory to provide about 6 mm ($\frac{1}{4}$ inch) of ground clearance to protect against tipping backward. The user manual states that

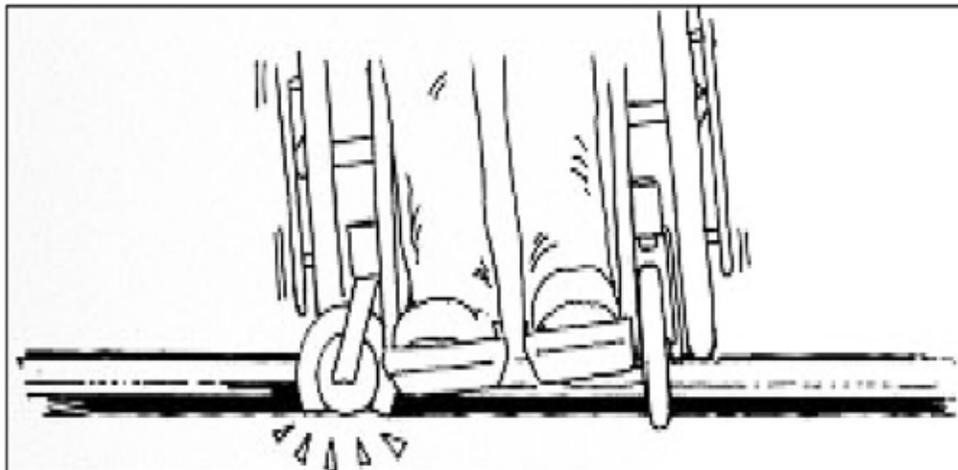
Figure 13. Wheelchair caster wheel stuck in a flangeway gap (Source: United States Department of Transportation, *Designing Sidewalks and Trails for Access Part II of II: Best Practices Design Guide* (September 2001), section 8.11: Railroad crossings, figure 8-26)

If crossing surfaces are uneven, flangeway gaps can pose an even greater challenge to users of assistive devices. Specifically, the caster wheels on wheelchairs can rotate when the surface level changes. If this occurs at the crossing, the caster wheels can drop into the flangeway gap, immobilizing the wheelchair (Figure 13).^{24,25}

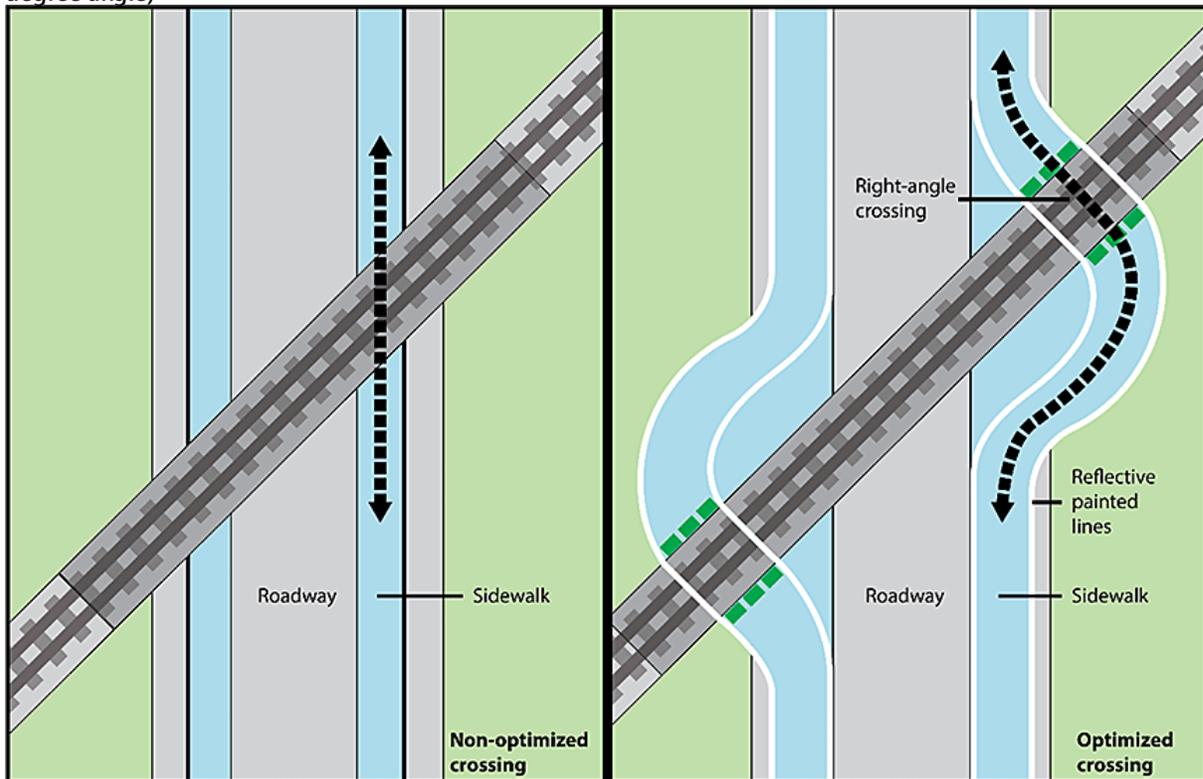
Figure 14. Designing sidewalks to optimize the railway crossing angle so that pedestrians can cross at a 90-degree angle)

The sidewalk angle will affect how the wheel on an assistive device will interact with the railway track. Both Operation Lifesaver and the U.S. Federal Railroad Administration (FRA) have recommended that wheelchair users cross railway tracks at a 90-degree angle to reduce the risk of a wheel becoming stuck in the flangeway gap.

The ability of a pedestrian to cross at a 90-degree angle depends on the design of the sidewalk crossing and the sidewalk width. Examples of a non-optimized sidewalk design and of an optimized sidewalk design are shown in Figure 14.
