## **RAIL TRANSPORTATION SAFETY INVESTIGATION REPORT R18H0039**

### **UNCONTROLLED MOVEMENT OF ROLLING STOCK**

Canadian Pacific Railway  
Remote control locomotive system  
Yard assignment T16-13  
Mile 195.5, Belleville Subdivision  
Toronto Yard  
Toronto, Ontario  
14 April 2018

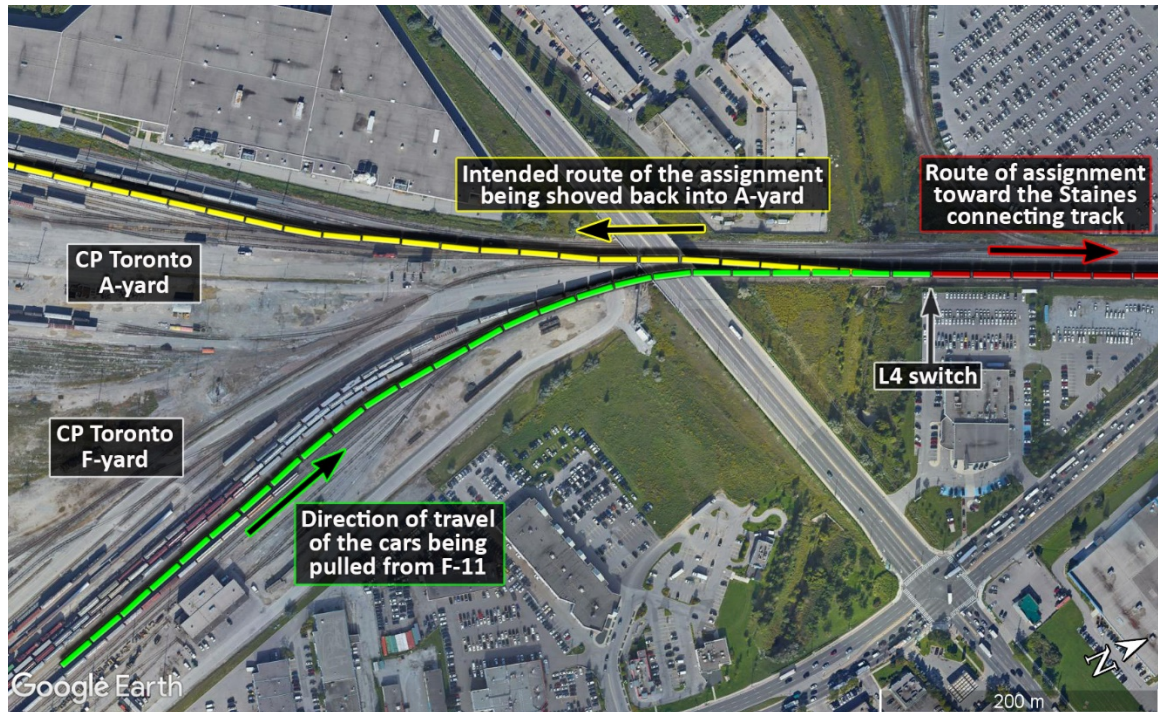
Figure S1. Map of east end of CP Toronto Yard (Source: Google Earth, with TSB annotations)

The plan had been for the assignment to pull 88 cars, weighing 6400 tons and measuring 6250 feet in length, from track F-11 eastward on the Staines connecting track. This move required the assignment to proceed past the Tapscott Road public crossing and to continue until the last car was past the L4 switch. The assignment was then to be reversed back into the A-yard (Figure S1).

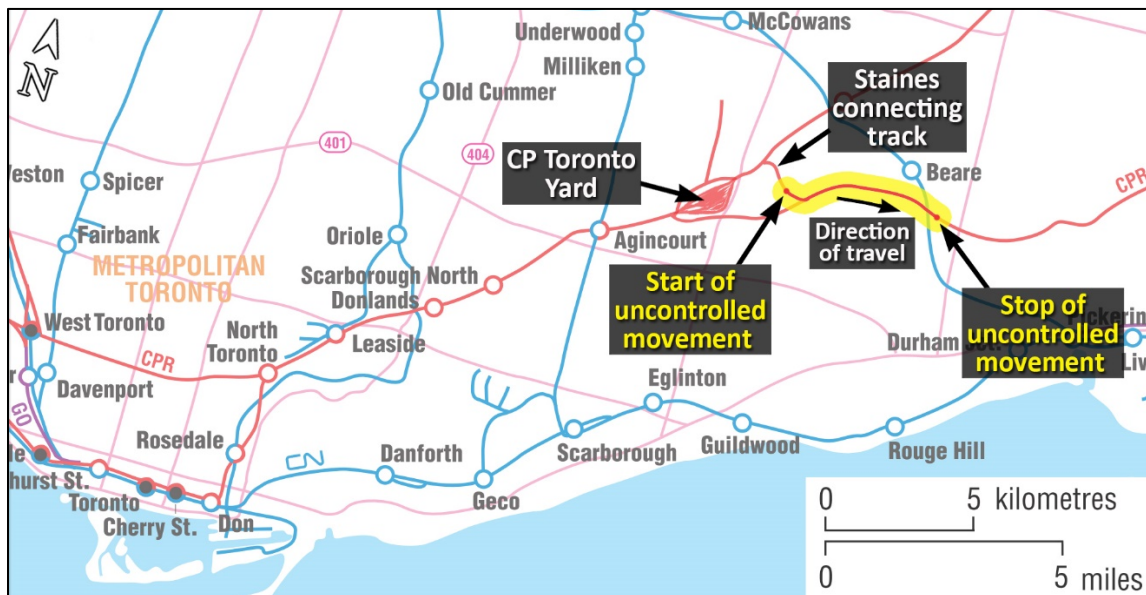
Figure 1. Map of accident location, showing the start and stop points of the uncontrolled movement (Source: Railway Association of Canada, Canadian Rail Atlas, with TSB annotations)

On 14 April 2018, Canadian Pacific Railway (CP) yard assignment T16-13 (the assignment), operated using a remote control locomotive system (RCLS), was performing switching operations at the east end of CP's Toronto Yard in Toronto, Ontario (Figure 1).

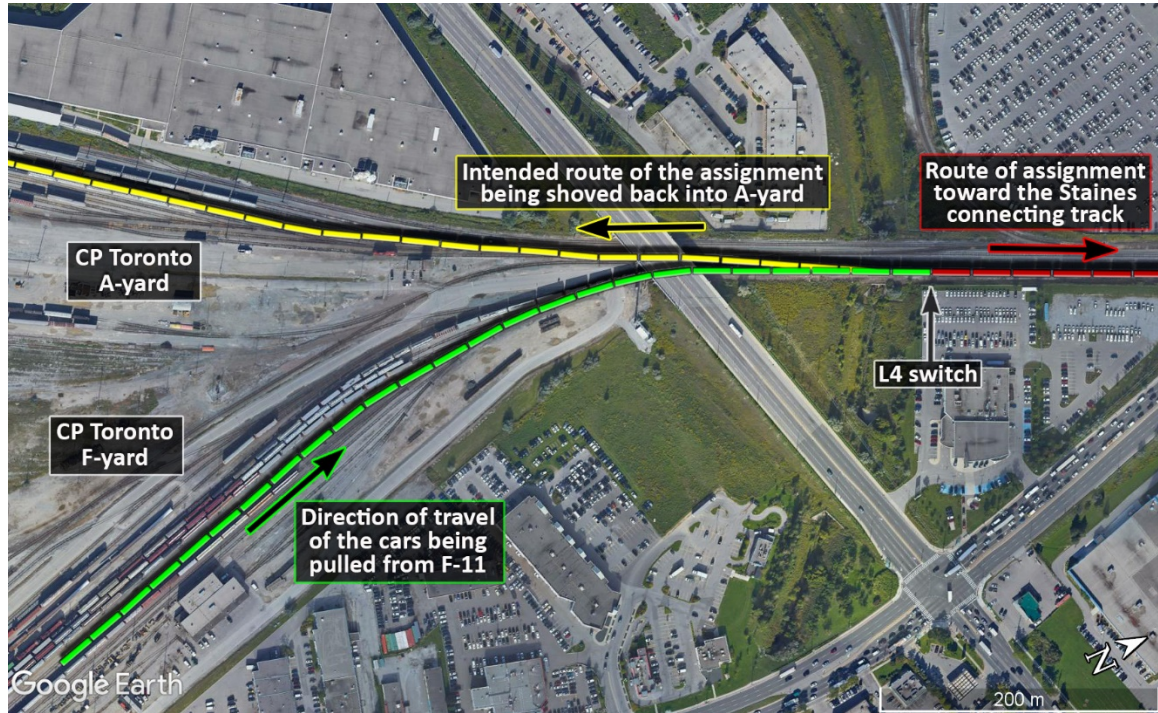
Figure 2. Map of east end of Toronto Yard (Source: Google Earth, with TSB annotations)

The crew planned to reverse the locomotives into track F-11 and connect onto the cars at the east end of the track. The assignment would then pull all 88 cars out onto the Staines connecting track and stop once the assignment cleared the L4 switch to shove back into A-yard (Figure 2).

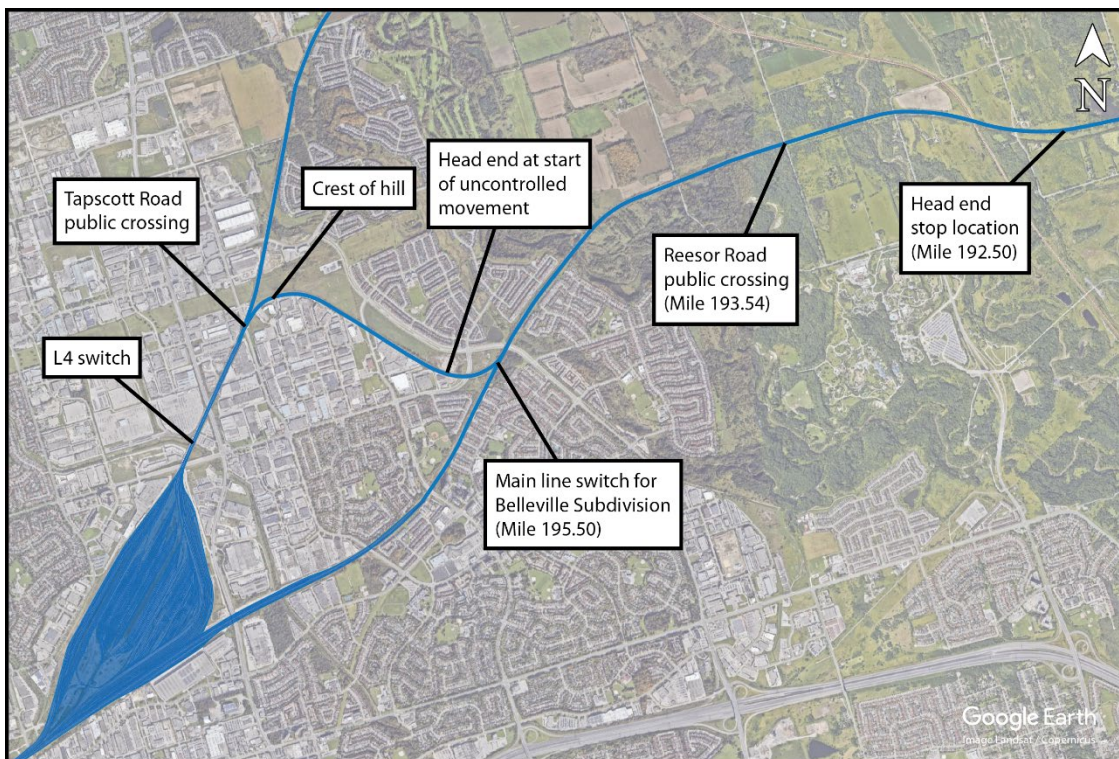
Figure 3. Route of uncontrolled movement (Source: Google Earth, with TSB annotations)

At about 0230, the assignment came to a stop near Mile 192.50 of the Belleville Subdivision, after having rolled uncontrolled for about 3 miles on the main track (Figure 3).

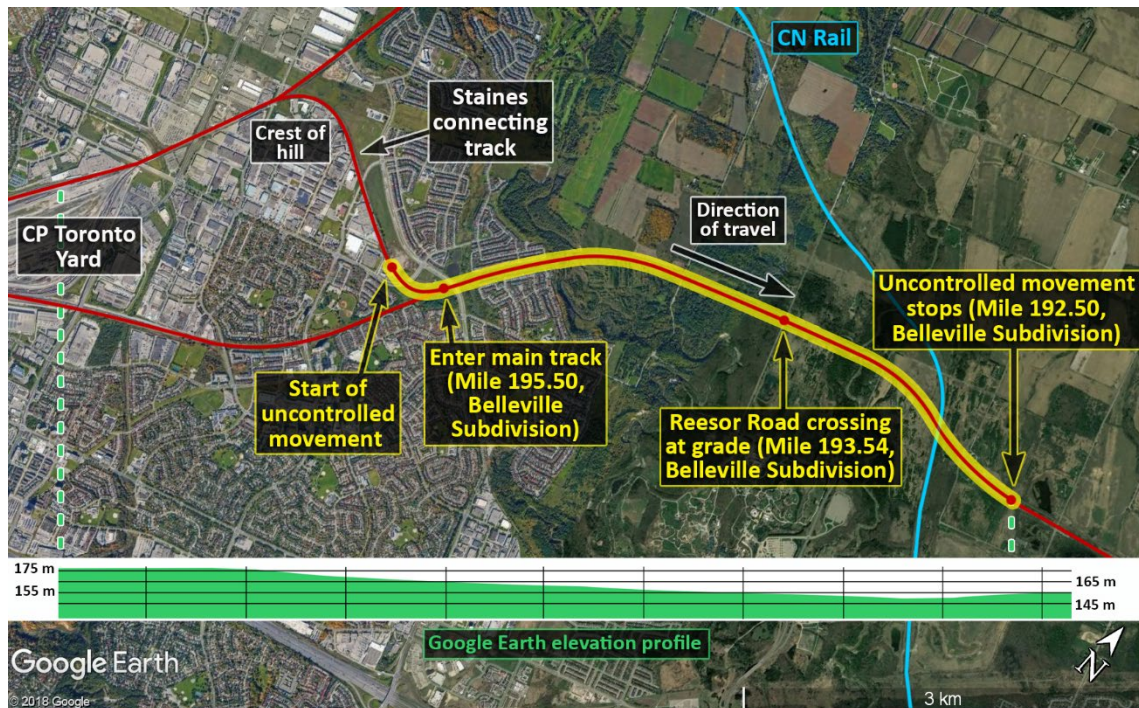
Figure 4. Route of uncontrolled movement and track elevation profile (Source: Google Earth, with TSB annotations)

From the L4 switch to just west of Tapscott Road, the track was relatively level, with a slight downward grade of 0.02%. From the L4 switch to the crest of a hill located about 500 feet east of the Tapscott Road crossing, the track had a slight upward grade of 0.16%. From the crest of the hill, the track descended for about 1.24 miles toward the Belleville Subdivision main track switch (Mile 195.50). Throughout this area, the descending grade varied between  $-0.88\%$  at the crest to  $-0.52\%$  approaching the main track switch. The average descending grade was  $-0.68\%$ . The descending grade continued eastward on the main track with an average descending grade of about  $-0.4\%$  until about Mile 193.0, at which point the main track began to ascend to Mile 192.50, where the locomotive came to a stop (Figure 4).

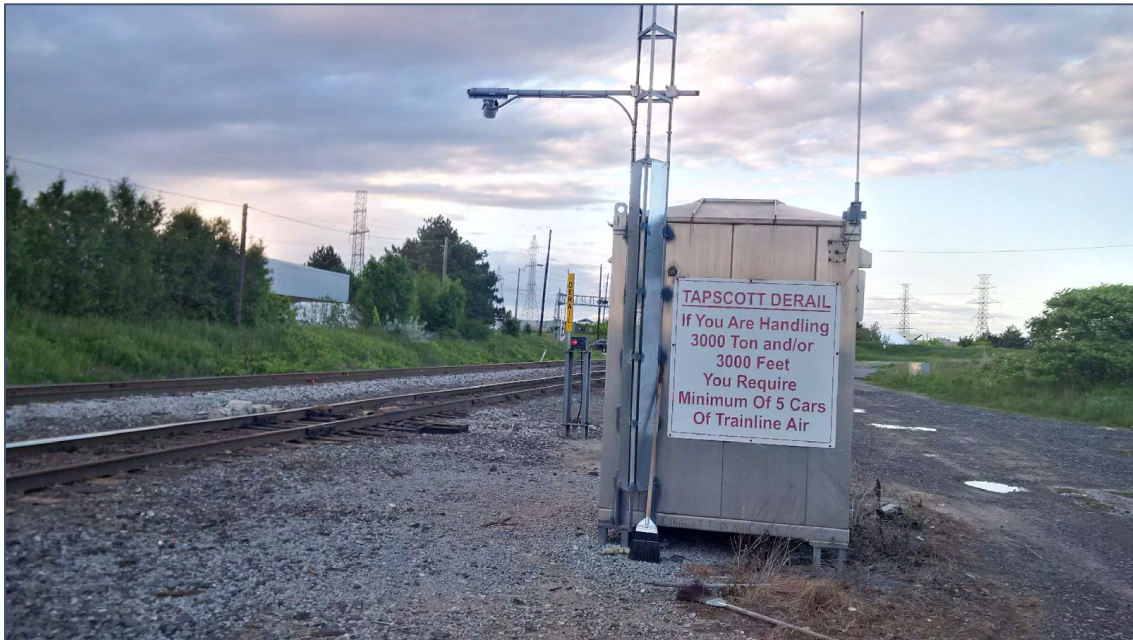
Figure 7. Sign on signal bungalow near the Tapscott Road crossing (Source: TSB)

In 2014, at Toronto Yard, CP had posted a sign on the signal bungalow at the remotely controlled derail located just west of Tapscott Road (Figure 7). The sign was intended to inform operating crews that when handling movements weighing at least 3000 tons and/or at least 3000 feet long, a minimum of 5 cars were required to be supplied with air to have operative air brakes that would help control the movement on the approaching descending grade. However, the use of the sign is not a rule or an operating instruction, as referenced in CROR General Rule B, and does not provide the context of why the additional operative freight car air brakes were required.
