RAILWAY OCCURRENCE REPORT

R97H0008

STRIKING OF A PUBLIC HIGHWAY OVERPASS

IRON HIGHWAY

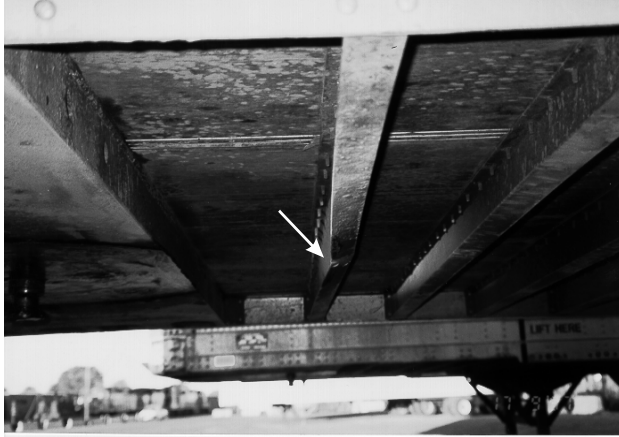
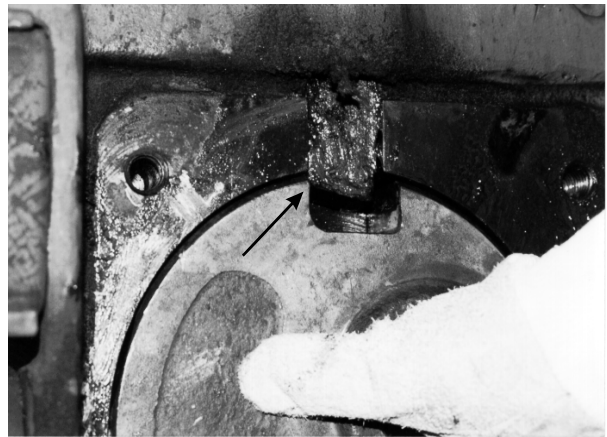
The hitch is designed so that the rotor lock plunger should not self-unlock when the engagement depth of the lock plunger exceeds approximately 1/8 inch.

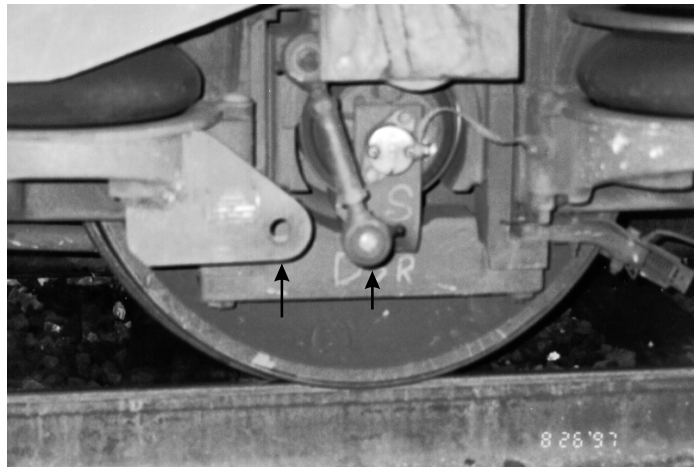
The rotary shock absorber (Vibrattech) on the Iron Highway equipment is used extensively in the passenger/commuter industry. It is designed to improve the ride characteristics of the equipment by controlling vertical bounce and to improve critical damping by 20 to 27 per cent. There are 84 shock absorbers on each Element. At nine locations, the shock absorbers were missing or disconnected on one side only, and at eight other locations, they were missing or disconnected on both sides. The latter situation applied to both the hitch end of the AP platform (where the trailer was connected) and the platform immediately ahead of the AP platform. The 25 missing or disconnected shock absorbers represent approximately 30 per cent of the total damping mechanisms on the entire Element.

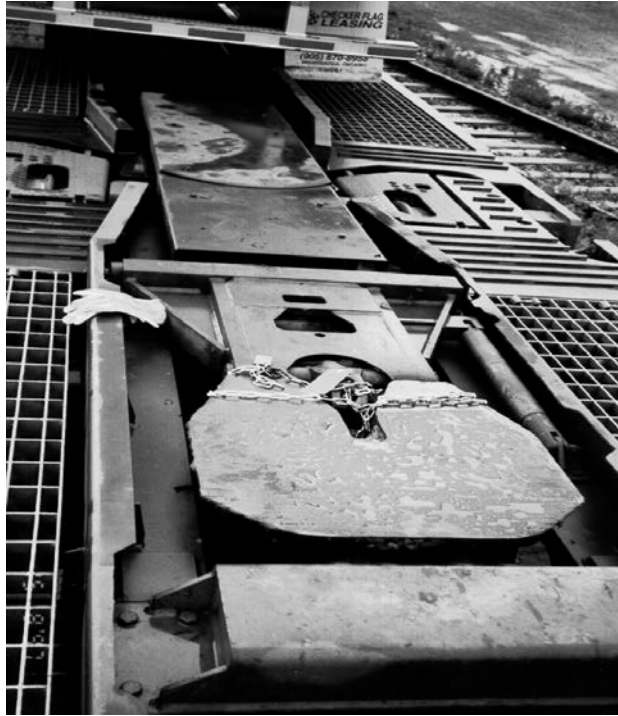
The cause of the bend in the indicator pin, as identified in TSB Engineering Branch report LP 150/97, was as follows: the rotor lock indicator pin hyper-extended during knock-down of the hitch, and then bent due to contact with the floor ribs of a trailer. Employees’ past experience with pins getting caught on floor underframes, and the number of bent pins examined by TSB investigators or referenced in inspection and repair records, suggest that this type of problem is not infrequent. During the off-loading sequence, a spotter may not be aware that an indicator pin has contacted a floor underframe, unless the hitch head actually remains jammed under the trailer. Because subsequent safety inspections of the Element are performed

when the train is empty and the hitches are collapsed to the floor, the view of the lock indicator pin is obscured by the geometry of the hitch head and the framework of the platform (see Figure 12). Because the damaged pin went unrepaired, the conditions existed for the accident to occur.
