AIR TRANSPORTATION SAFETY INVESTIGATION REPORT A22O0125

COLLISION WITH TERRAIN

Privately registered
Grumman Aircraft Engineering Corp. G44 (Widgeon), C-FNGD
Stratford Municipal Airport, Ontario, 1.3 NM ENE
23 August 2022

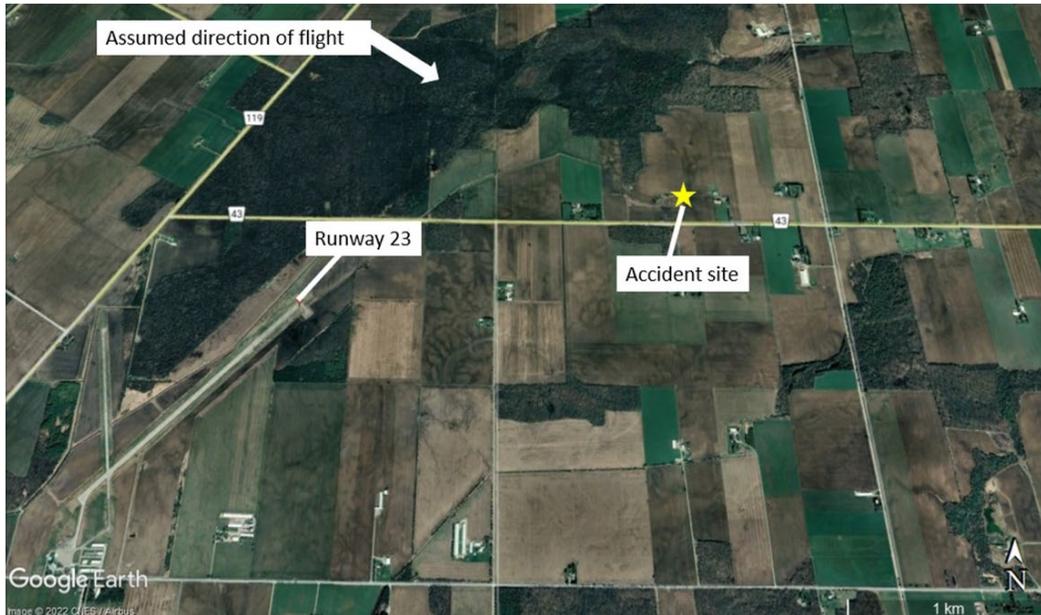
Figure 1. Map showing the accident site in relation to the intended destination (Runway 23), and assumed direction of flight (right base leg for Runway 23) (Source: Google Earth, with TSB annotations)

cultivated field, 1.3 nautical miles (NM) east-northeast of the Runway 23 threshold (Figure 1). There was a significant post-impact fire and the aircraft was destroyed. The pilot was fatally injured.
